Case Study 9

MSC CARLA

Complete Hull Failure in a Lengthened Container Vessel

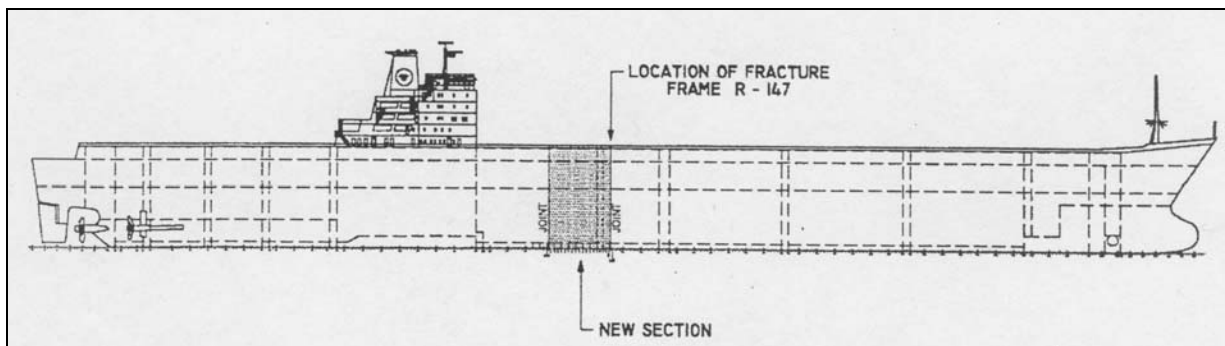
Figure 3. Location of Midbody and Fracture

The hull of MSC CARLA broke apart at the forward end of the new midbody. The bow portion sank after five days. The stern was towed into port.

MSC CARLA broke cleanly through the shell plate between frames R and 147 – the forward end of the new midbody. Because the stern of the vessel survived the casualty, substantial forensic evidence was available to experts to ascertain the mechanics of the failure. Because of the location of the fracture, the midbody addition was immediately suspect. Forensic analysis identified both design and manufacturing defects that contributed to the failure of MSC CARLA.

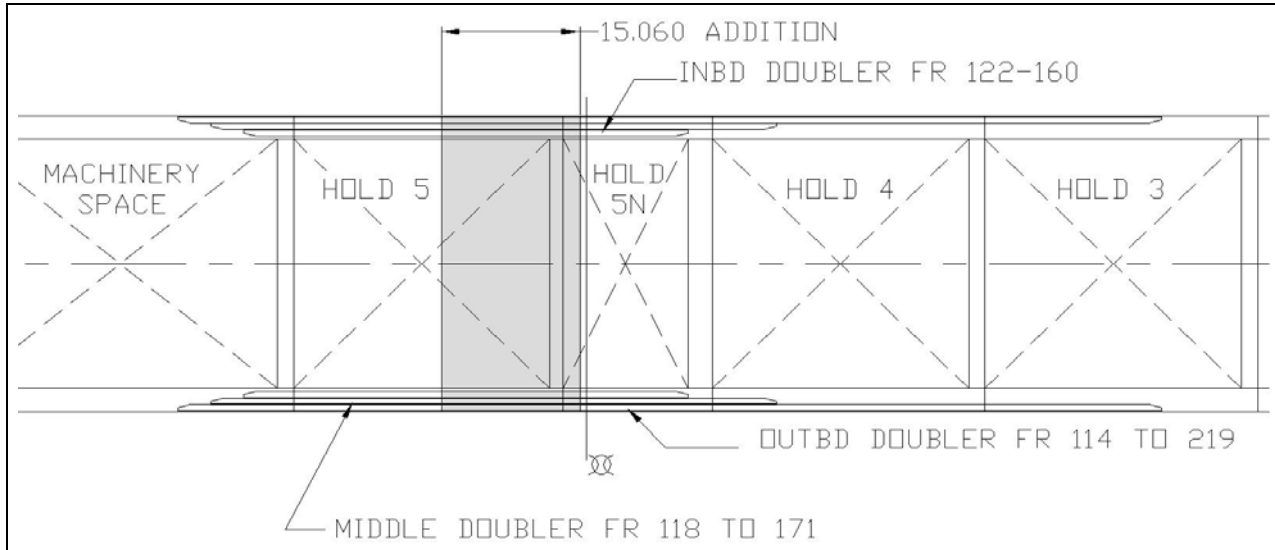
Figure 4. Plan View, Main Deck

Six doubler straps (three port, three stbd) were added at the main deck over the box girders to increase the section modulus of the midship section to compensate for the

increase in length. Minimum required section modulus in ABS is a function of length squared. With the increase in length of 14.27m over 275.22m or 5.2 percent, the increase in required section modulus is 10.6 percent. There are several aspects of the doubler design that acted to diminish their effectiveness.

The doubler straps were designed as 650mm wide by 45mm thick and attached by 21mm fillet welds. Both ABS and Lloyds caution against using doubling that is excessively thick relative to the thickness of the existing plate. ABS advises limiting doubler material to 1.25 times the existing plate, but stipulates that 1.5 may be allowed in isolated cases. They warn that the situations where they have seen ratios up to 1.5,

results have not been favorable. Specifically, cracking has occurred in way of the butt joints. Lloyds limits doubler material to 2 times the existing plate, but their experience was limited to ratios of 1.25 times. On MSC CARLA the existing deck plating was 33mm in way of the joint and as thin as 30mm within the length of the doubler straps. The corresponding thickness ratios are 1.36 and 1.5, respectively, within the limits of ABS and Lloyds but outside the bounds of their favorable experience. Lloyds recommends the breadth to thickness ratio of doublers not exceed 15. At 650mm by 45mm, the straps on the MSC CARLA have a ratio of 14.4. In Lloyds' technical bulletin on the subject, their case studies were limited to doublers less than 550mm wide and only three cases were considered that were over 450mm. ABS recommends a maximum doubler width of 574mm without the use of plug welds. There were no plug welds used on the MSC CARLA.

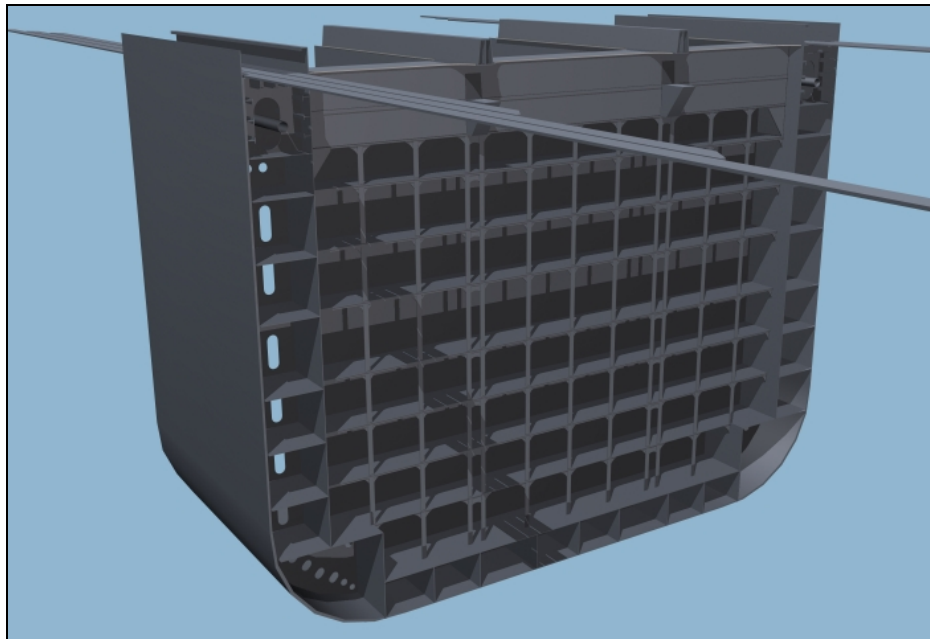
Figure 5. New Midbody and Straps

In order to enhance the longitudinal strength of the lengthened vessel, straps of plating were added on the main deck in way of the box girders at either side. These straps were 650mm wide by 45mm thick and welded with 21mm fillet welds. There were three straps on each side, extending from frame 114 to 219 outboard, frame 118 to 171 in the middle, and frame 122 to 160 inboard.

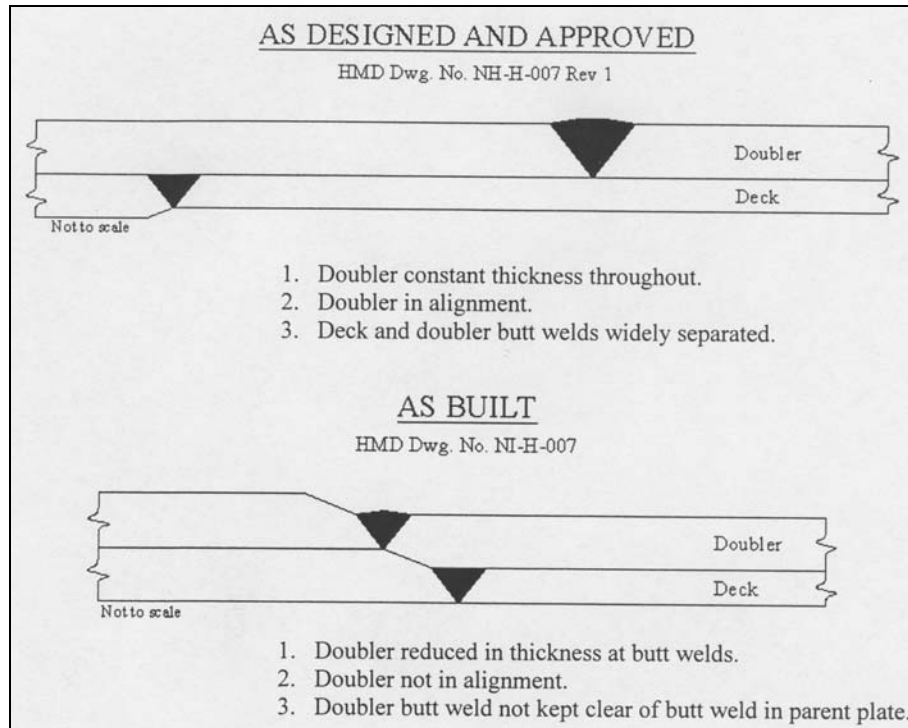
Figure 6. Deck and Doubler Alignment

In order to mitigate any weakness of these joints, it was specifically called out on the drawings that butt welds in the doublers be at least 1m away from the butt welds in the deck plates. When installed this was not adhered to, resulting in a common joint where both the deck and doubler are welded in the same location.

The deck plate in the existing ship was 30mm, while the deck plate in the new midbody was 33mm. In order to provide a flush surface for the doubler straps to land on, the new deck was to be flush above deck with the additional thickness below.

Butt welds in the doublers were to be full penetration and as such the edges were beveled. When the beveled edges were aligned on the ship, their geometry with the thicker deck plate is such that the effective thickness of the doubler is reduced. This occurs in an area of high stress due to the overlapping butt welds.

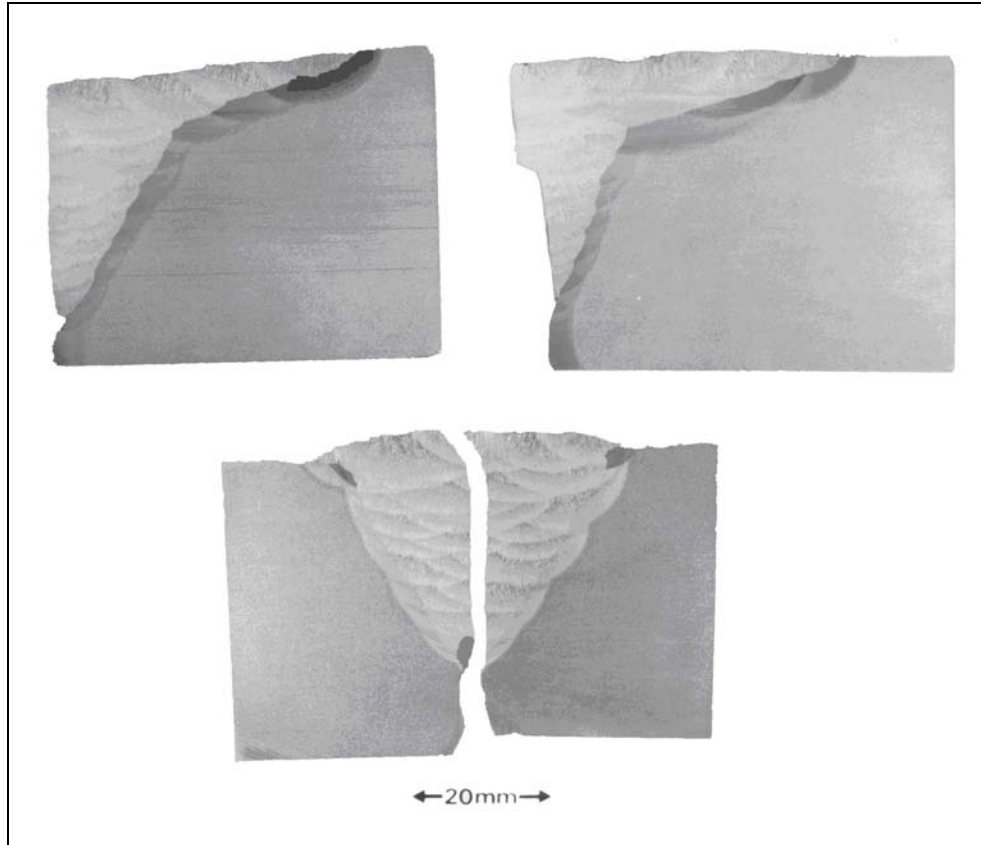
Figure 7. Doubler Strap Butt Welds with Insufficient Penetration

In addition to items that were installed improperly, MSC CARLA's lengthening was plagued by poor welding quality. While the butt welds of the doubler straps were meant to be full penetration, they were not, and later inspection showed that many had significant slag inclusion. Following the casualty, forensic experts inspected the butt welds in way of the new midbody. Of 14 locations observed, six had been repaired previously, and nine had some fatigue cracking present.

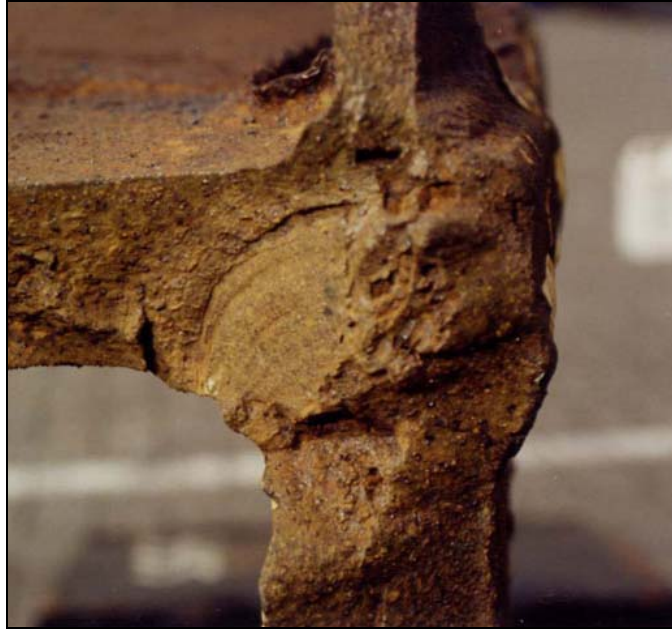
Figure 8. Excessive Weld Material, Port Side Joint

In any container ship, the longitudinal box girders are critical structure; they provide the bulk of the longitudinal strength at the deck level as well as torsional support to the vessel. Therefore, it is essential that their structure be installed properly and with great care. Following the MSC CARLA casualty, surveyors found serious fit-up and welding problems at the box girder corners both port and starboard. On the port side, it was evident that the deck plate and shear strake had not mated up correctly and an attempt had been made to fill this with weld material. On the starboard side a large cavity was present where the weld had not adequately penetrated to fill the beveling at the joint. It is at this location that the fracture is believed to have originated.
