Case Study 10

R/V WESTERN FLYER

Chronic Cracking in an Aluminum SWATH Research Vessel

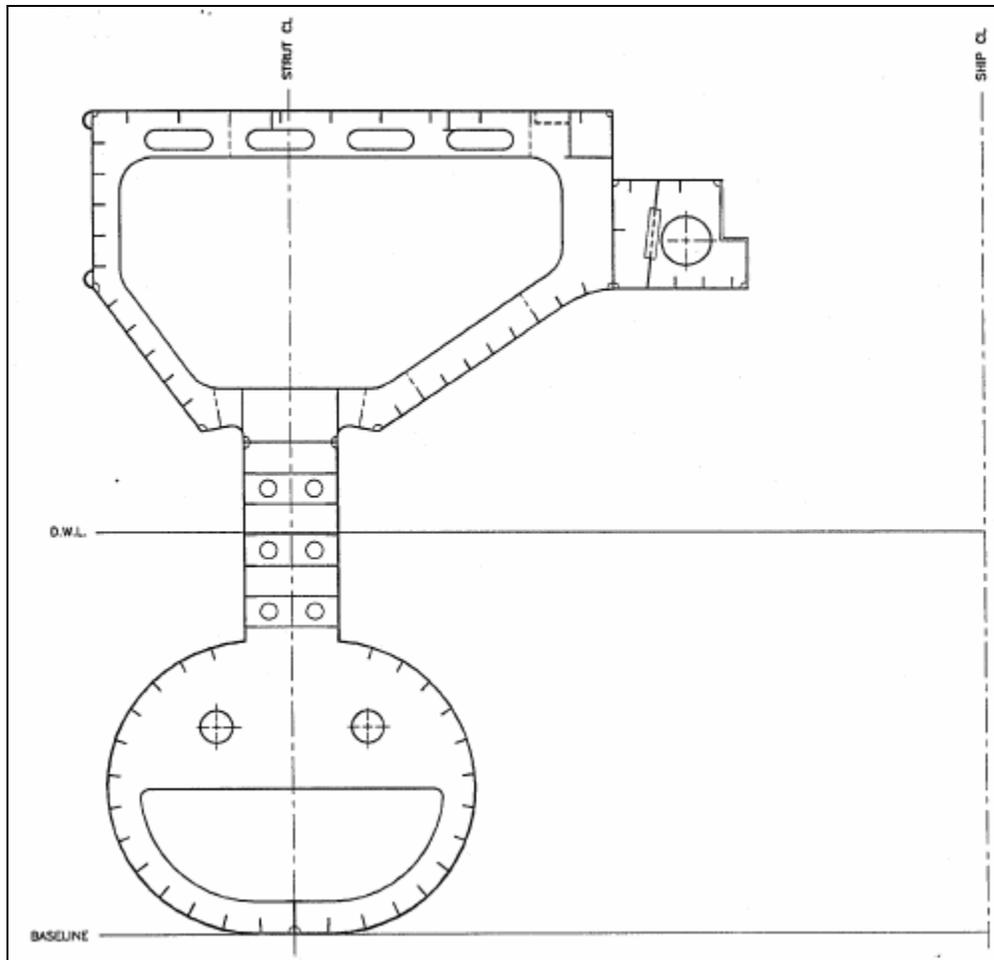
Figure 2. Transverse Web Frame

Figure 2 shows a typical transverse web frame. All structure is 5086 aluminum, except for isolated bulkhead and deckhouse framing that is 6061. Web frames are spaced every three feet, with transverse bulkheads every 15 feet.

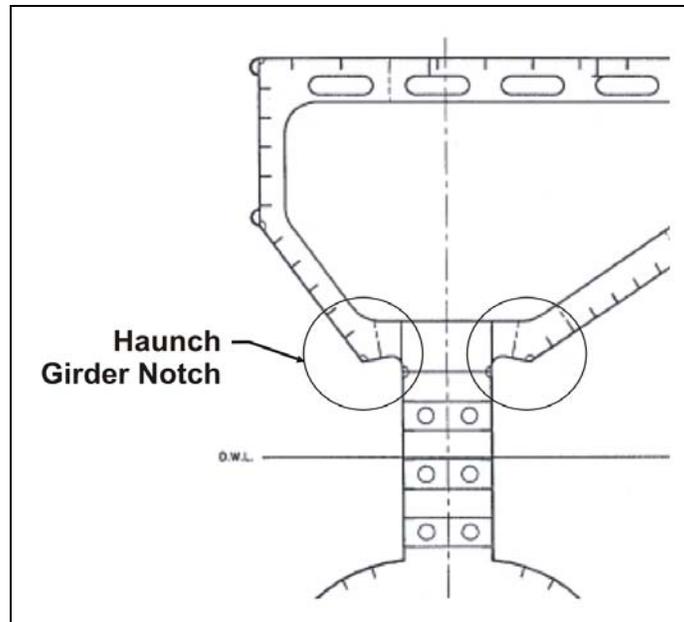
Figure 3. Haunch Girder Notch

While the cracking in the transom was the result of coincident plate seams, butts and corners, the majority of the cracking was in transverse frames and watertight bulkheads in way of the haunch girder notch. Cracking in the transverse frames was primarily in locations without adequate bracketing in way of the notch. Some side shell cracking was seen in way of the transverse bulkheads. See Figure 3.

In the first two months of limited operation and vessel monitoring, over 100 new cracks developed. All of these cracks were at the ends of welds in the haunch area. A stress monitoring program was installed on the vessel to provide a visual and audible alarm on the bridge to alert the crew of a need to change course.

In order to continue operating while extensive structural analysis was performed, the strategy of repair and monitoring was adopted. All cracks were repaired and brackets were installed on those frames without them previously. In order to assess the efficacy of the repair, operation was to proceed in worsening sea conditions with the possibility of altering course to minimize loading on the structure.

- Faired the notch between the strut and haunch.
- Added half frames in way of the haunch.
- Deepened existing haunch frames.

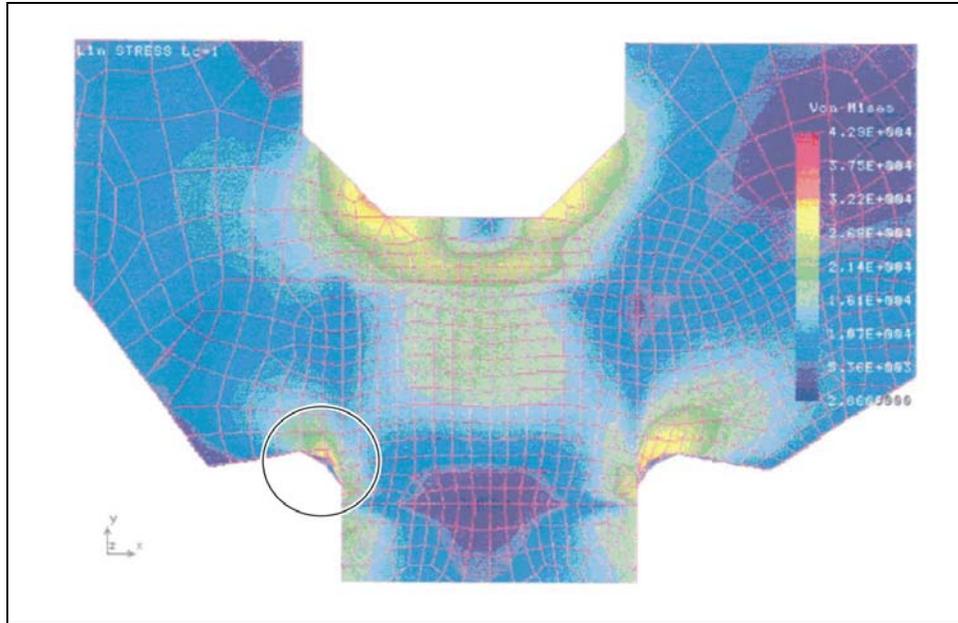
Figure 4. Stress in Transverse Bulkhead, Beam Sea, Sea State 5

Two-dimensional finite element analysis was completed on a typical bulkhead and web frame. Loading on the models was determined based on beam seas in Sea States 3-5. The loading on the hull for a regular incident wave over a range of frequencies was calculated using MIT's wave analysis program (WAMIT). The response in regular waves was applied to a Bretschneider spectrum to determine the extreme loads for each mode (roll, heave, pitch, etc.). Because the extreme forces do not occur together, combinations were created maximizing one mode at a time. The results of this initial FEA showed that even with brackets in place the stress in the haunch girder notch was over 40,000psi in Sea State 5. See Figure 4.

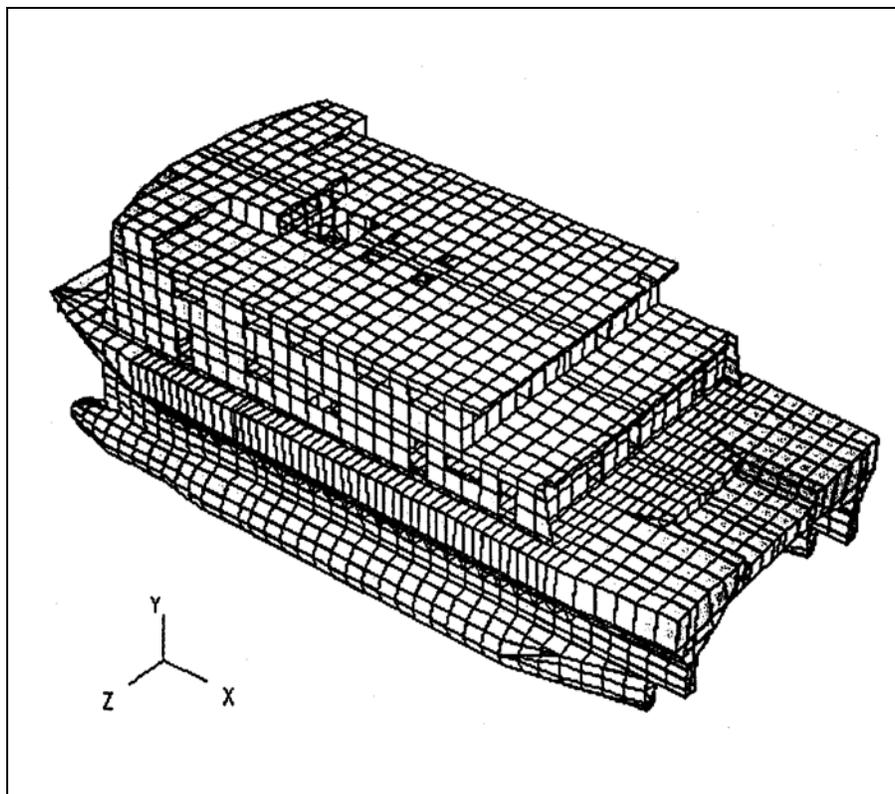
Figure 5. Global 3-D Finite Element Model

In order to understand more fully the response of the structure of the R/V Western Flyer, a global three dimensional finite element model of the entire hull and deckhouse was constructed. See Figure 5.

Results of the global FEA confirmed failures experienced in several areas of the vessel. High stresses were shown in the haunch girder notch areas and at the corners of the deckhouse bulkhead and deck intersections. Panel buckling was calculated (and had occurred) in the transverse structure aft of the moonpool and in areas of the deckhouse.

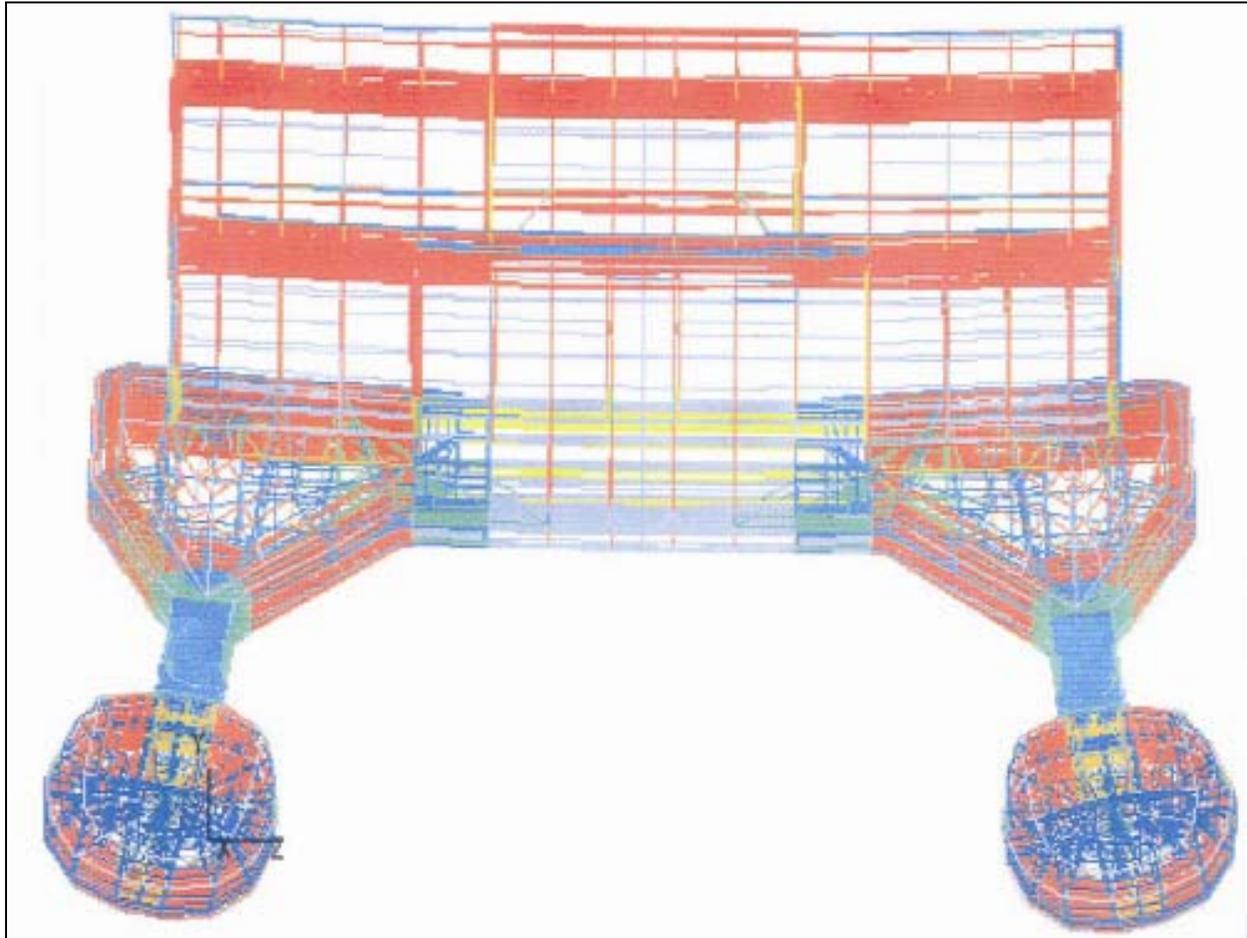
Figure 6. Deflection Plot, Prying Condition

A pressure distribution over the wetted surface of the hull was developed using an equivalent irregular wave. The resulting loading is a squeezing/prying moment acting on the pontoons. This analysis was repeated for the vessel with the proposed modifications to assess their effectiveness. The design load for the modified vessel is higher than the existing due to changes in the pontoons to counteract weight addition.

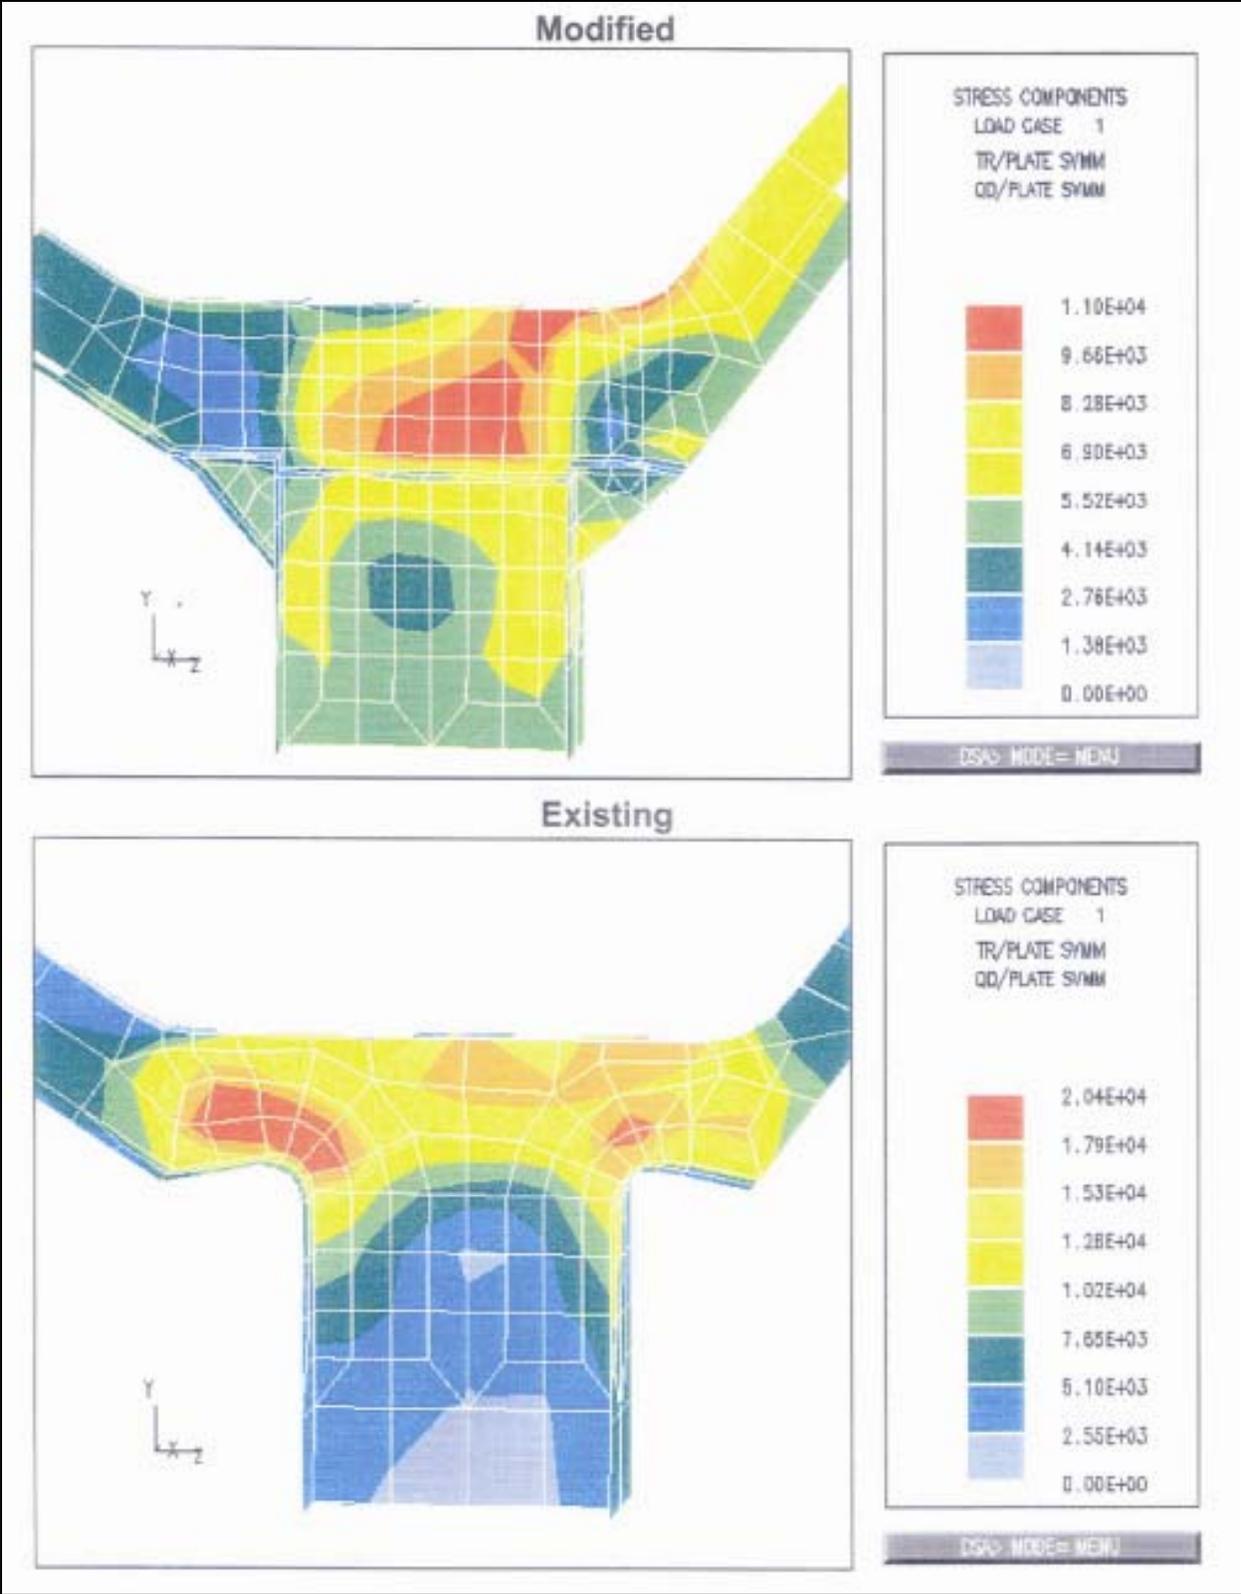
Figure 7. Haunch/Strut Stress with/without Fairing

Figure 7 shows the effect of the modification to the haunch girder notch on the stress distribution.

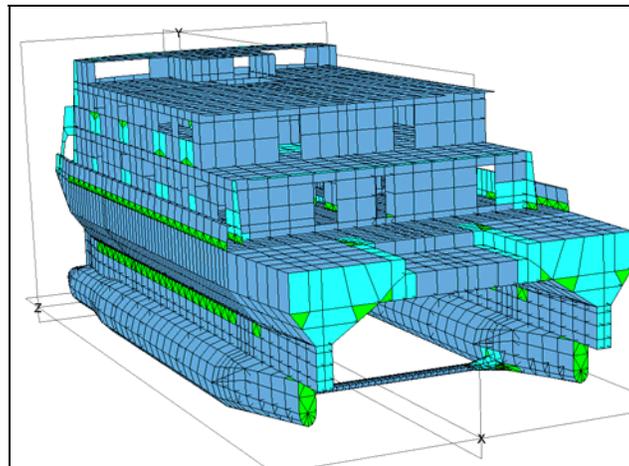
Figure 8. Global Model with Strut Installed

Unfortunately, the 1998 modifications were not sufficient to completely solve the cracking problem on R/V Western Flyer. She continued to experience cracking at the junction of the deckhouse and main deck. Because the deckhouse is stepped away from the side, the prying moment causes the deck to bend up around the house. In 2005, after various other attempts, a strut was added aft at Frame 28 to connect the hulls to resist prying. See Figures 8 and 9. Frame 28 was chosen because it coincides with transverse bulkheads above and below deck, specifically the aft house bulkhead. Because ROV operations are conducted through a moon pool, strut installation any further forward would interfere.

The crew reports no adverse effects on performance due to either the aft strut or the increase in pontoon diameter. Continued crack monitoring shows no additional cracking in way of the haunch or pontoon joints.
