## **Ship Structure Committee Case Study**

### *RMS TITANIC: ALTERNATIVE THEORY: Complete Hull Failure Following Collision with Iceberg*

**Summary:** The wreck of RMS Titanic is arguably the most famous marine casualty of modern times. On 14 April 1912 during her maiden voyage, RMS Titanic struck an iceberg southeast of Newfoundland, Canada. She floated for approximately two hours, eventually assuming an extreme trim by the bow and breaking in half.

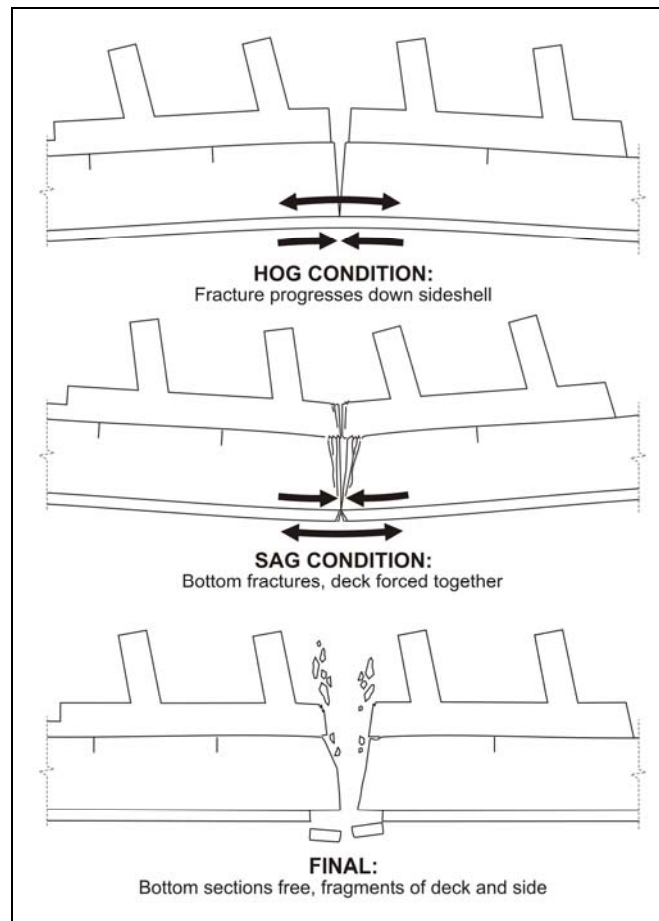
**Figure 1.** Mechanics of Long’s Theory

The debris field shows two large bow and stern sections, the “new” bottom pieces and a large amount of fragmented debris. The fragmented debris accounts for an inverted V-shaped portion of the hull that is otherwise missing from the larger pieces. Mr. Long’s theory is that the vessel commenced to fracture at the aft expansion joint. As the fracture traveled through the side shell, seawater poured into the stern portion, causing stress to be reduced, permitting the bottom structure to take the load for a short time. As reduced forces induced a sagging moment, the bottom was pulled free, while the upper hull was forced back together, causing the splintering of the missing V portion. See Figure 1.

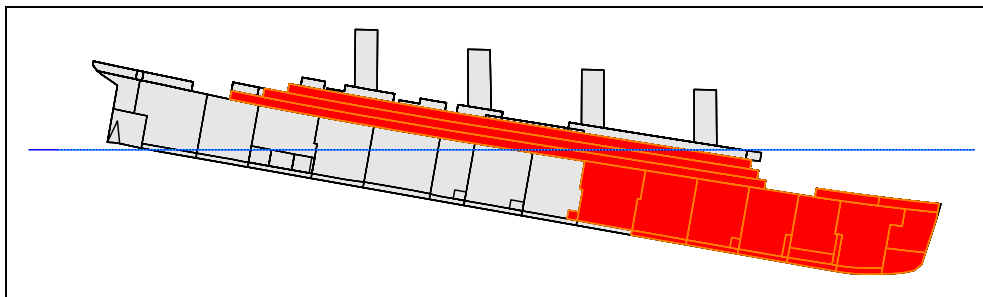
**Figure 6.** 10 degree Trim Flooding Condition

To approximate the casualty, progressive flooding was considered beginning at the forepeak tank. As shown in Figure 6, the final flooding condition analyzed experienced 10 degrees of trim by the bow, and included flooding to the Forepeak Tank and Stores, Holds 1-3, Double Bottoms 1-3, Boiler Rooms 4-6 and Decks A, B, and C.

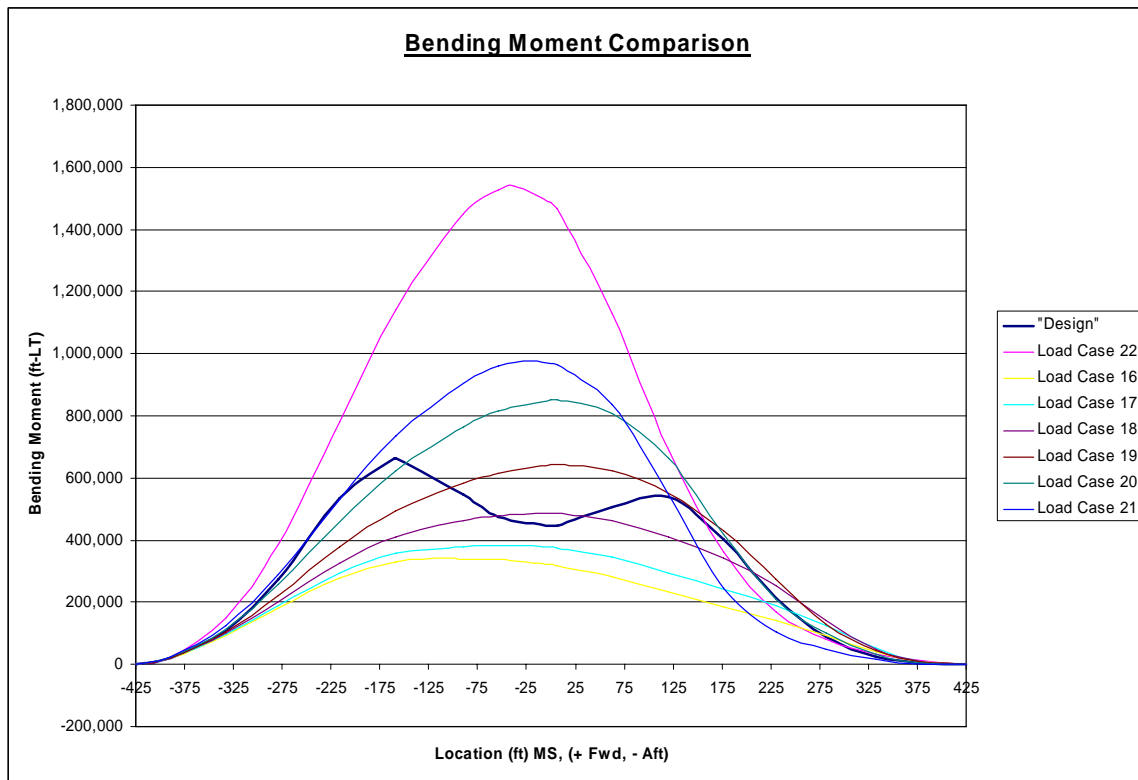
Figure 7. Bending Moment Comparison

Figures 8 and 9 compare the shear and bending moments over Titanic's length for each flooding condition against a theoretical design condition. The "Design" bending moment was taken to be the maximum bending moment calculated from load cases 1-13, the "Design" bending moment was determined to be 661,768 ft-LT in Hog and 151,840 ft-LT in Sag. The calculated flooded bending moment with enough flooding to create 10 degrees of trim (load case 22) was determined to be 1,538,892 ft-LT in Hog. The analysis shows that the bending moment resulting from the assumed flooding scenario far exceeds the "Design" bending moment.

It was found that the predicted flooded bending moments exceeded the predicted “design” bending moments in excess of two times. If damage to the hull girder occurred as a result of the flooding condition and associated bending moment, this would not necessarily indicate the vessel was insufficiently designed, disproving that portion of the hypothesis. The analysis does confirm high bending moments at only 10 degrees of trim, lending credence to the shallow angle fracture theory. In addition, longitudinal stability is lost at much shallower angles than the 40 degrees widely believed to be Titanic’s final intact attitude.

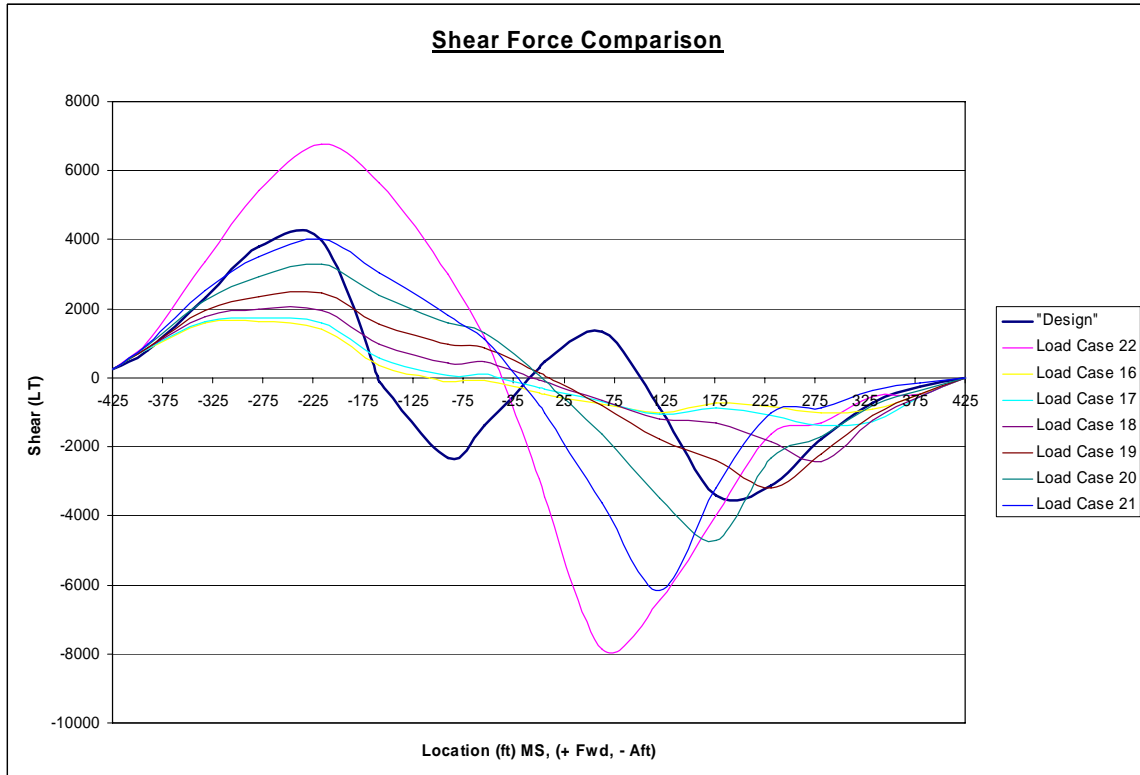
**Figure 8.** Shear Force Comparison

Similarly, the peak shear stress calculated from load cases 1-13, was determined to be 4,285 LT, 216 ft aft amidships (frame 72 aft amidships). The calculated flooded peak shear stress with enough flooding to create 10 degrees of trim (load case 22) was determined to be 7,847 LT, 63 ft forward amidships (frame 22 forward amidships).
