Yesterday's Technology—Today's Ships— Some Tanker Experience

D. J. Szostak, Member, Marine Transport Lines, Inc., New York, N.Y.

ABSTRACT

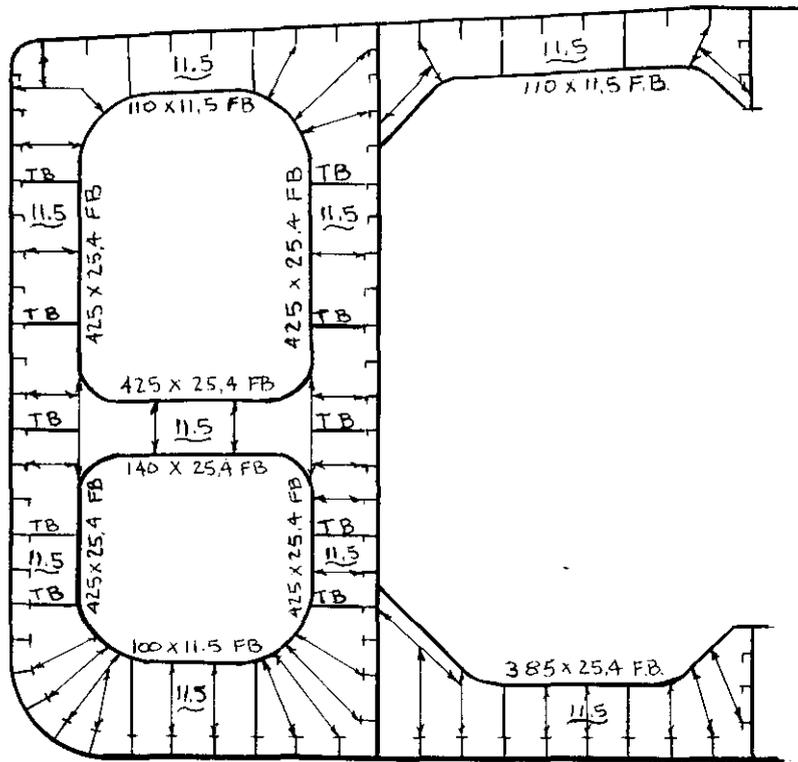
Figure 9 - Case I - Midship Section As Built

This vessel was designed according to methods and rules in existence in 1964. The scantlings of the transverse ring according to 1964 rules and as built as are indicated in Figure 9. At the time of plan development the scantlings were checked by beam theory methods and found to be within acceptable limits.

Figure 9 it may be seen that the principal changes occur in the size of web plate thickness, relocation of tripping brackets at the strut, and a balanced design of the strut. The lack of continuity in the face plate arrangement remains, however.

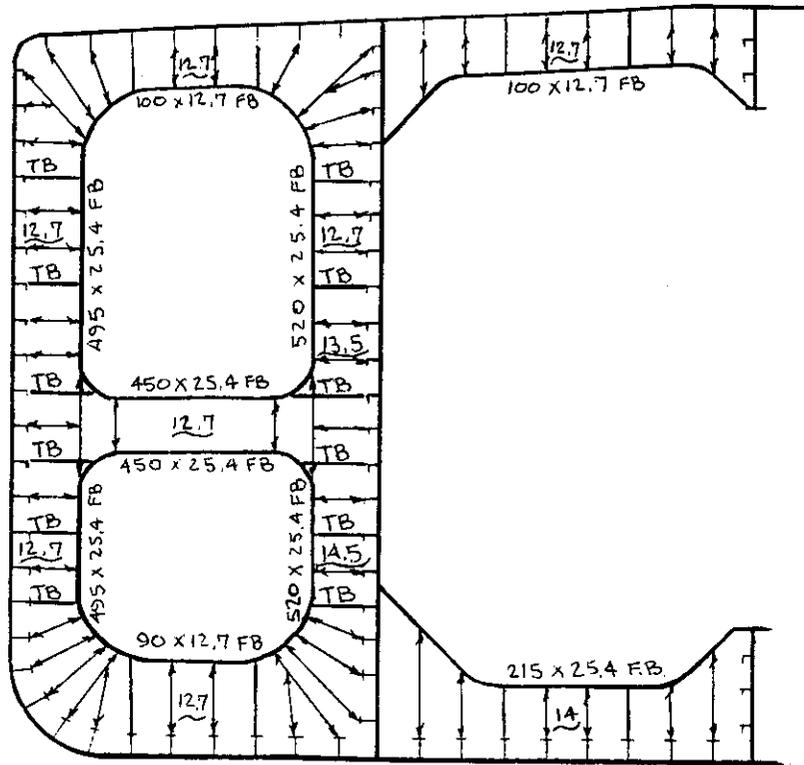
Figure 11 - Case I - Midship Section Utilizing 1968 Rules and Notices

At the time of reanalysis the 1968 classification society rules and recent notices were applied to this design to compare the existing vessel to the then current design criteria. This is shown in Figure 11. When compared with the original scantlings of

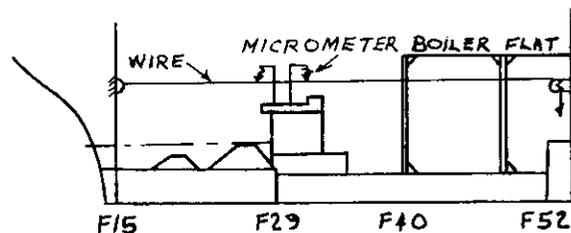
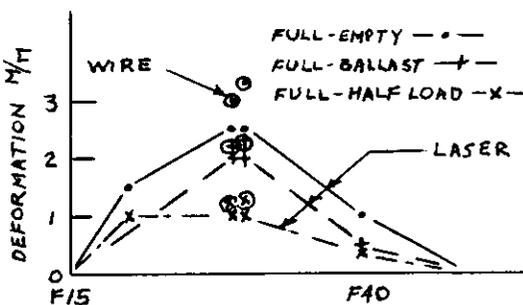
Figure 20 - Measured \mathcal{C} Deflection

The results of the shipboard measurements are given in Figure 20. Not only were the deflections considerably greater than

calculated, but the point of maximum deflection was much further aft than anticipated. In this case the maximum deflection occurred at the main gear casing.

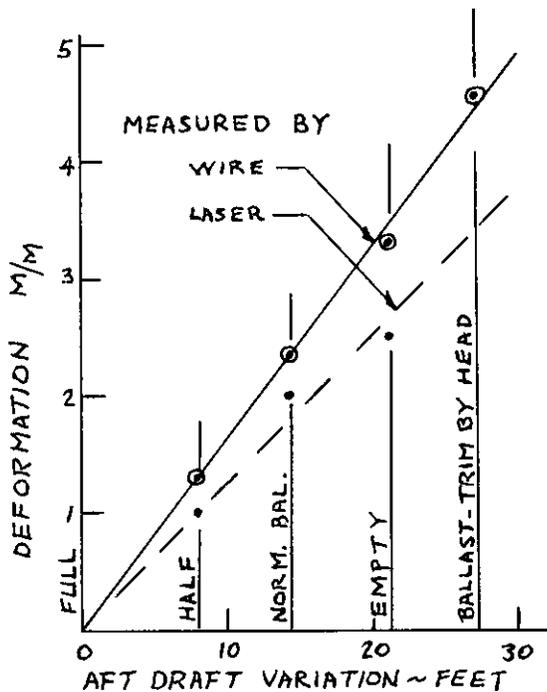
Figure 21 - Deflection at Bull Gear Forward Bearing

The deformation at the bull gear forward bearing as a function of the after draft variation is plotted in Figure 21. The slope of 1.65mm per 10 feet of draft is almost four times the calculated deformation of 0.42mm/10 feet previously mentioned. The causes for the poor analytical results are not known but are assumed to be primarily due to faulty boundary condition assumptions and disregard of the effects of interconnecting structures and pillars.

The latter method is recommended. Serious consideration should be given to increasing the depth of the engine room double bottom floors and to increase the effective rigidity of the engine foundations. Mounting the propulsion plant as far aft as practicable will locate the equipment where the floor breadth is less and thus reduce the effect of double bottom deflection. References 14 and 16 have pertinent discussions on this point.
