THE SOCIETY OF NAVAL ARCHITECTS AND MARINE ENGINEERS
601 Pavonia Avenue, Suite 400, Jersey City, New Jersey 07306 USA
Paper presented at the Marine Structural Inspection, Maintenance, and Monitoring Symposium
Sheraton National Hotel, Arlington, Virginia, March 18-19, 1991

Report on the Trans-Alaska Pipeline Service Tanker Structural Failure Study

J.D. Sipes, J.M. MacDonald, M.R. Bowen, H.P. Cojeen, B. Salerno, J.C. Maxham and J. Baxter,
Office of Marine Safety, Security and Environmental Protection, U.S. Coast Guard, Washington, DC

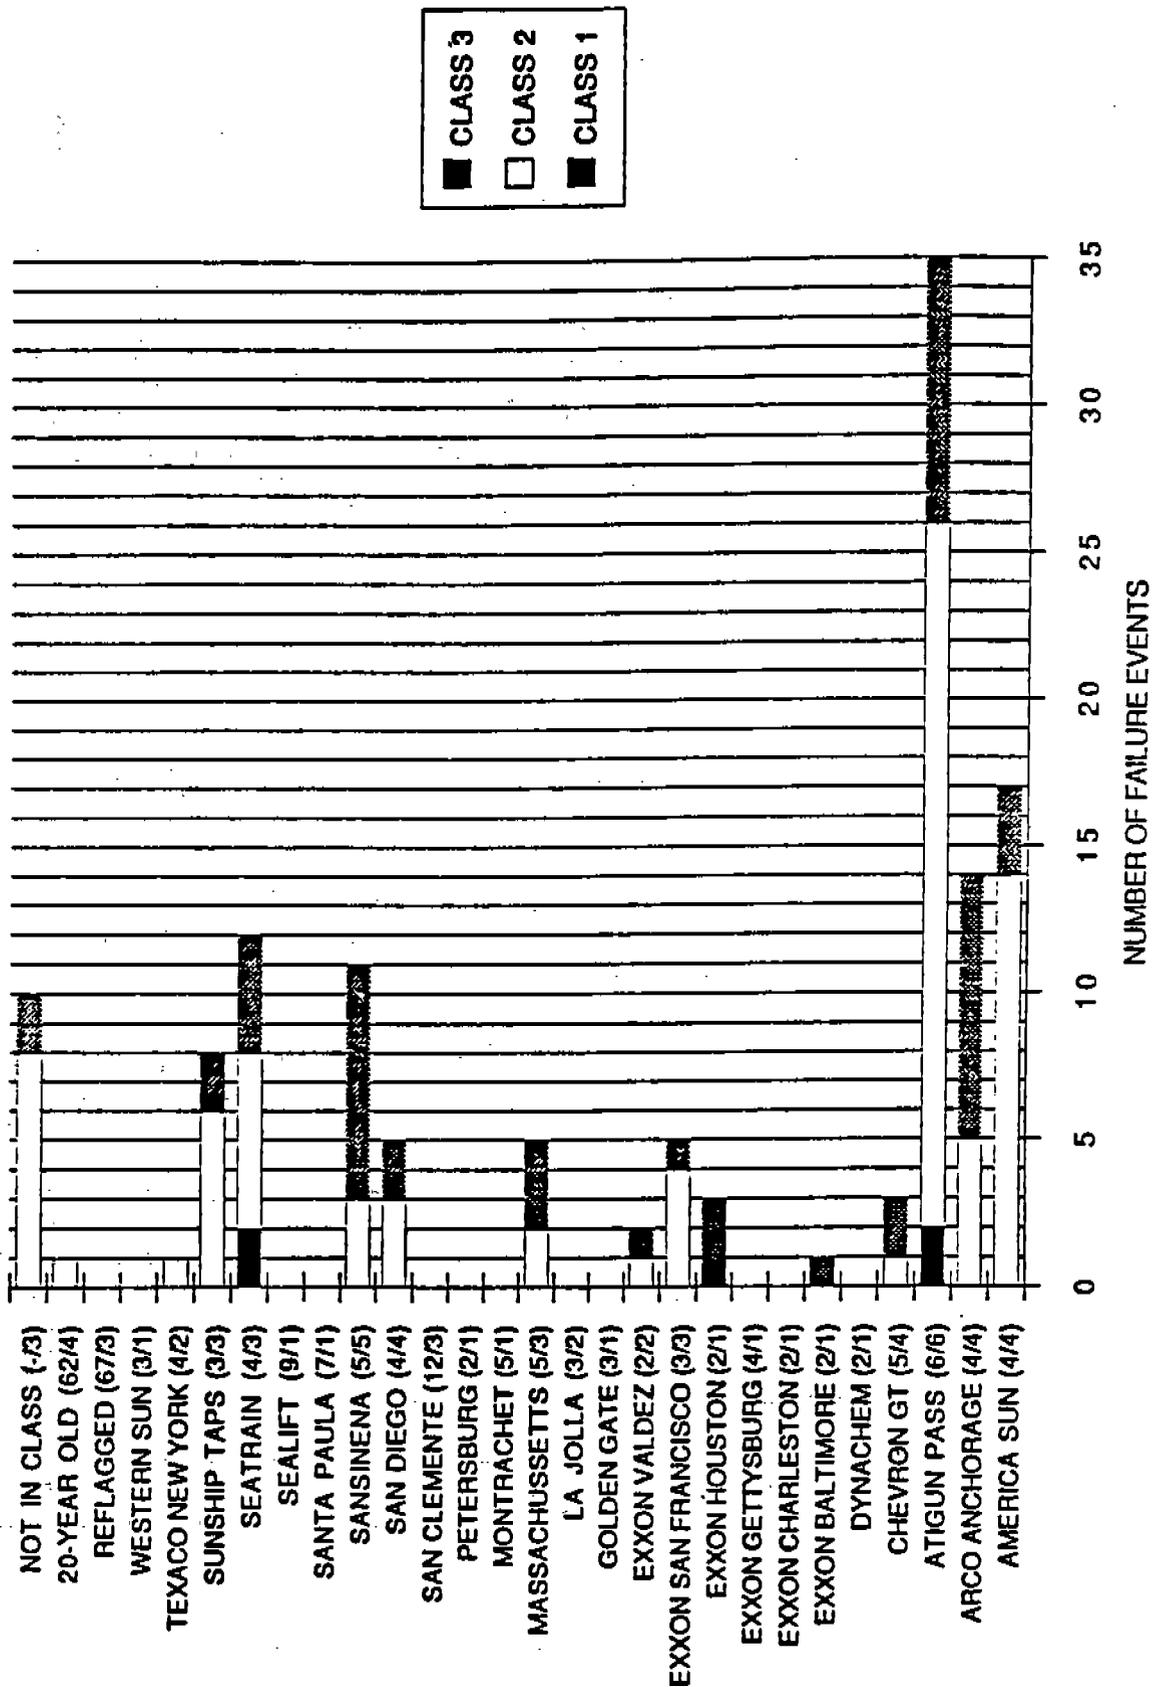
FIGURE III-1

Figure III-1 shows that the 69 vessels subject to this Study comprised 28 separate vessel classes (27 established classes and one special "Not In A Class" category, set up only for this Study, for three TAPS vessels not in an established class). Of those 28 classes, the Atigun Pass Class, consisting of 6 vessels whose entire cargo block section was constructed of high tensile steel, alone accounted for 26.3% of the documented structural failure events. Five classes, comprising 23 vessels, accounted for 66.9% of the documented failures. In addition, the vessel MOBIL ARCTIC (Not In A Class) accounted for 8 of the failure events, making a total of 24 (34.8%) vessels accounting for 72.9% of the documented failure events. Therefore, as a result of our analyses and information provided by the operating companies, the following vessels were identified as requiring special inspection, monitoring and/or reporting measures, as indicated:

STRUCTURAL FAILURE EVENTS BY VESSEL CLASS
 NUMBERS IN () SHOW # OF VESSELS IN CLASS/# WITH AT LEAST ONE PORT CALL IN VALDEZ

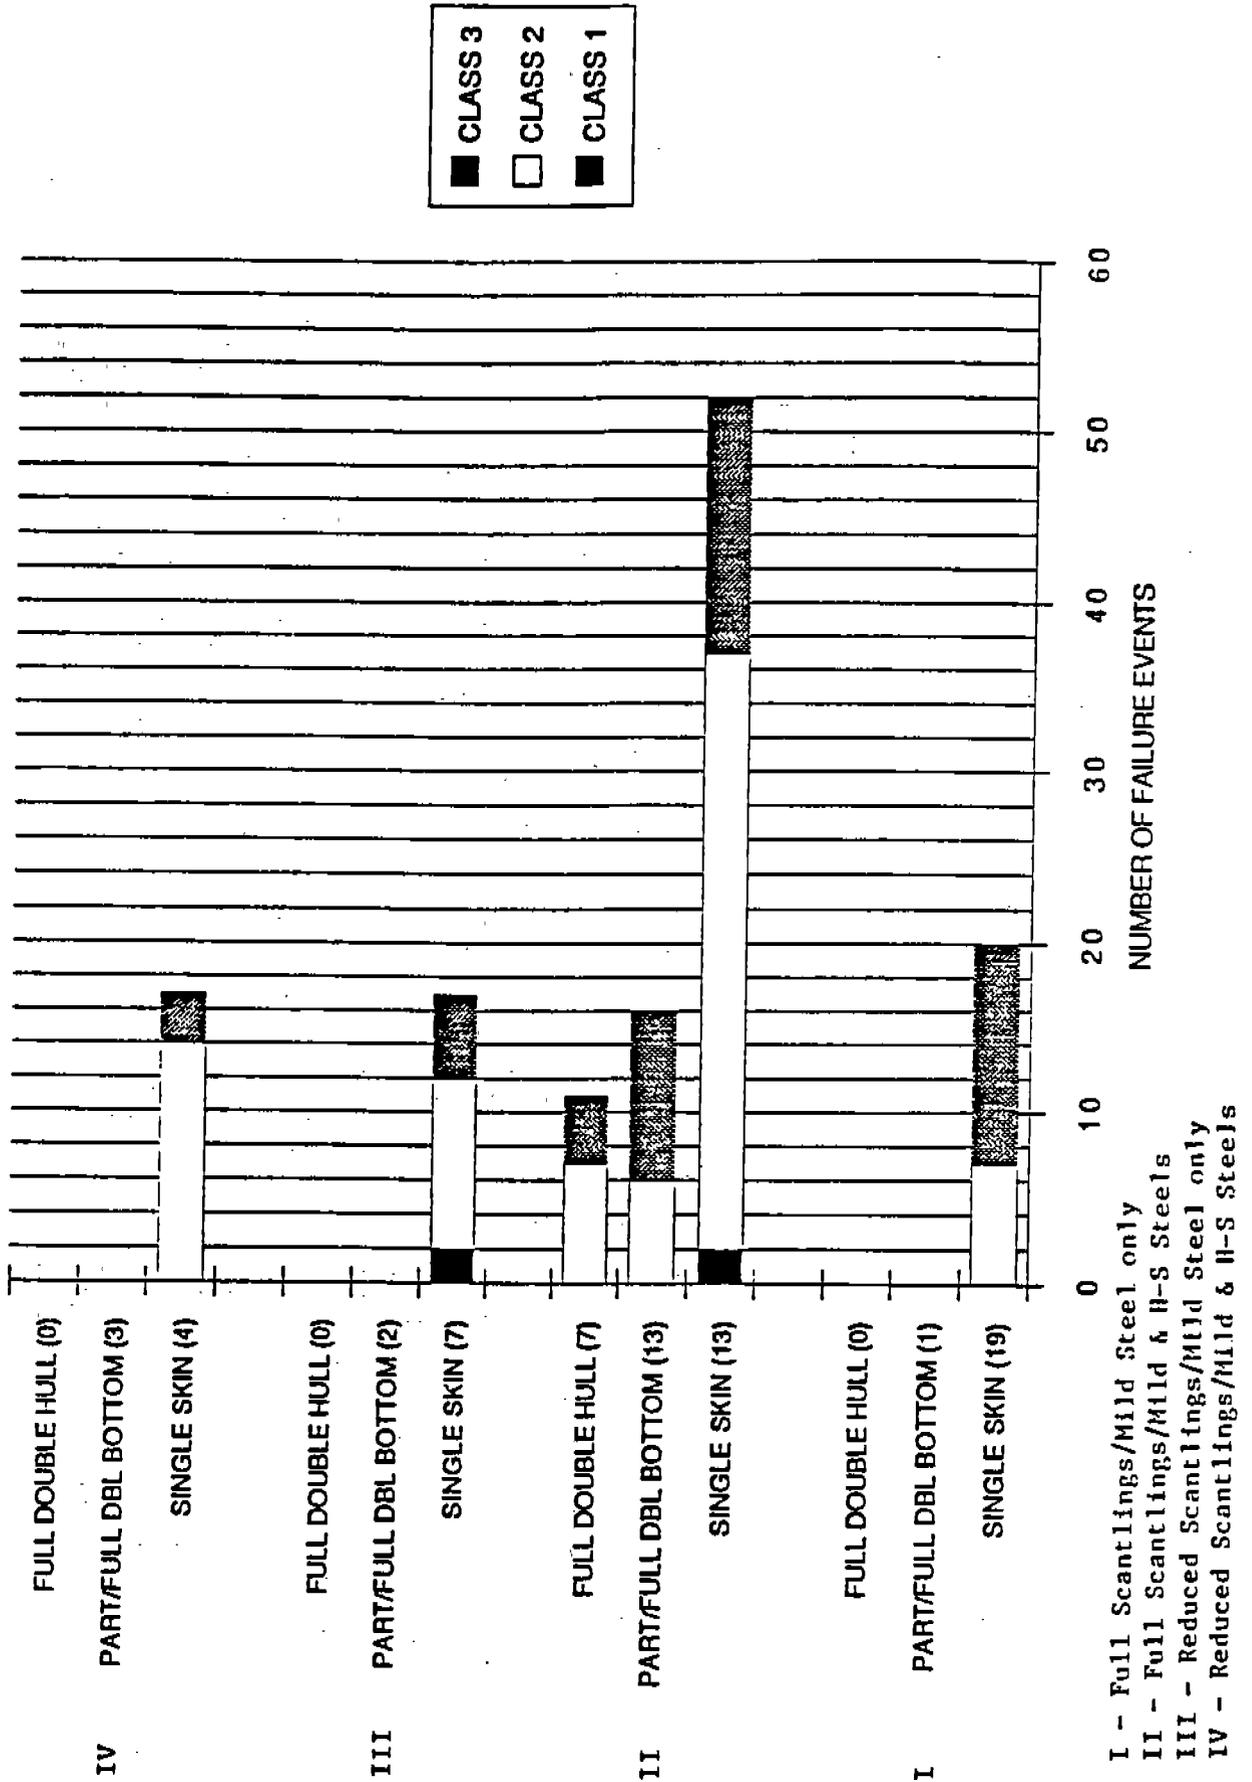
FIGURE III-2

STRUCTURAL FAILURE EVENTS BY METHOD OF CONSTRUCTION
 NUMBER IN () IS THE TOTAL NUMBER OF VESSELS WITHIN THAT GROUP

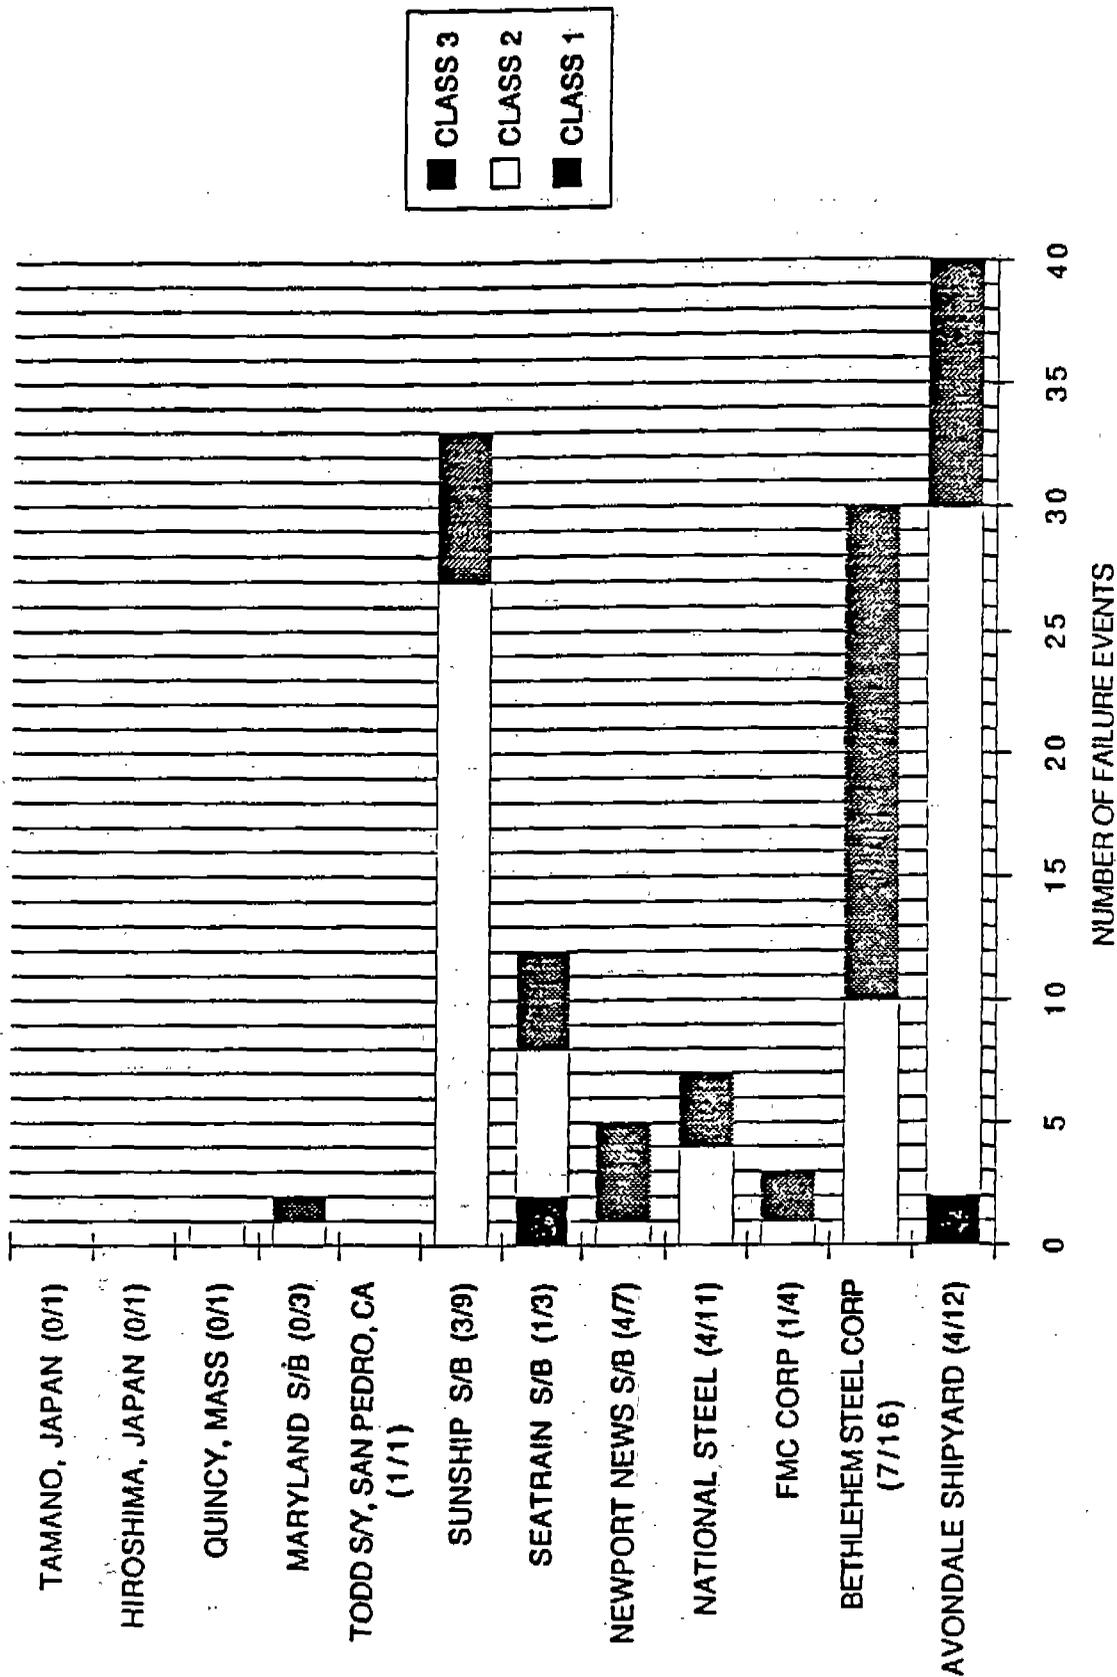
FIGURE III-3

STRUCTURAL FAILURE EVENTS BY PLACE OF BUILD
 NUMBERS IN () ARE # OF VESSEL CLASSES / # OF VESSELS BUILT THAT HAVE AT LEAST ONE PORT
 CALL IN VALDEZ SINCE 1984

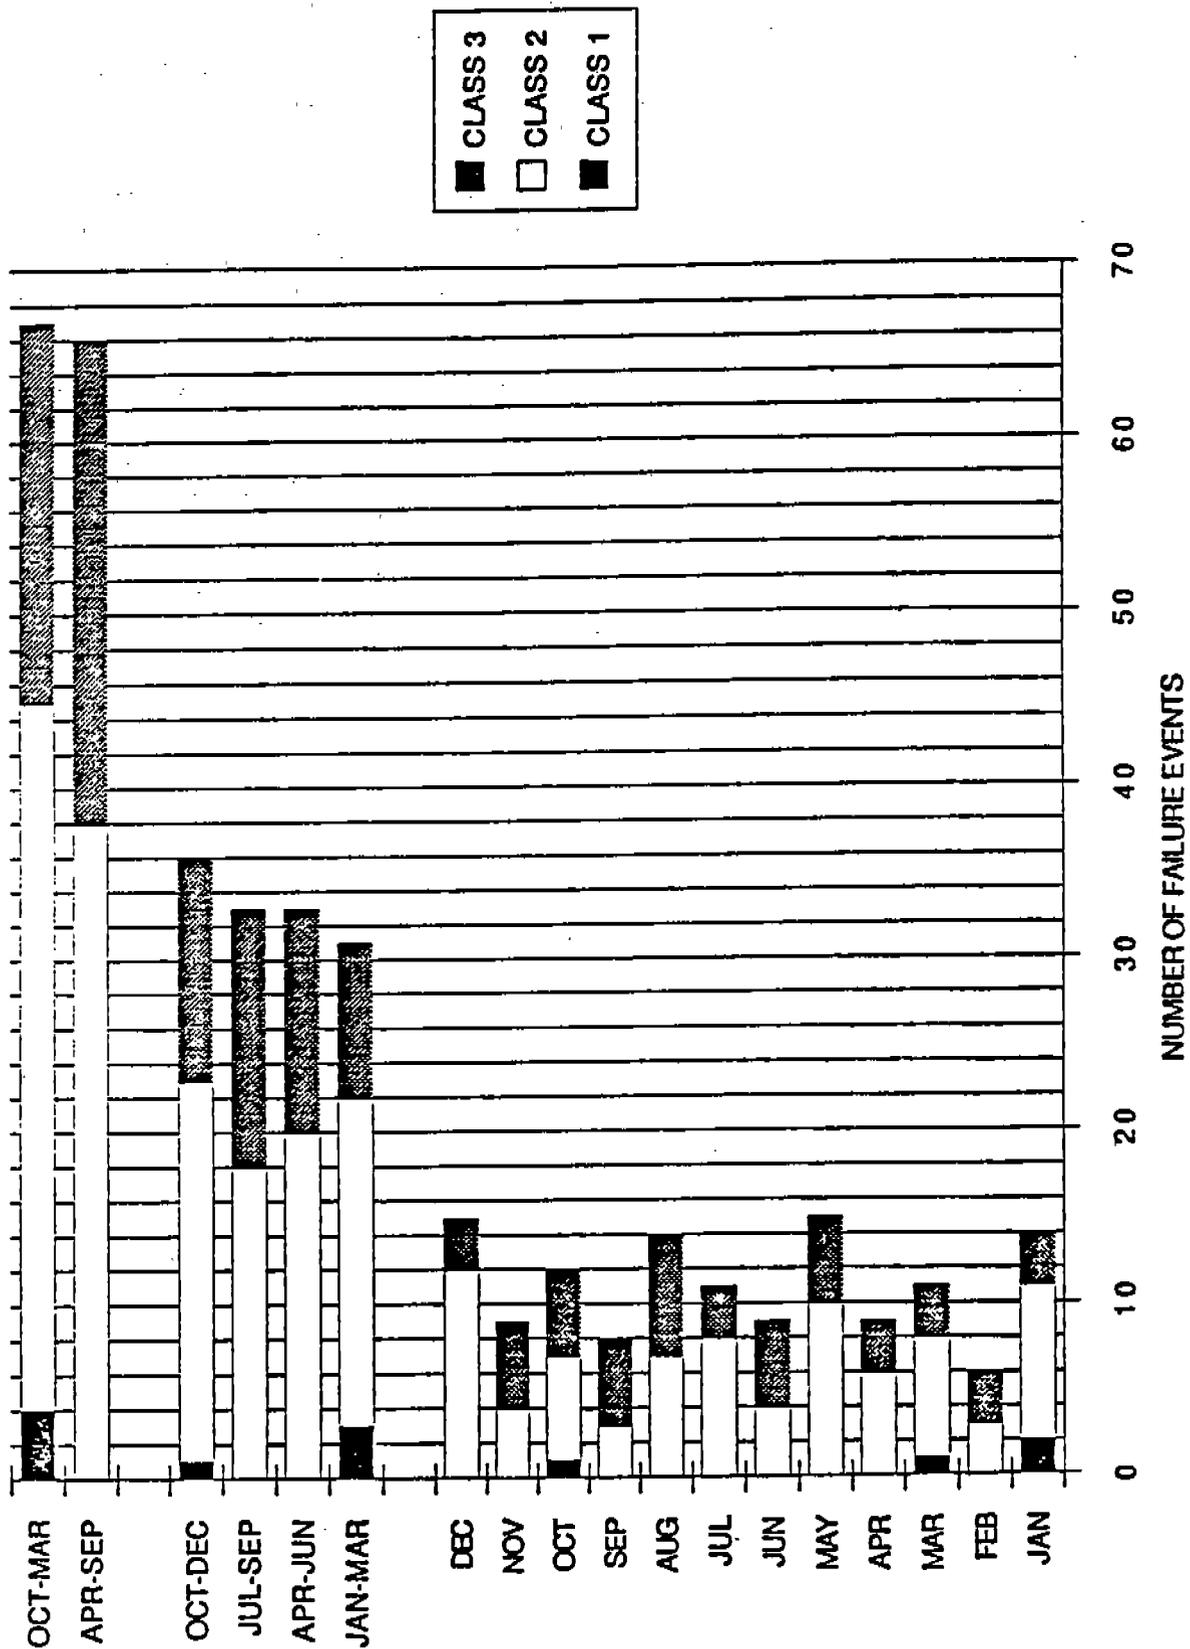
FIGURE III-4

STRUCTURAL FAILURE EVENTS BY TIME OF YEAR
