Paper presented at the Marine Structural Inspection, Maintenance, and Monitoring Symposium
Sheraton National Hotel, Arlington, Virginia, March 18-19, 1991

Requalification and IMR Program for the Belayim Field

R. Brandi, Tecnomare S.P.A., Venice, Italy
H. Abu el Nasr and M. Keira, Petrobel
H. Hazem, Enppi

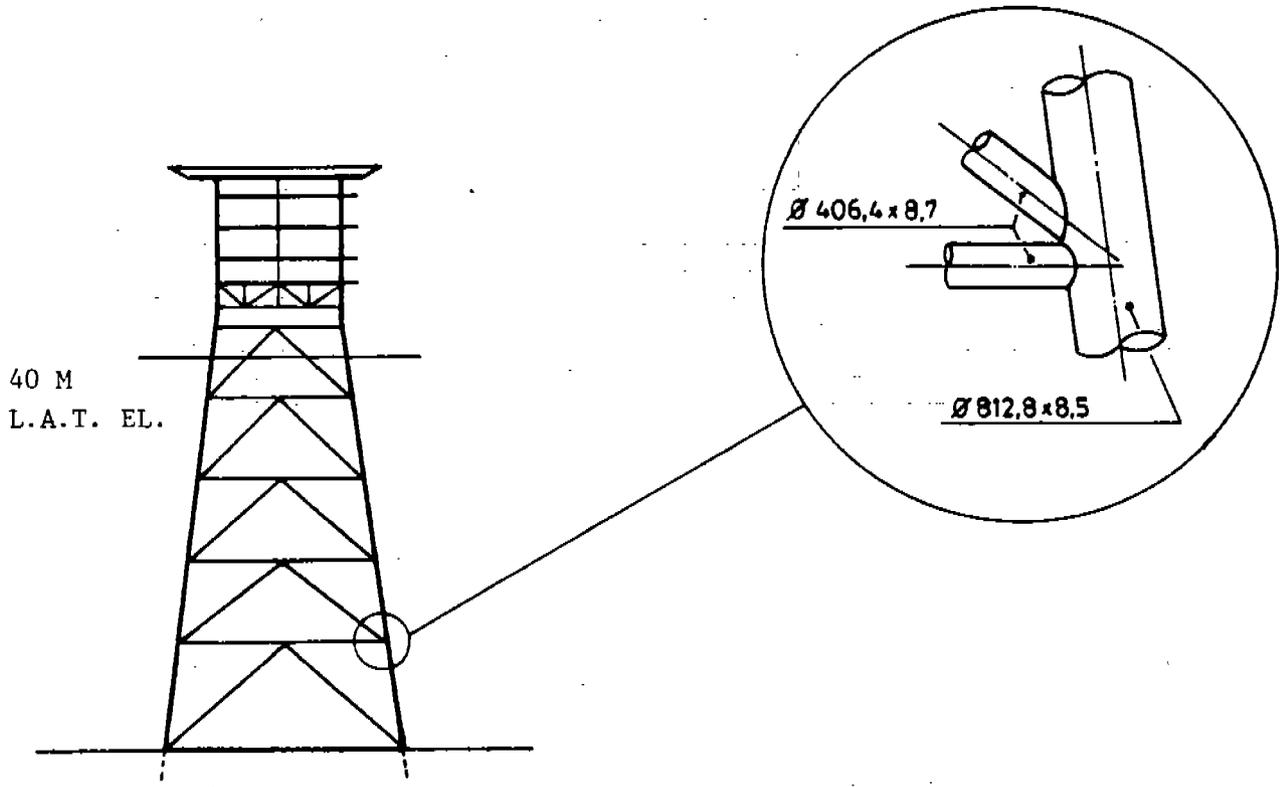
FIG. 1 - BELAYIM FIELD - F10 PLATFORM

In several instances a value over 2.5 was reached, 2.9 being the maximum computed value, for the node illustrated in fig. 1.

provided a way to mitigate significantly the remedial interventions. As a general criterion, for the nodes having a utility ratio below 1.6 no provision was made. For the platforms where the leg nodes had higher stresses, the grouting of the annulus between piles and legs was recommended (see tab. I).
