FINAL REPORT
ON
FATIGUE TESTS OF SHIP WELDS

BY
S. C. HOLLISTER, J. GARCIA AND T. R. CUYKENDALL

Cornell University

Serial No. SSC-14

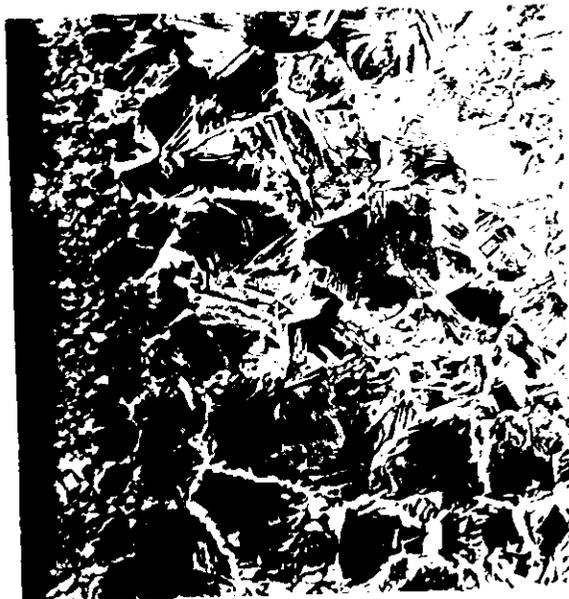
**FIGURE 22: PHOTOMICROGRAPHS OF SURFACES
ORIENTED AS SHOWN IN FIG.21 . MAGNIFICATION: 200X.
2% NITAL ETCH. THE EDGE OF THE HOLE IS AT THE
LEFT OF THE UPPER PHOTOGRAPHS.**

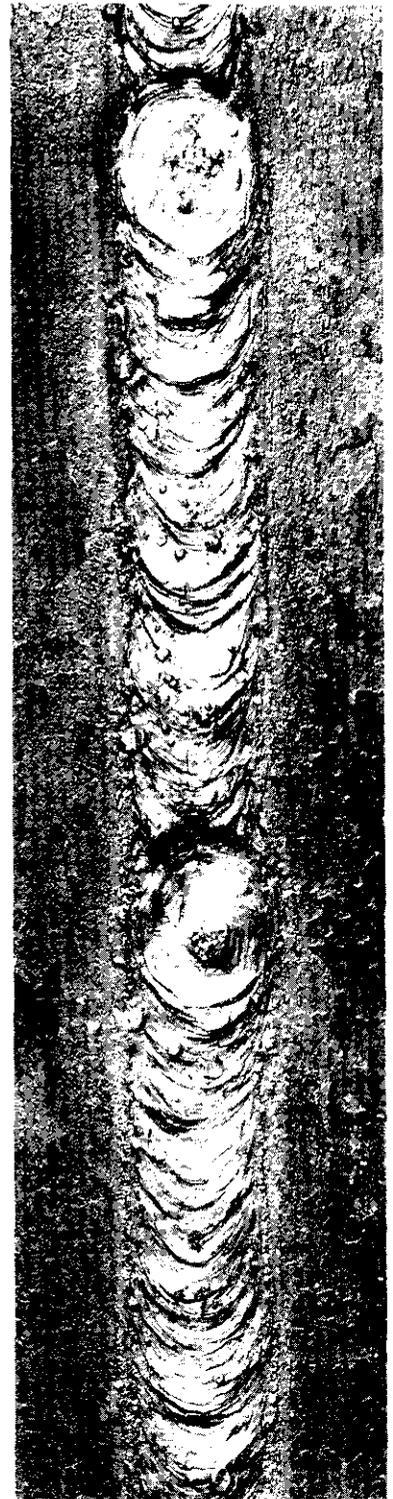
Figure 23 Specimen AA-6

X-Ray

Back Face

16 - 24 in. From Top

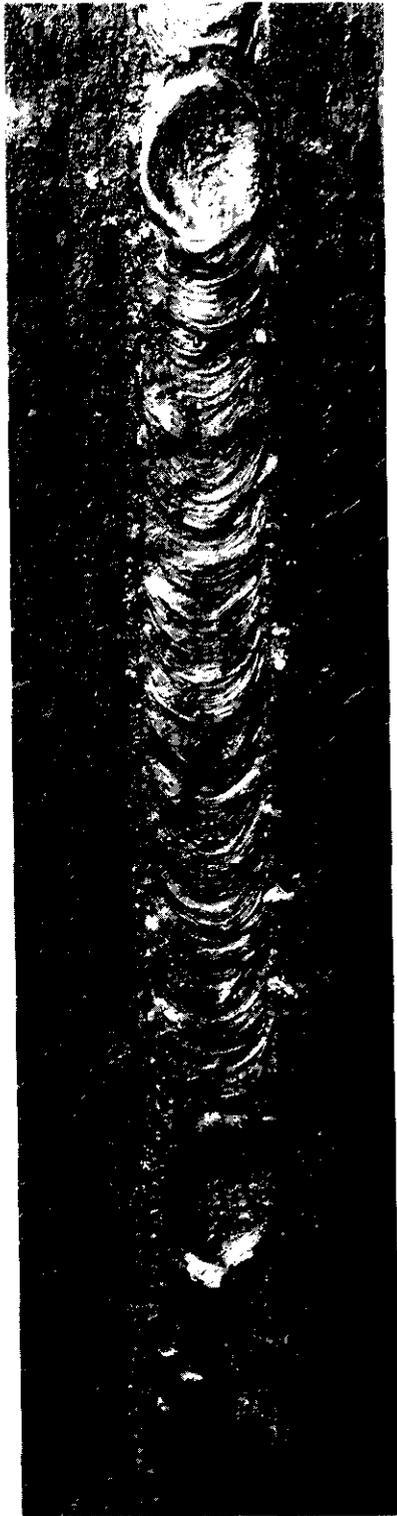
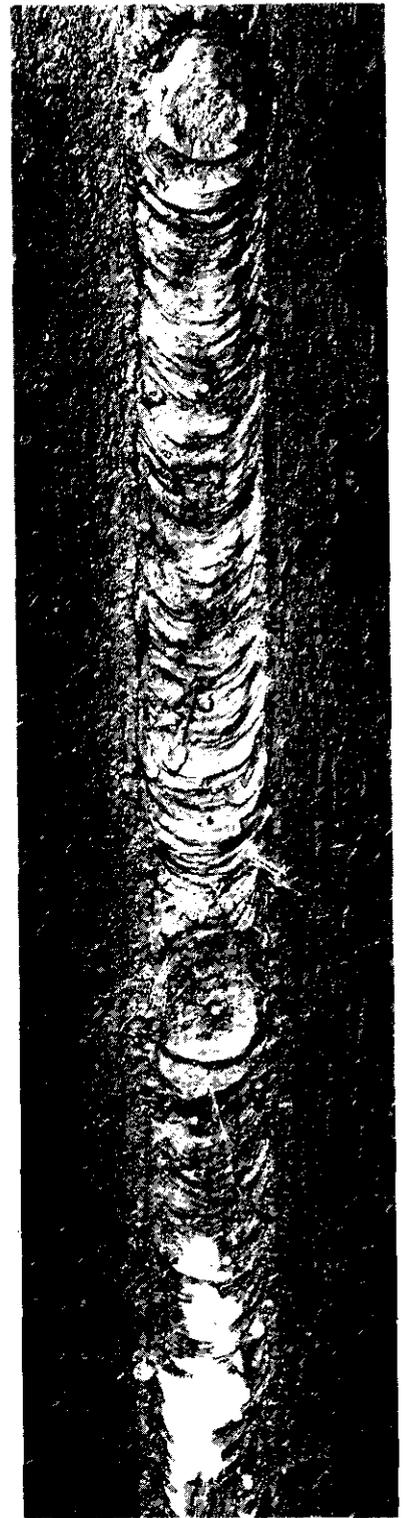
Figure 24

Front Face

X-Ray

Specimen DE-3

Back Face

40 - 48 in. From Top

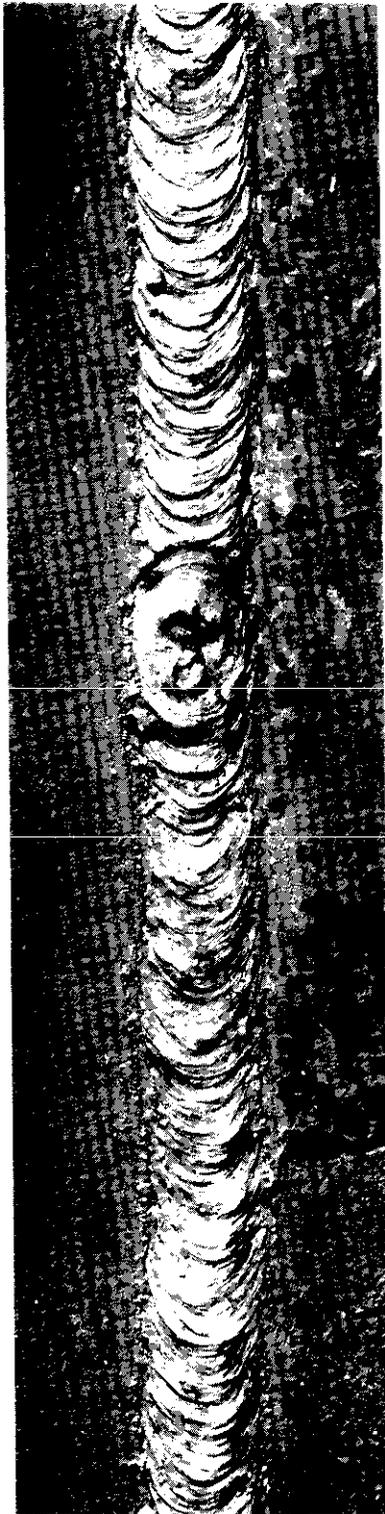
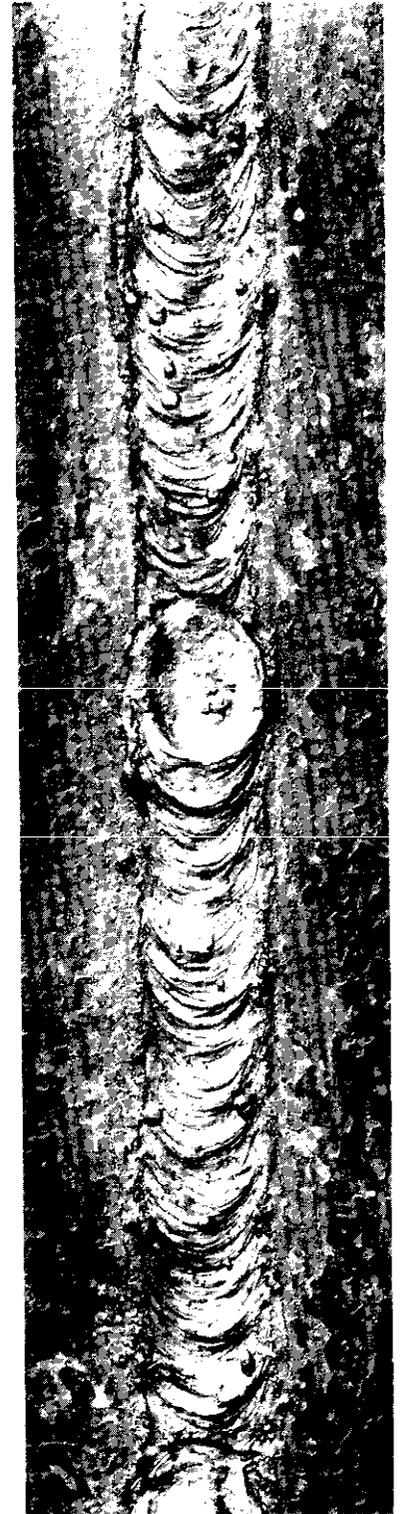
Figure 25

Front Face

X-Ray

Specimen EE-3

Back Face

16 - 24 in. From Top

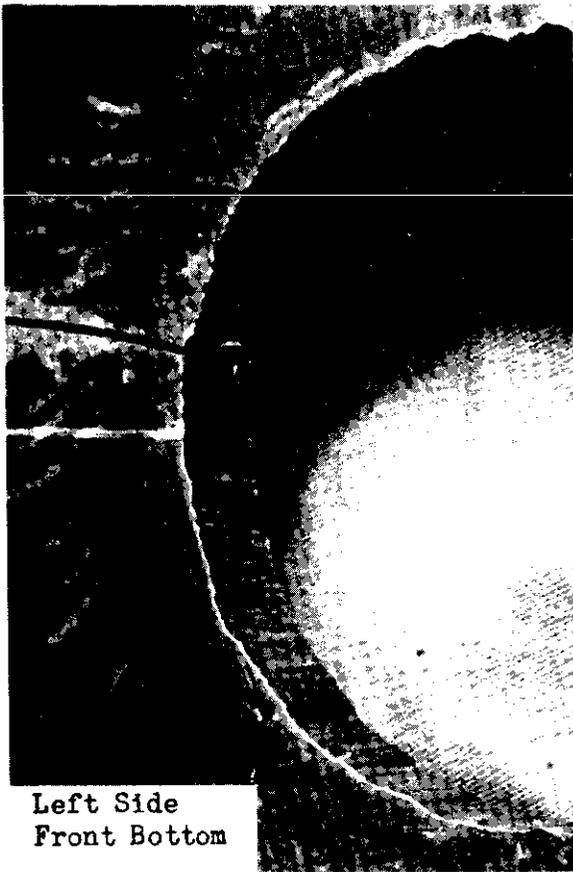
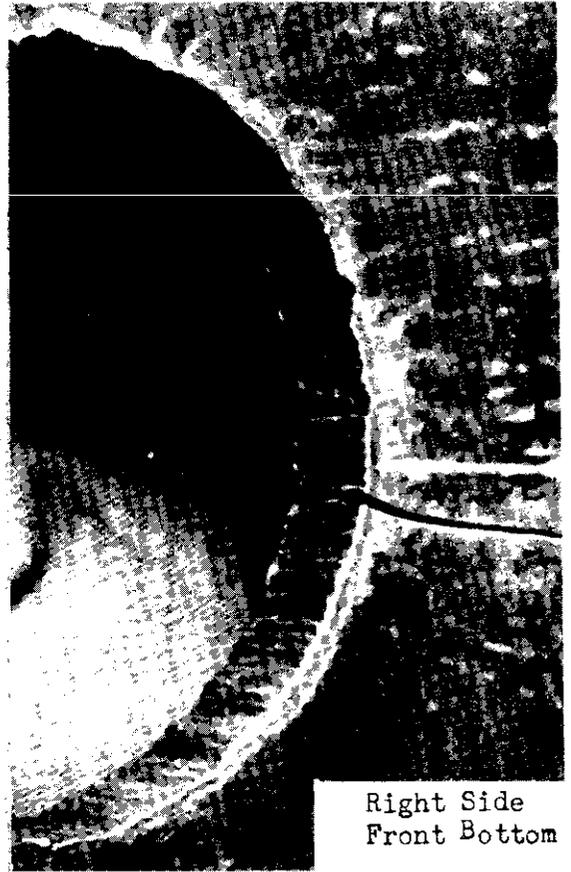
Specimen FA-3 Figure 28

Left Side
Front Bottom

Right Side
Front Bottom

The fatigue results of all specimens with unreinforced openings of $4\frac{1}{4}$ inch diameter are listed in Table V. Obviously, all fractures occurred on or close to the transverse center line of the specimen; the exact location and details of the fractures for specimens not previously reported are shown in Figs. 9 to 20, inc., and certain pertinent and typical fractures are shown by photographs Figs. 28 to 34, inc.

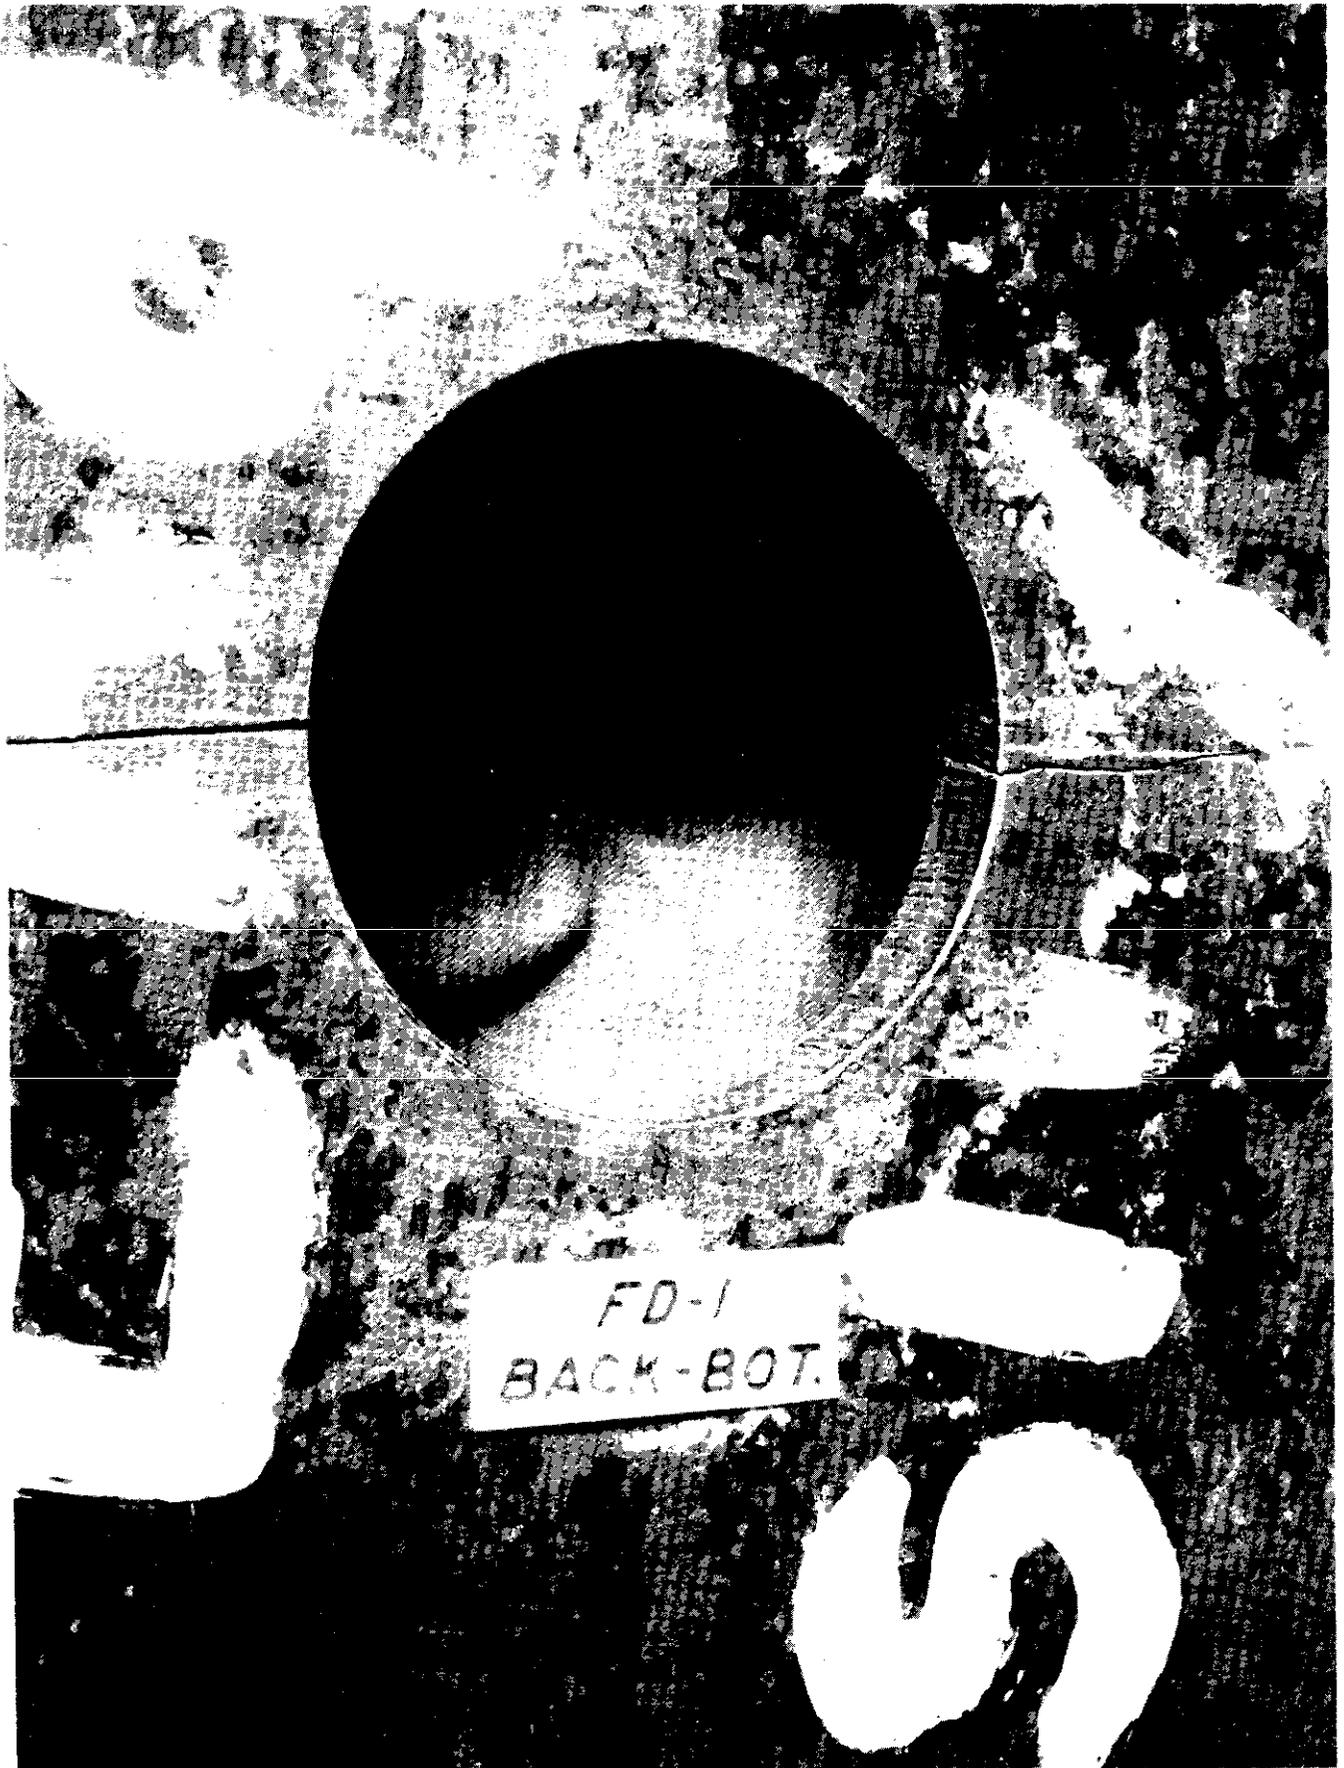
Figure 31

Specimen FD-1

Back Bottom
