**SSC-174**

**Investigation of Residual Stresses  
In Steel Weldments**

**KOICHI MASUBUCHI and D. C. MARTIN**

Final Report  
on  
Project SR-167  
"Investigation of Residual Stresses  
in Steel Weldments"  
to the  
Ship Structure Committee

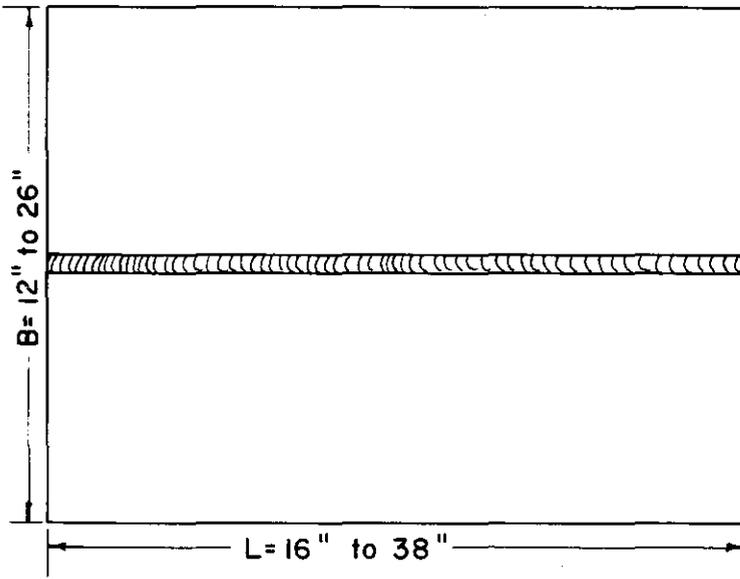
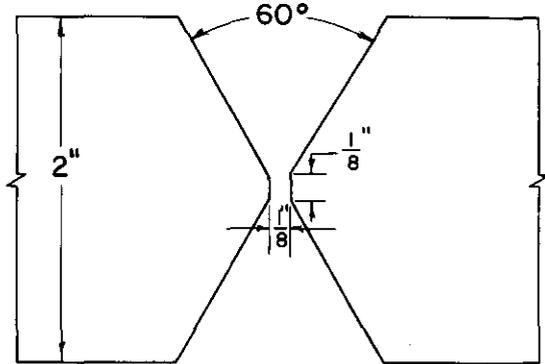
a. General View

b. Joint Preparation for 1/2-Inch-Thick Plate (Shielded Metal-Arc, Submerged Arc, and MIG Processes), Specimens FM5, FM6, FM7, FM8, FH1, FH2, FT1, FT2, FT3, F41, F43, F45, F47, F48, and F49

c. Joint Preparation for 2-Inch-Thick Plate (Shielded Metal-Arc Process), Specimens GM1, GH1, and GH2

- (1) Simple butt joints, as shown in Figure 1
- (2) Butt joints with repair welds
- (3) Slit-groove welds, as shown in Figure 2(a)
- (4) Cross butt joint, as shown in Figure 2(b)
- (5) Circular-groove welds, as shown in Figure 2(c)
- (6) Fillet welds, as shown in Figure 3
- (7) Complex welded structures, as shown in Figure 4
- (8) Bead-on-plate specimens.

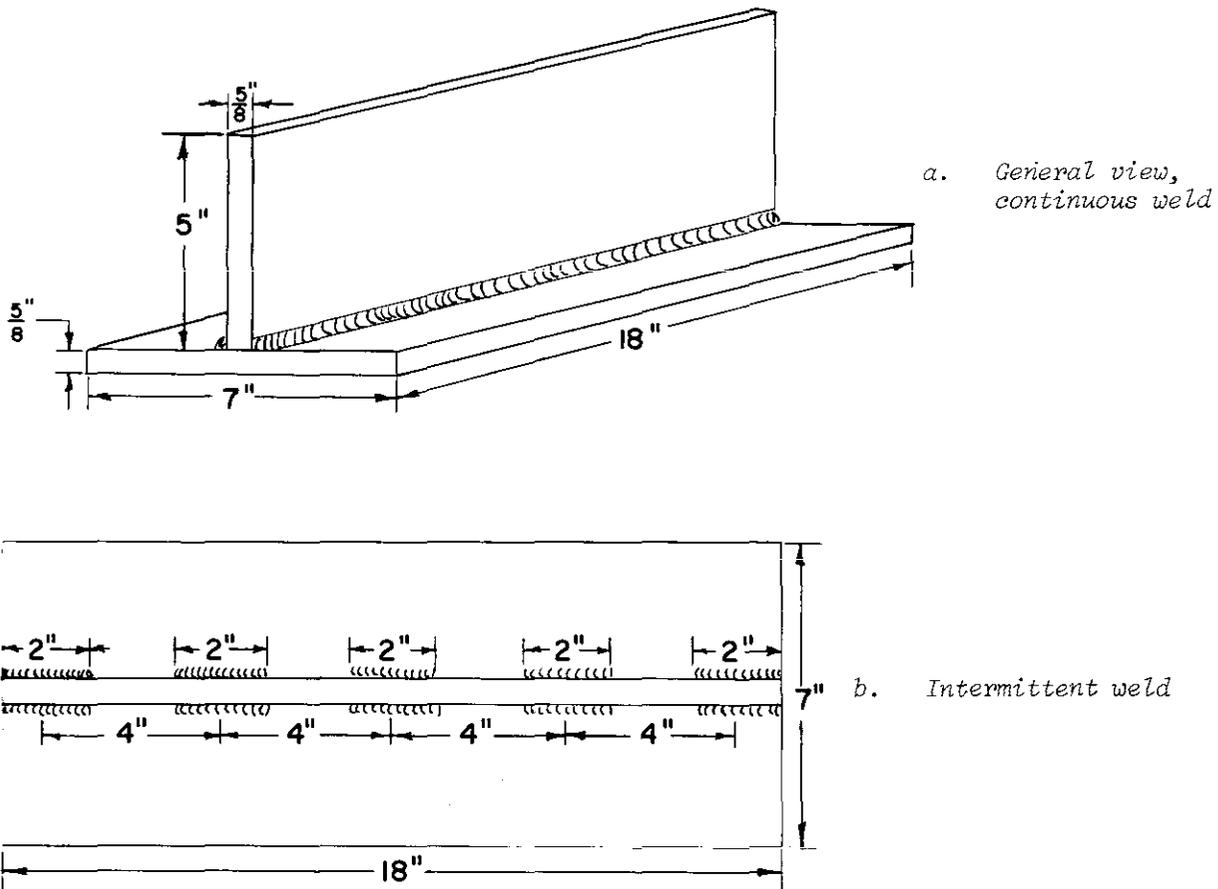
Fig. 3. Fillet welds, SAE 4340 steel specimens A4-F1, A4-F2, A4-F3, and A4-F4. Commercial high-strength heat-treated structural-steel specimens were prepared with 3/4-inch-thick plates.

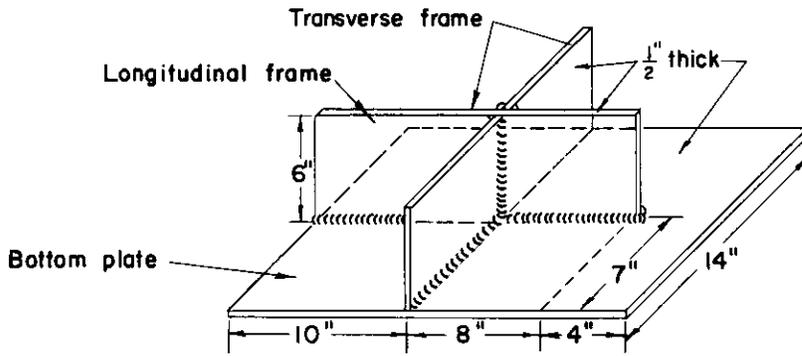
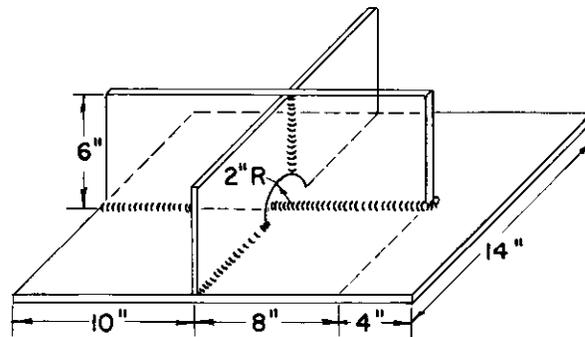
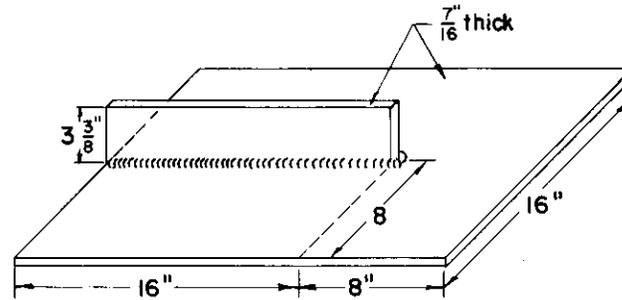
a. Type A, Structure With Directly Intersecting Longitudinal and Transverse Frames, Specimen B11

b. Type B, Structure With a Through Longitudinal Frame and Transverse Frames With 2-Inch-Radius Cutouts, Specimen B12

c. Type D, Structure With a Longitudinal Frame, Specimens 3CM, 3C41 and 3C42

Types A, B, and C structures were made with a longitudinal through frame and two transverse frames welded to a bottom plate. One end of the longitudinal frame continued to a free edge of the bottom plate, while the other end stopped short of the opposite free edge of the bottom plate, making an abrupt structural

discontinuity. These specimens were made from heat-treated SAE 4340 steel plates 1/2 inch thick, and they were used for the hydrogen-induced-cracking tests.

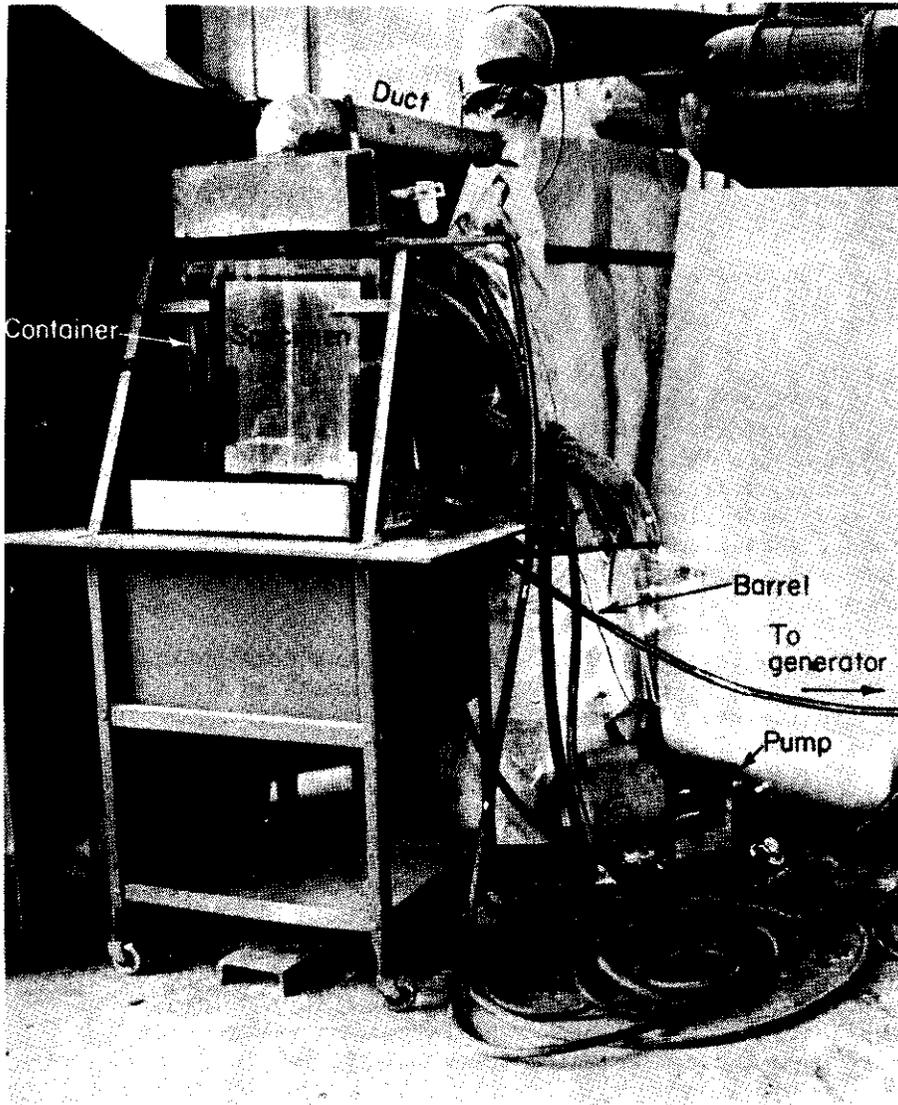
Fig. 5. Set-up for hydrogen-induced cracking tests on some welded specimens and press-fit specimens. The specimens were hydrogen charged in a container with transparent walls. The electrolyte was circulated by a pump between the container and the barrel. Other specimens were hydrogen charged in the barrel or a specially made large tank.

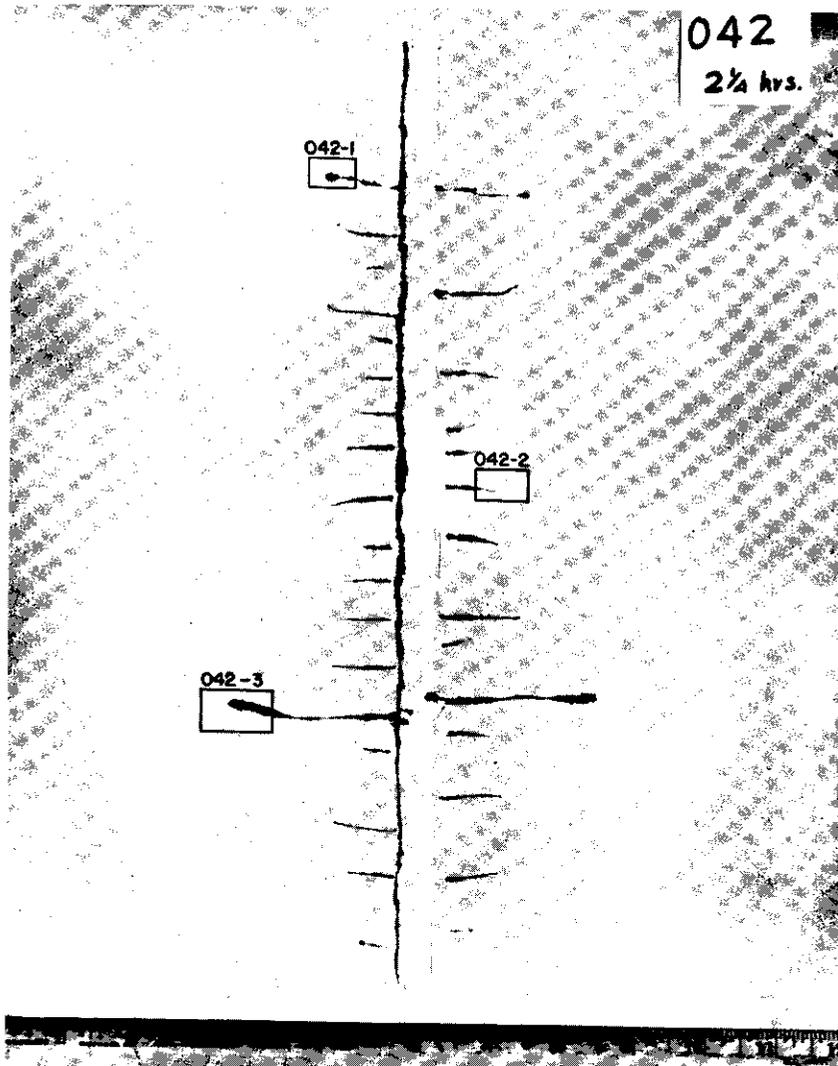
Fig. 8b. Crack pattern after hydrogen-induced-cracking test for 2-1/4 hours. Specimens 042 - 1, 042 - 2, and 042 - 3 were taken for metallographic examinations of fracture surfaces.

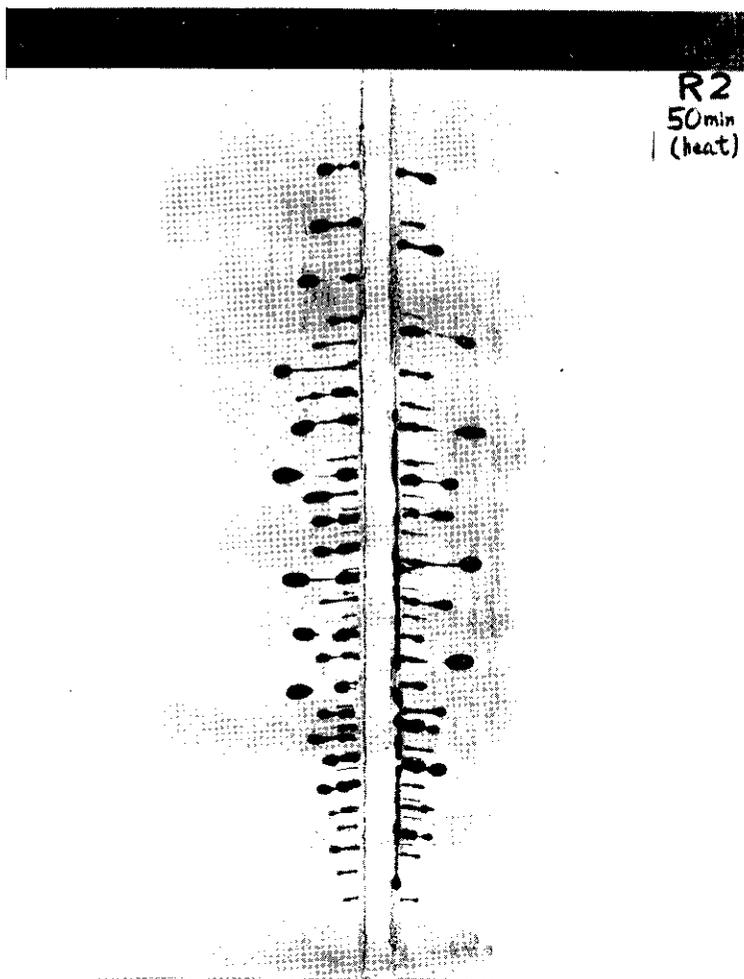
Fig. 9. Crack pattern in a simple-butt joint made from SAE 4340 steel oil quenched and tempered at 500F (Specimen R2) after hydrogen-induced-cracking test for 50 minutes. After the test, the specimen was heated in a furnace at 400 F for two hours.

Figure 9 shows the crack pattern obtained on Specimen R2, another simple butt joint made in SAE 4340 steel oil quenched and tempered at 500 F. Several transverse cracks were observed after hydrogen charging for 40 minutes. The hydrogen charging was continued for 10 more minutes until systematic cracks

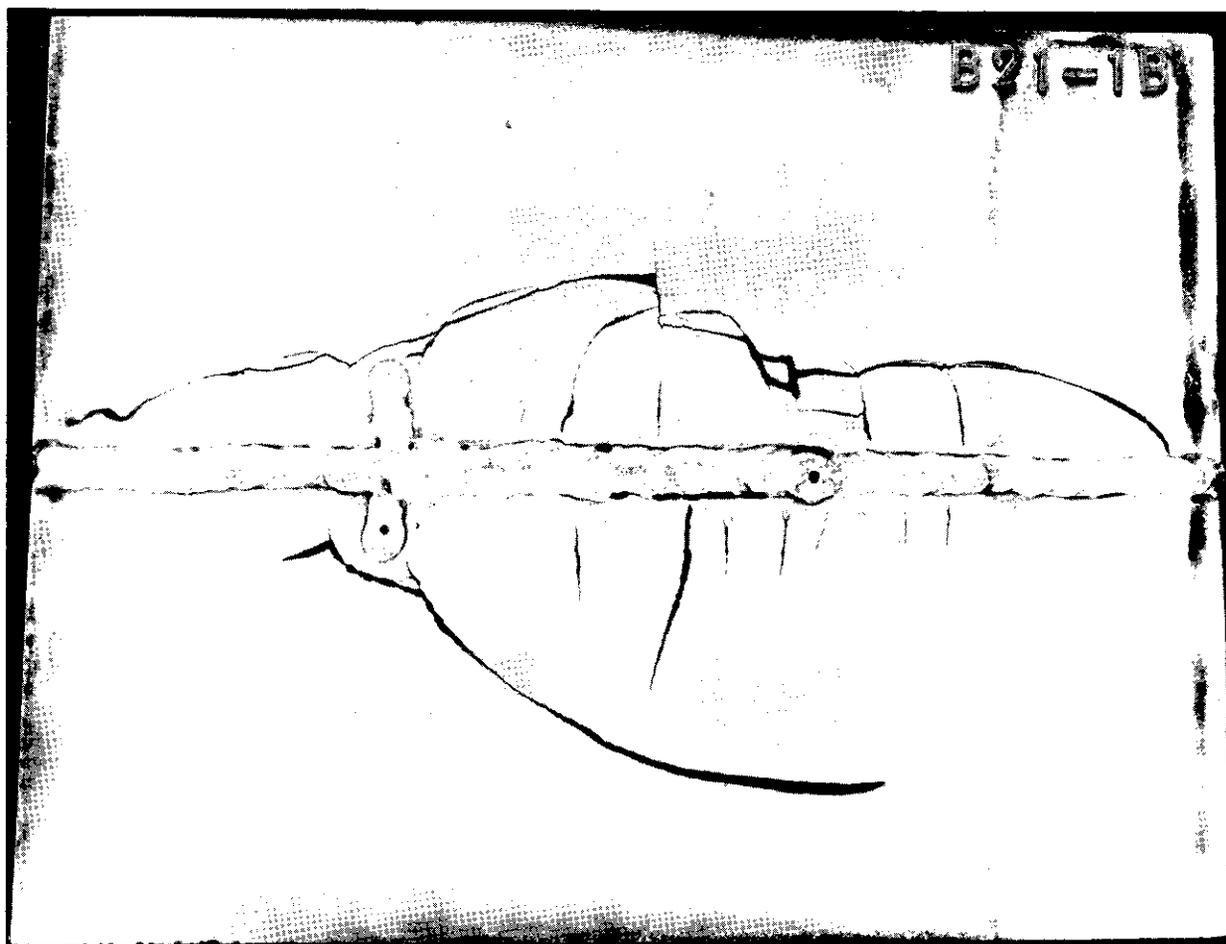
Fig. 10. Crack pattern in Specimen B21 - 1. Back surface.

To study the effect of repair welds on the distribution of residual stresses, repair welds were made on two butt joints, 12 by 16 inches in size. On Specimen B21-1 made in SAE 4340 steel, the weld metal in a 6-inch-long portion in the center of the 16-inch-long weld was removed and a short transverse groove, about 2 inches long, also was made at one end of the 6-inch-long portion; then these longitudinal and transverse grooves were welded.\*\* A similar repair weld was made in Specimen AT-B1 made from the commercial high-strength structural steel.

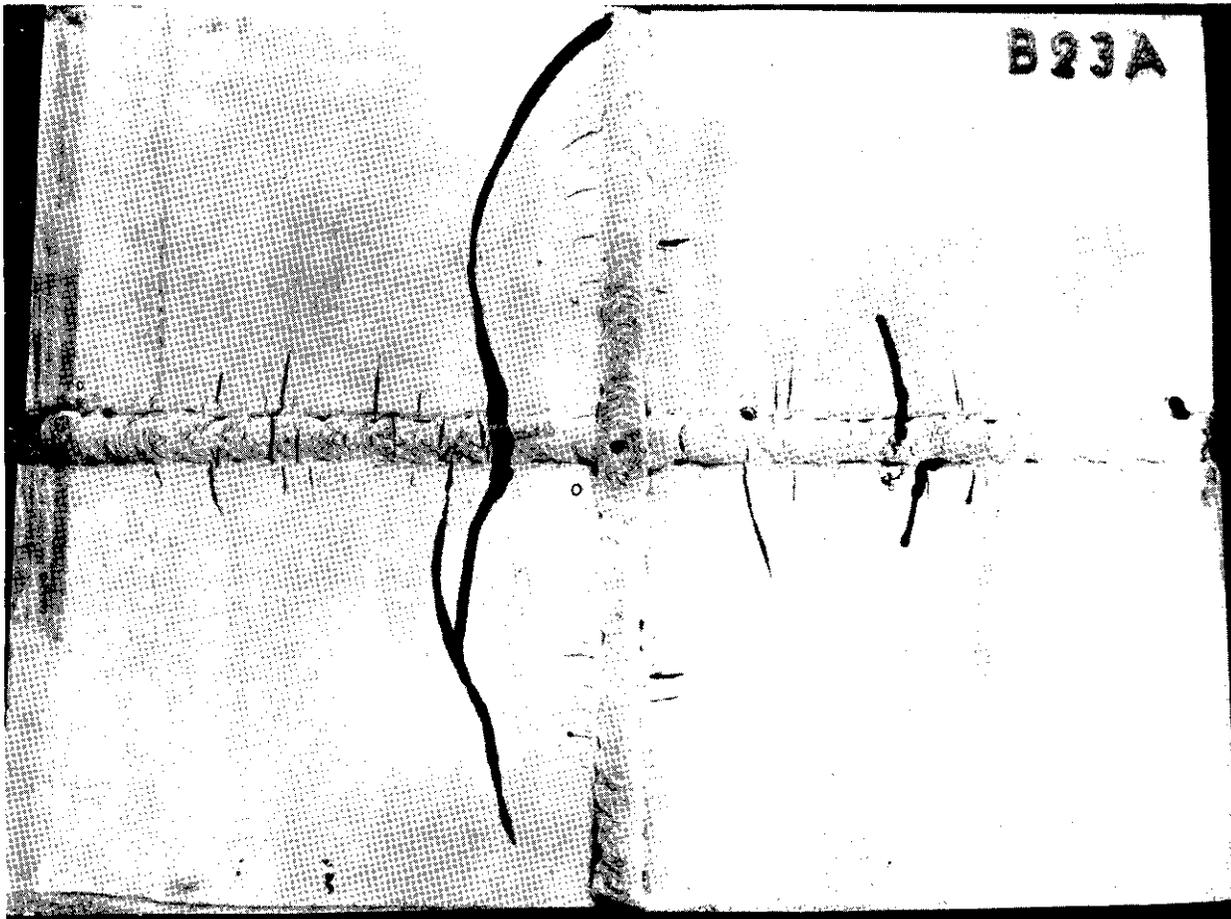
*Fig. 11. Crack pattern in cross-butt joint.*

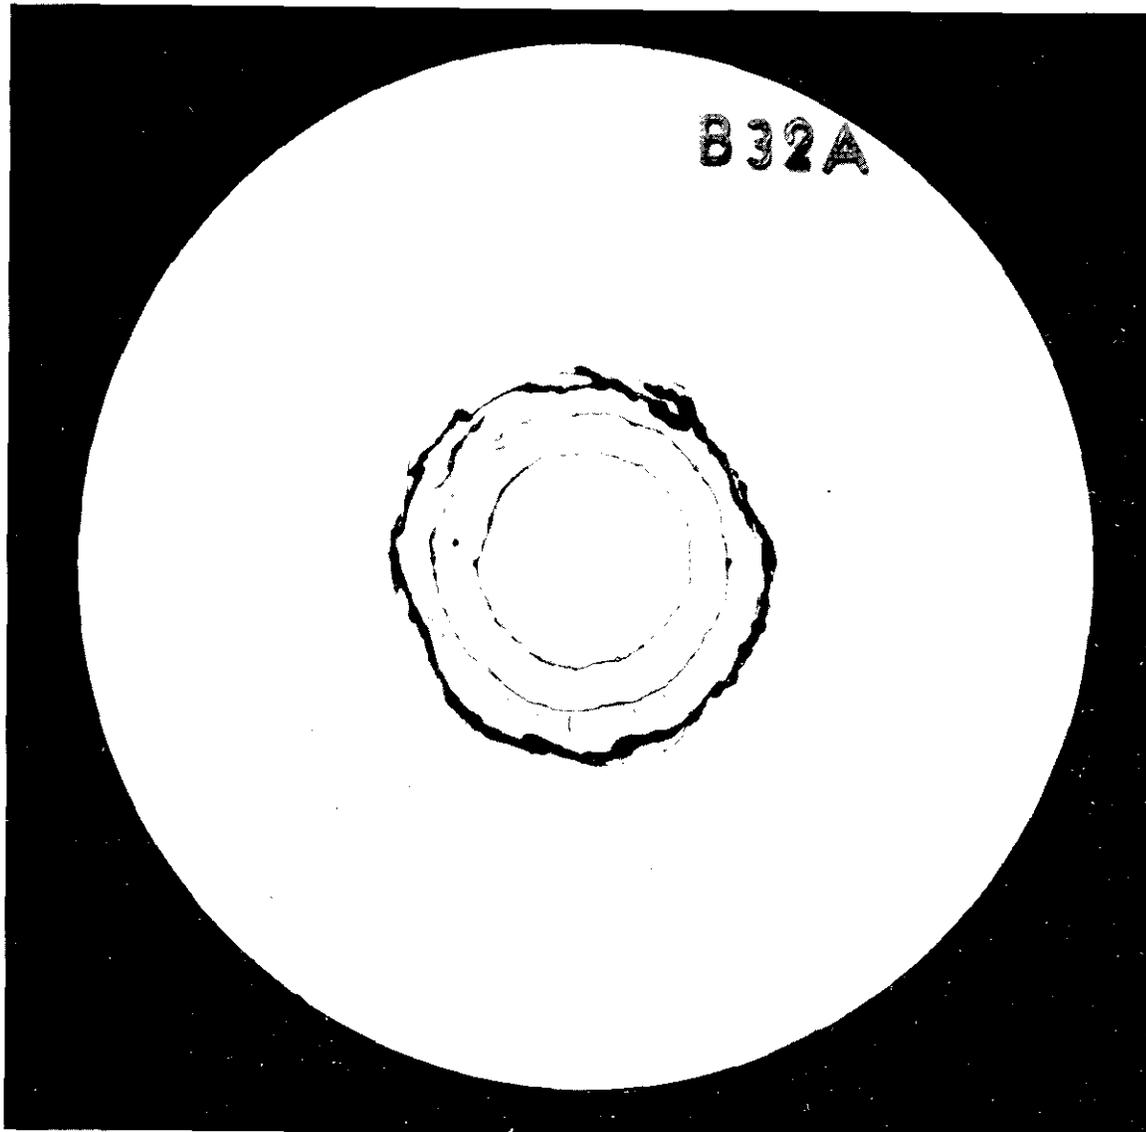
*Fig. 12. Crack pattern in circular-groove weld.*

In Specimen B32, the major crack was a circular one surrounding the groove weld. The specimen also contained a system of radial cracks on one surface.

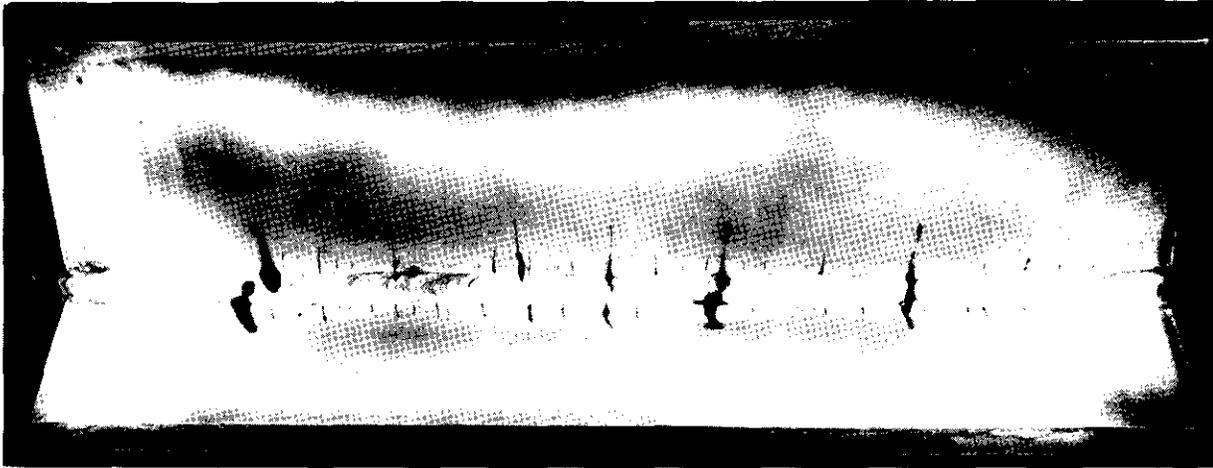
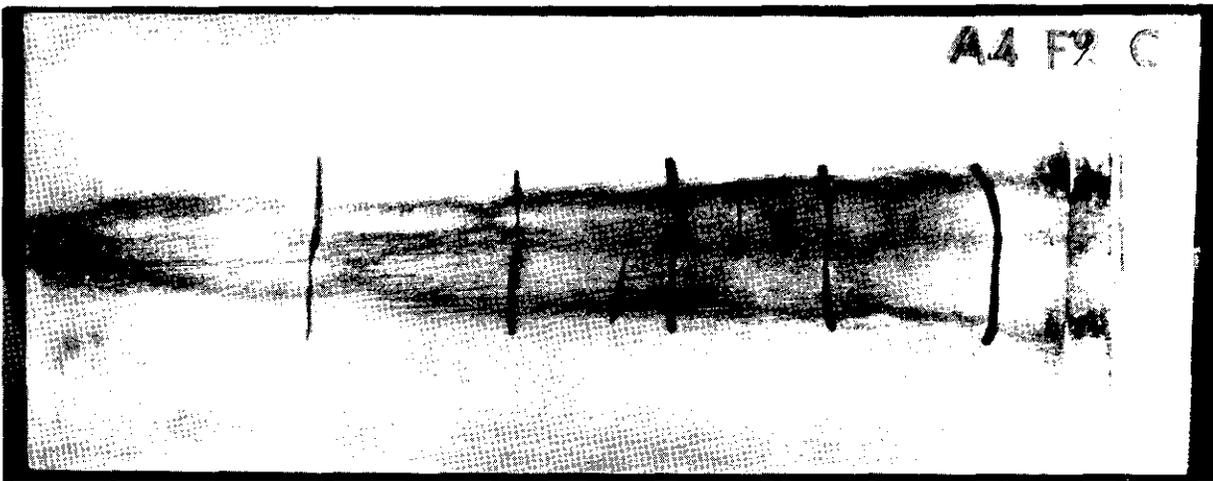
a. Front side

b. Back side

In the heavy-intermittent-weld specimen, curved cracks were observed at the ends of each fillet weld, as shown in Figure 15a. Curved cracks around the fillet weld also were observed on the back surface (Figure 15b). Tiny trans-

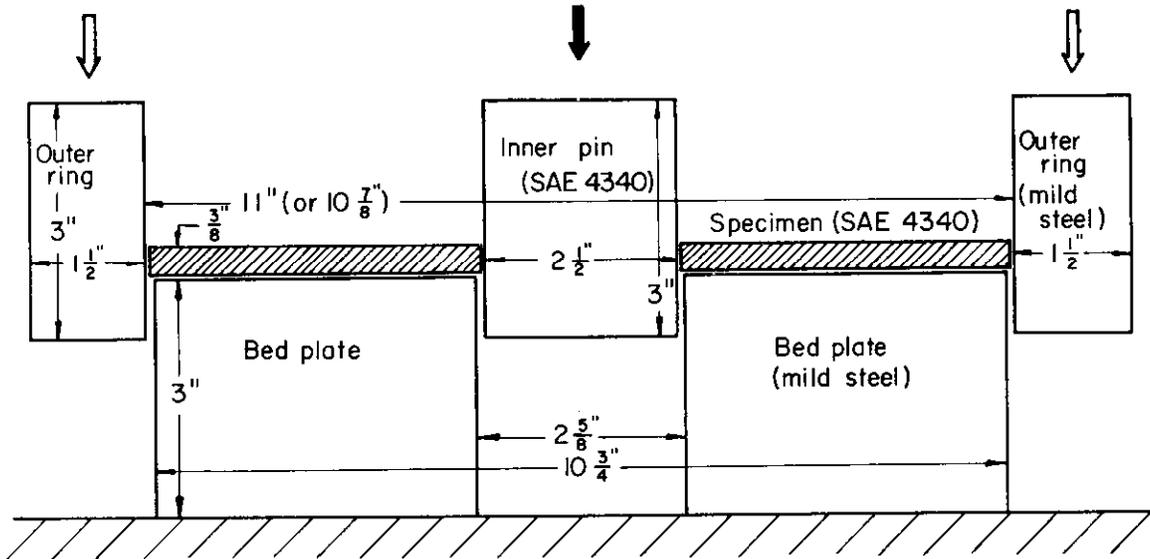
Fig. 20. Procedures for making a press-fit specimen (Heat-treated SAE 4340 steel).

Figure 20 shows procedures for making the press-fit specimens from heat-treated SAE 4340 steel. In Specimens K1, K2, and K4, a tapered pin was pressed into the specimen. Magnitudes of stresses introduced varied from one specimen to another. In preparing Specimen K3, a tapered pin was pressed into the specimen, and a ring was pressed onto the specimen. The outer ring was used in an attempt to produce compressive stresses in areas near the outer edge of the specimen. The outer ring, 10-7/8 inches in inner diameter, 14 inches in outer diameter, was made of mild steel. The outer diameter of the specimen was 10-7/8 inches. The inner surface of the outer ring was tapered, as was the outer circumference of the specimen.

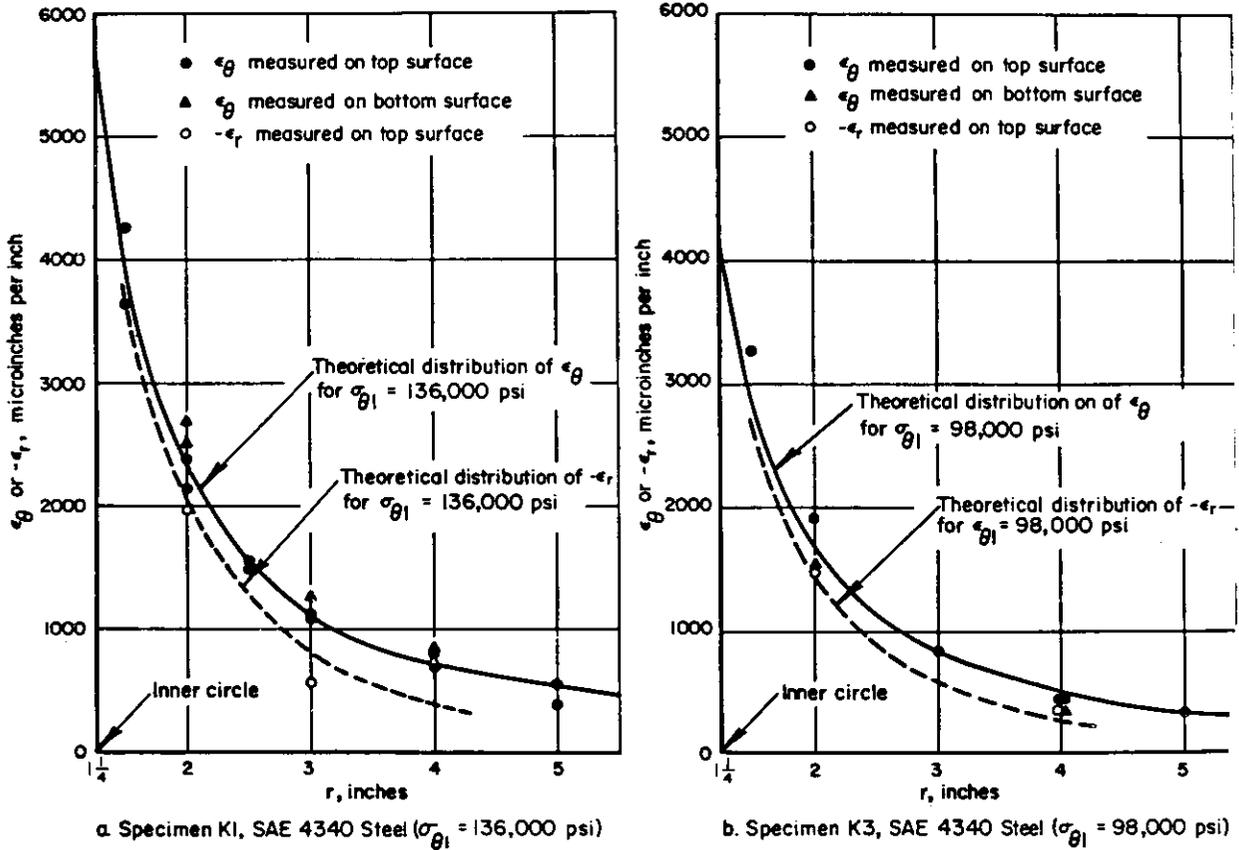
Fig. 21. Strain distributions in press-fit specimens.

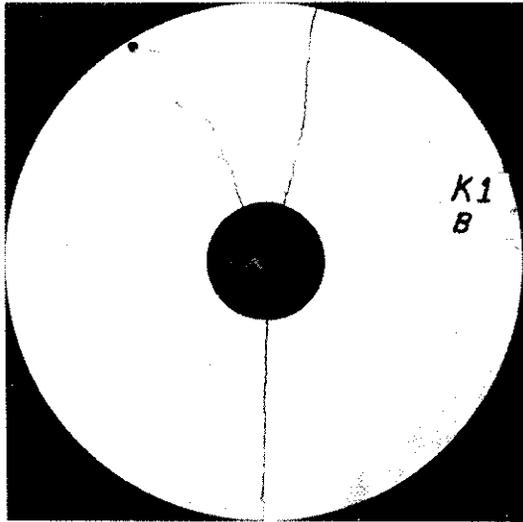
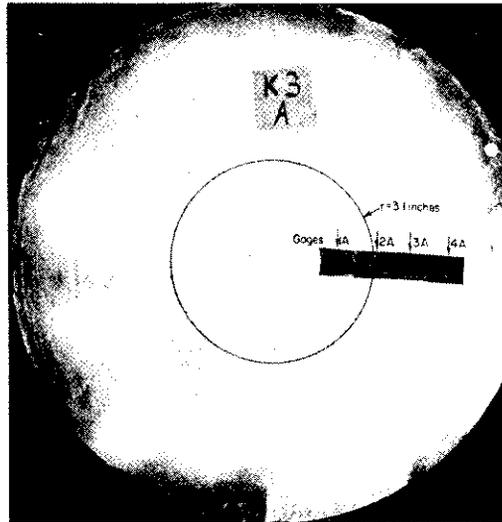
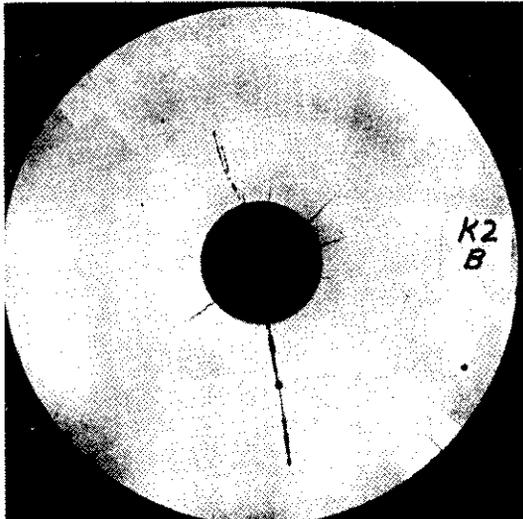
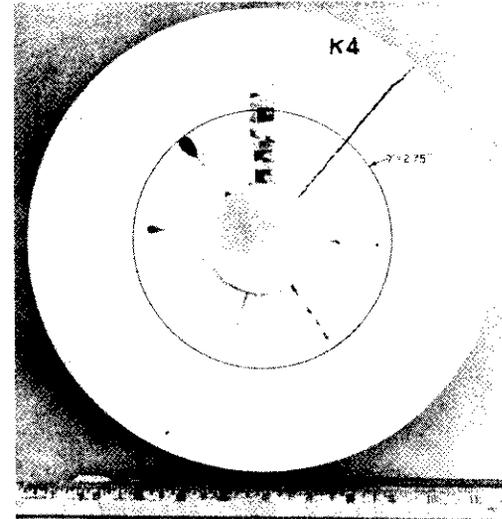
a. Specimen K1,  $\sigma_{\theta 1} = 136,000$  Psi, Tested for 3 hours.

c. Specimen K3,  $\sigma_{\theta 1} = 98,000$  Psi, Tested for 4 hours.

b. Specimen K2,  $\sigma_{\theta 1} = 68,000$  Psi, Tested for 3 hours.

d. Specimen K4,  $\sigma_{\theta 1} = 81,000$  Psi, Tested for 5-1/2 hours.

From the group of strain values measured at various locations, calculated values of  $\sigma_{\theta 1}$  for Specimens K1, K2, K4, and LT1 were:

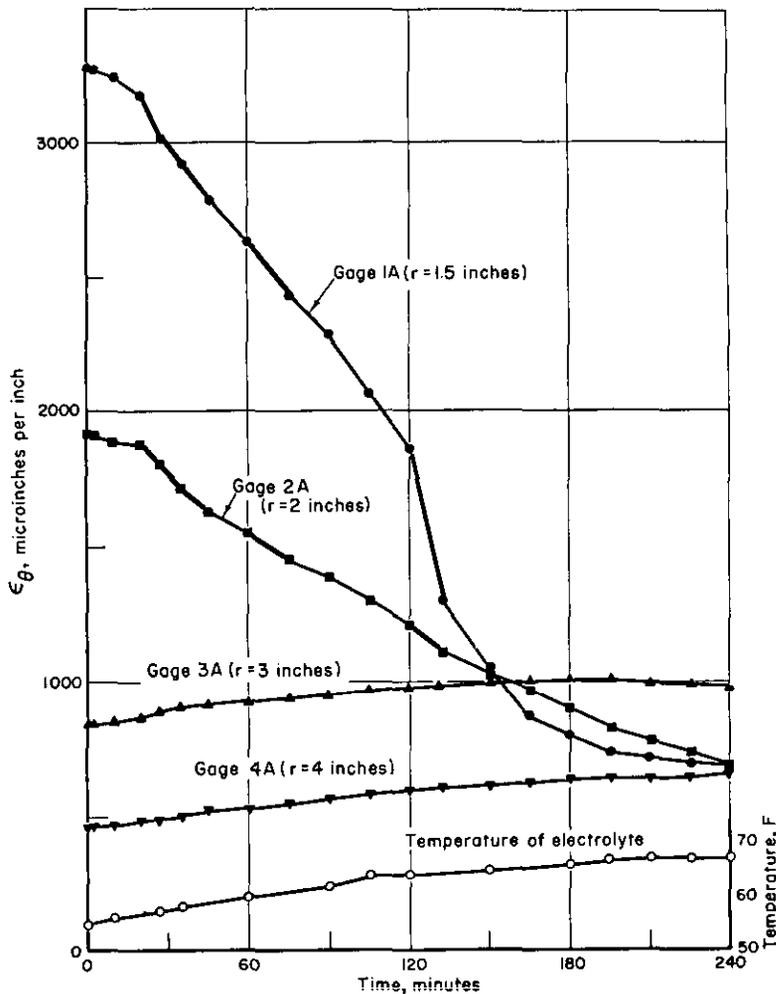
Fig. 23. Change of strains during hydrogen-induced-cracking test on a press-fit specimen. (K3).

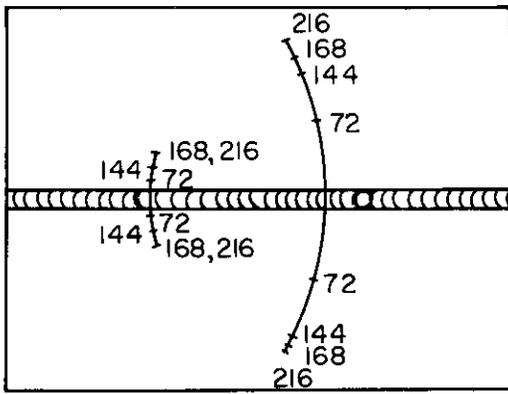
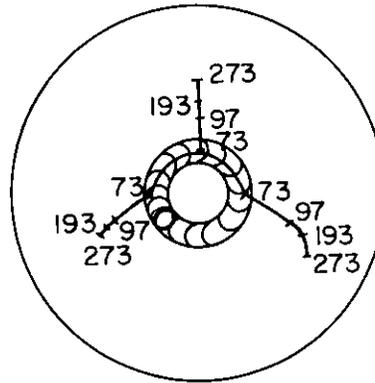
a. Simple butt joint, Specimen C1

b. Circular-groove weld, Specimen C3

- (1) Five specimens made in mild steel including three simple butt joints (Specimens FM5, FM7, and C1), one slit-groove weld (Specimen C2), and one circular-groove weld (Specimen C3)

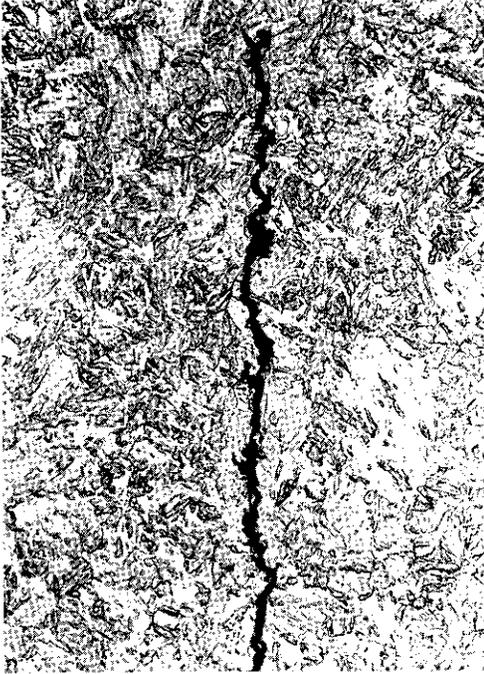
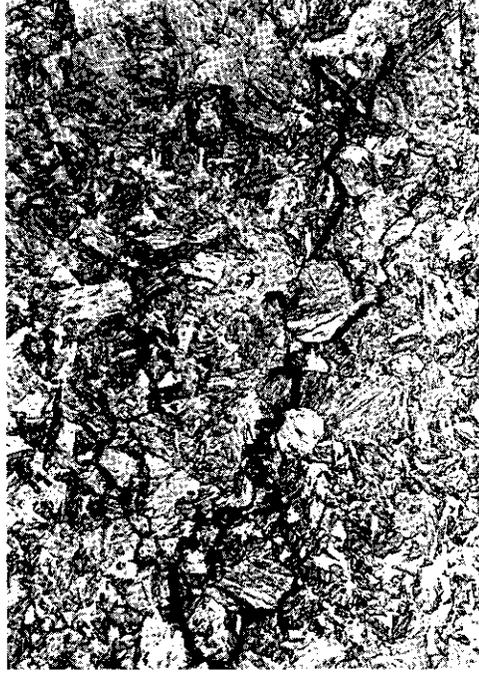
a. Commercial high-strength, heat-treated structural steel after hydrogen-induced-cracking test. (336 X)

b. Commercial high-strength, heat-treated structural steel after stress-corrosion-cracking test. (396 X)

c. Heat-treated SAE 4340 steel after hydrogen-induced-cracking test. (396 X)

Fig. 27. Sections through cracks.

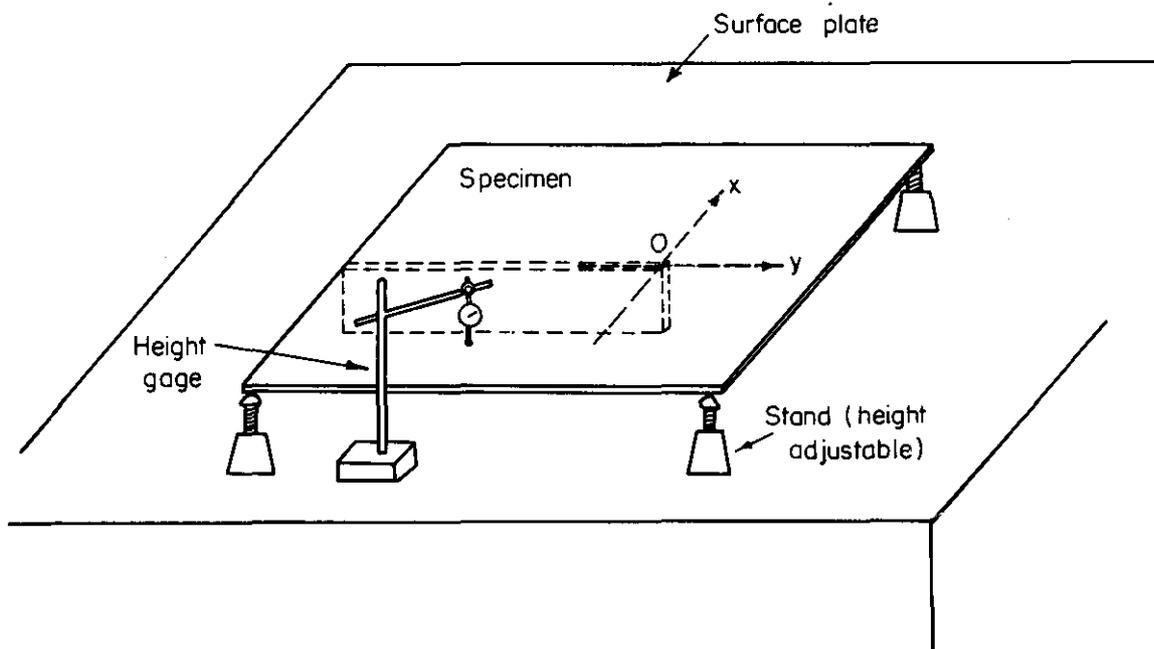
Fig. 29. Method of measuring distortion of complex welded structure.

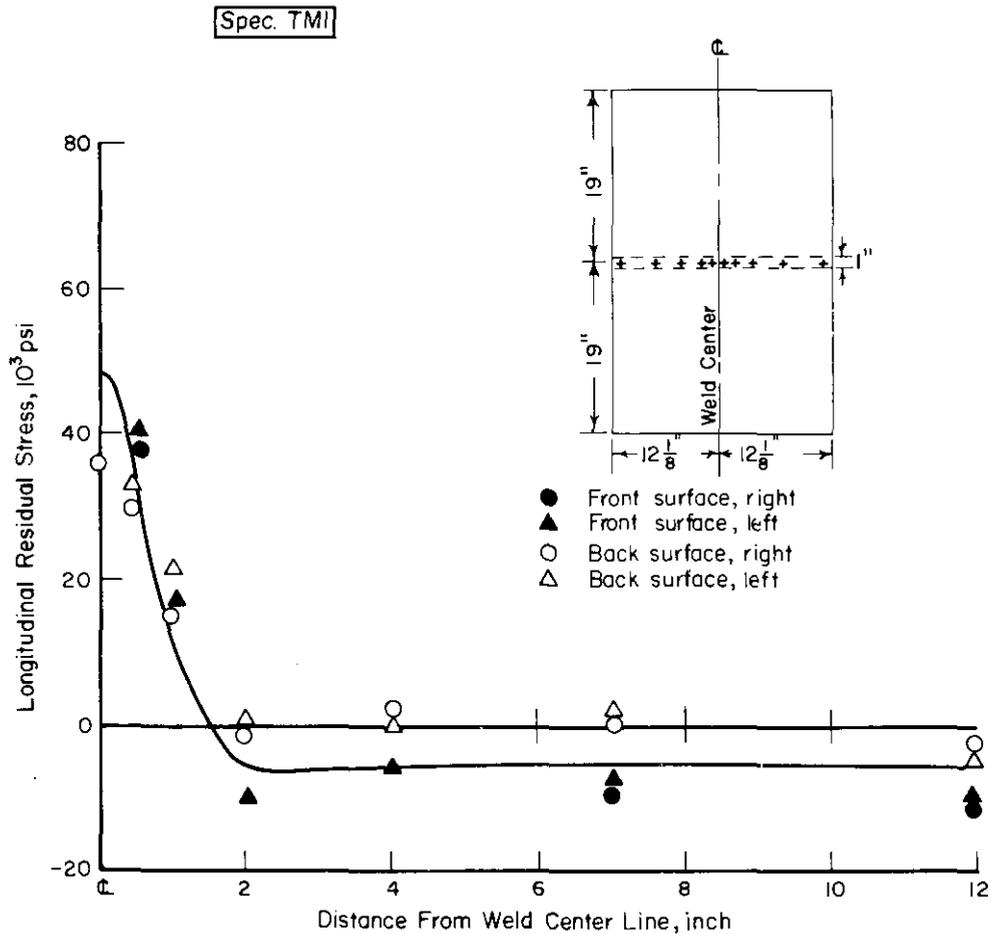
Fig. 30. Transverse distribution of longitudinal residual stresses in 38-inch-long butt joint made with mild steel.

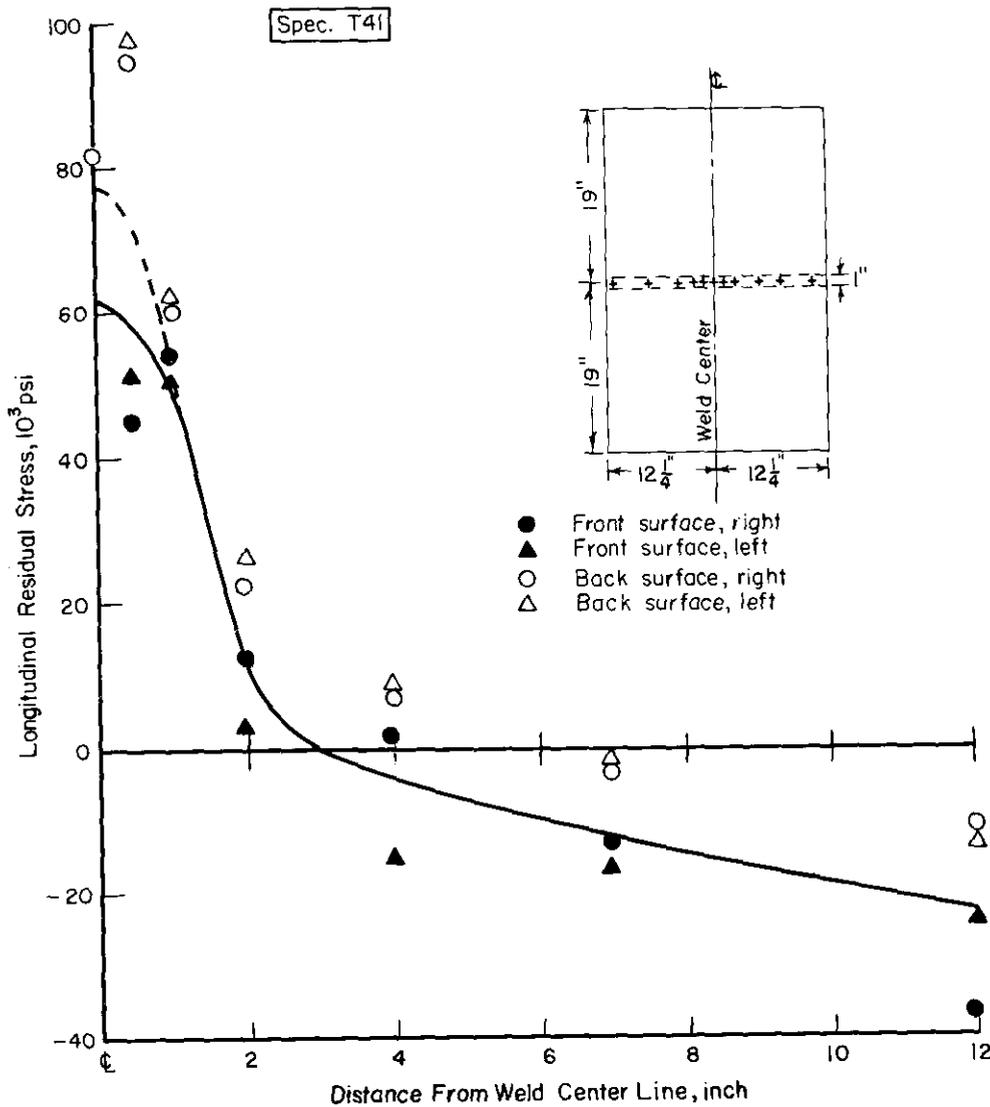
Fig. 31. Transverse distribution of longitudinal residual stresses in 38-inch-long butt joint made with heat-treated SAE 4340 steel.

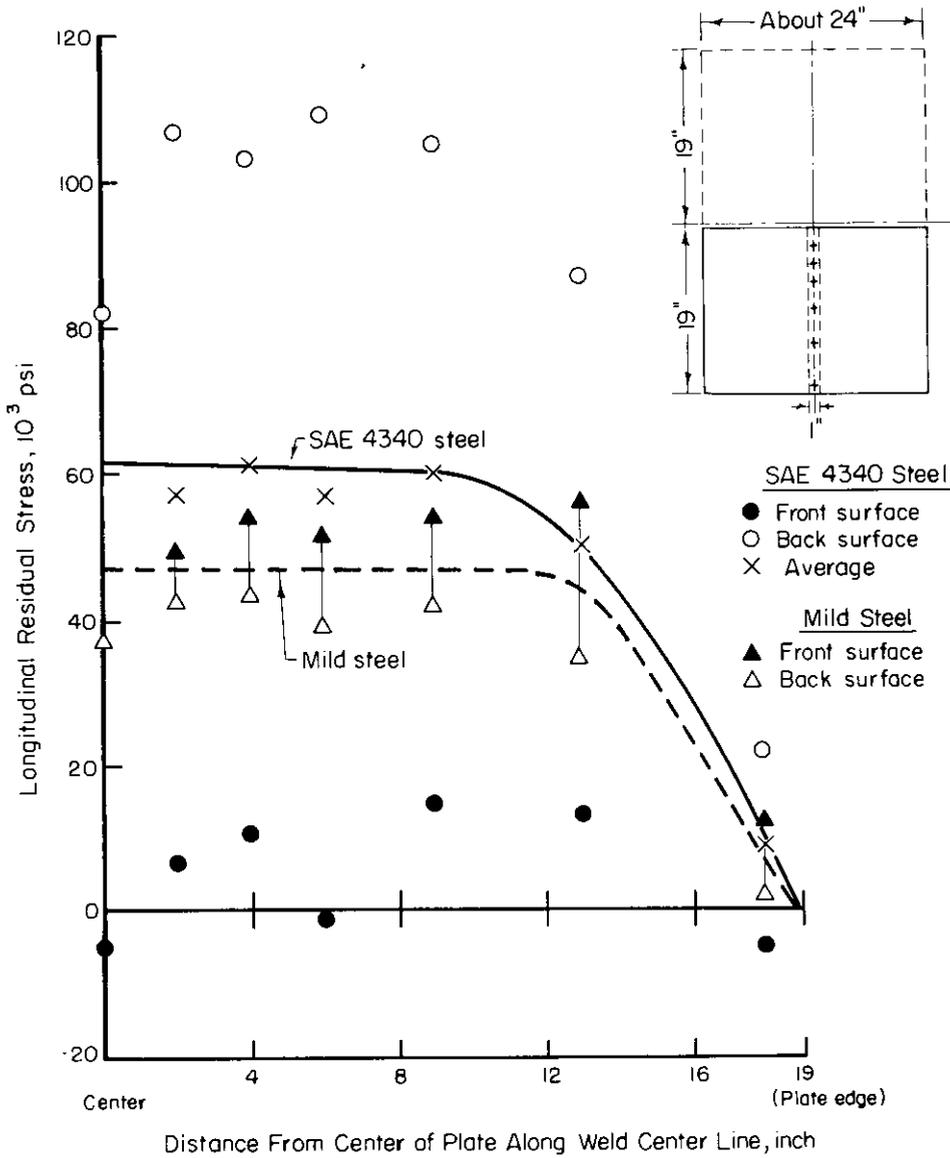
Fig. 32. Distribution along weld center line of longitudinal residual stresses in 38-inch-long butt joints made with SAE 4340 steel and mild steel.
