**SSC-174**

**Investigation of Residual Stresses  
In Steel Weldments**

**KOICHI MASUBUCHI and D. C. MARTIN**

Final Report  
on  
Project SR-167  
"Investigation of Residual Stresses  
in Steel Weldments"  
to the  
Ship Structure Committee

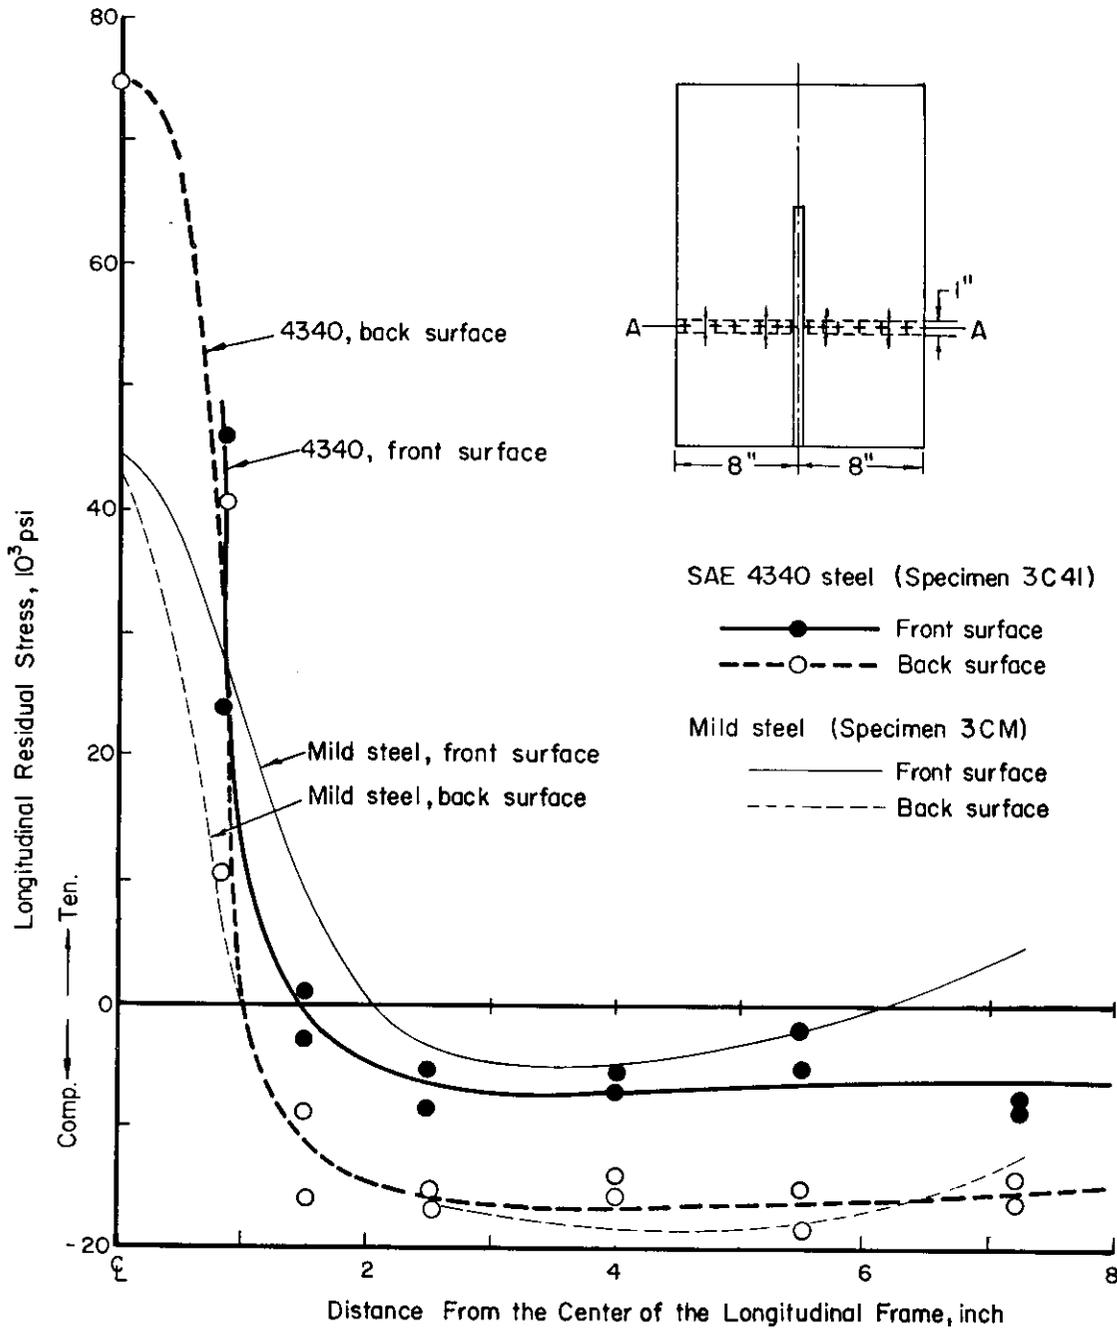
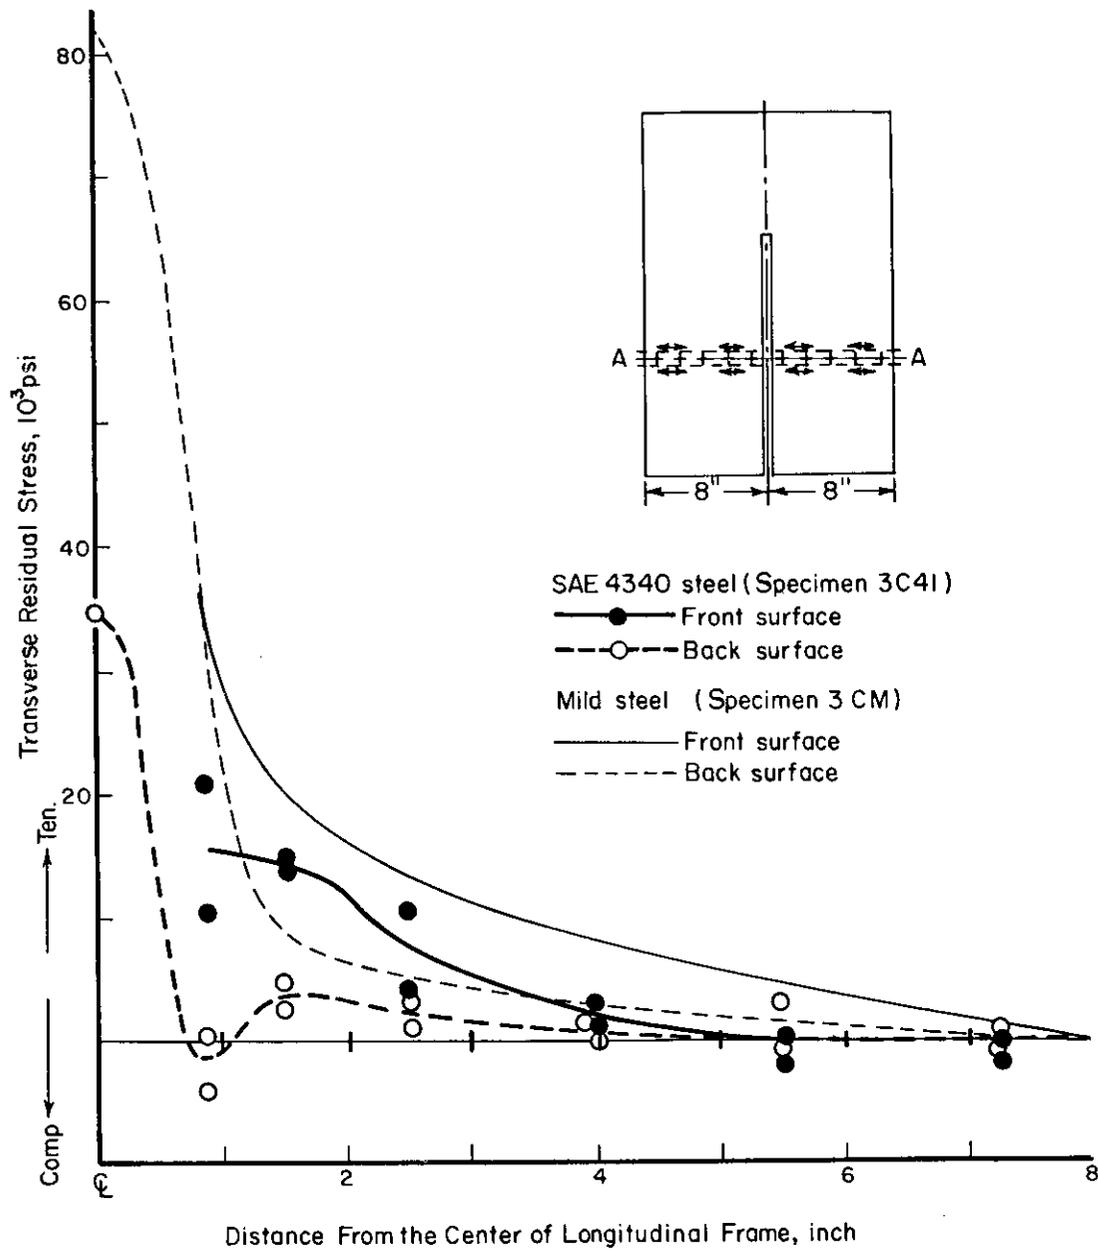
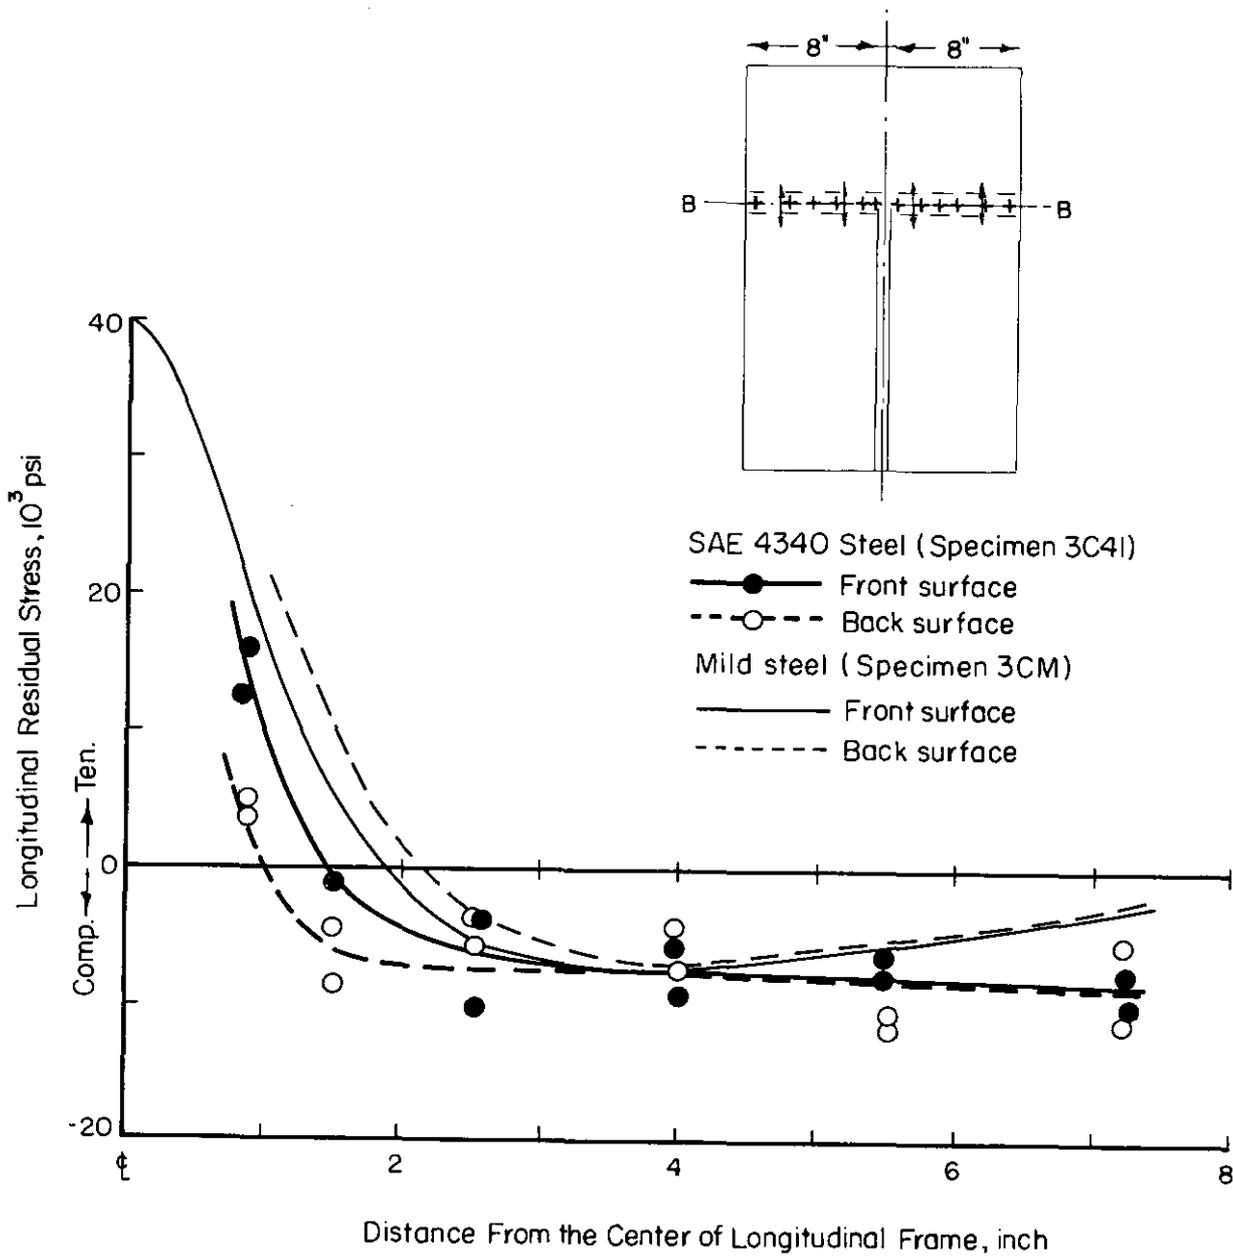
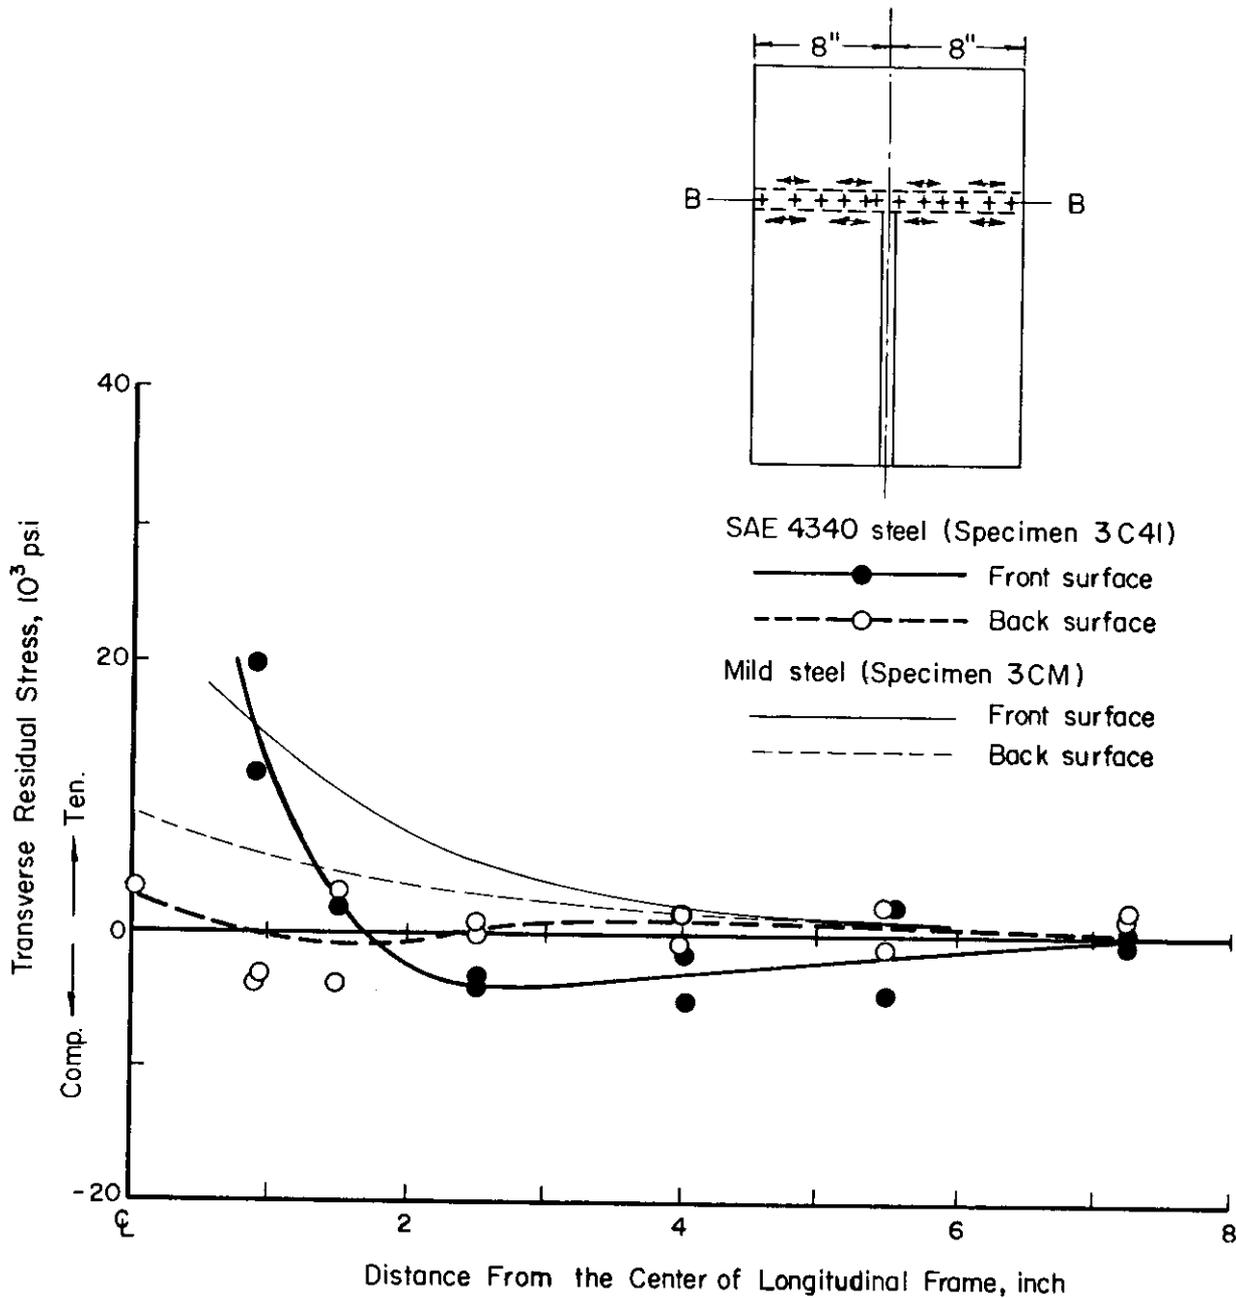
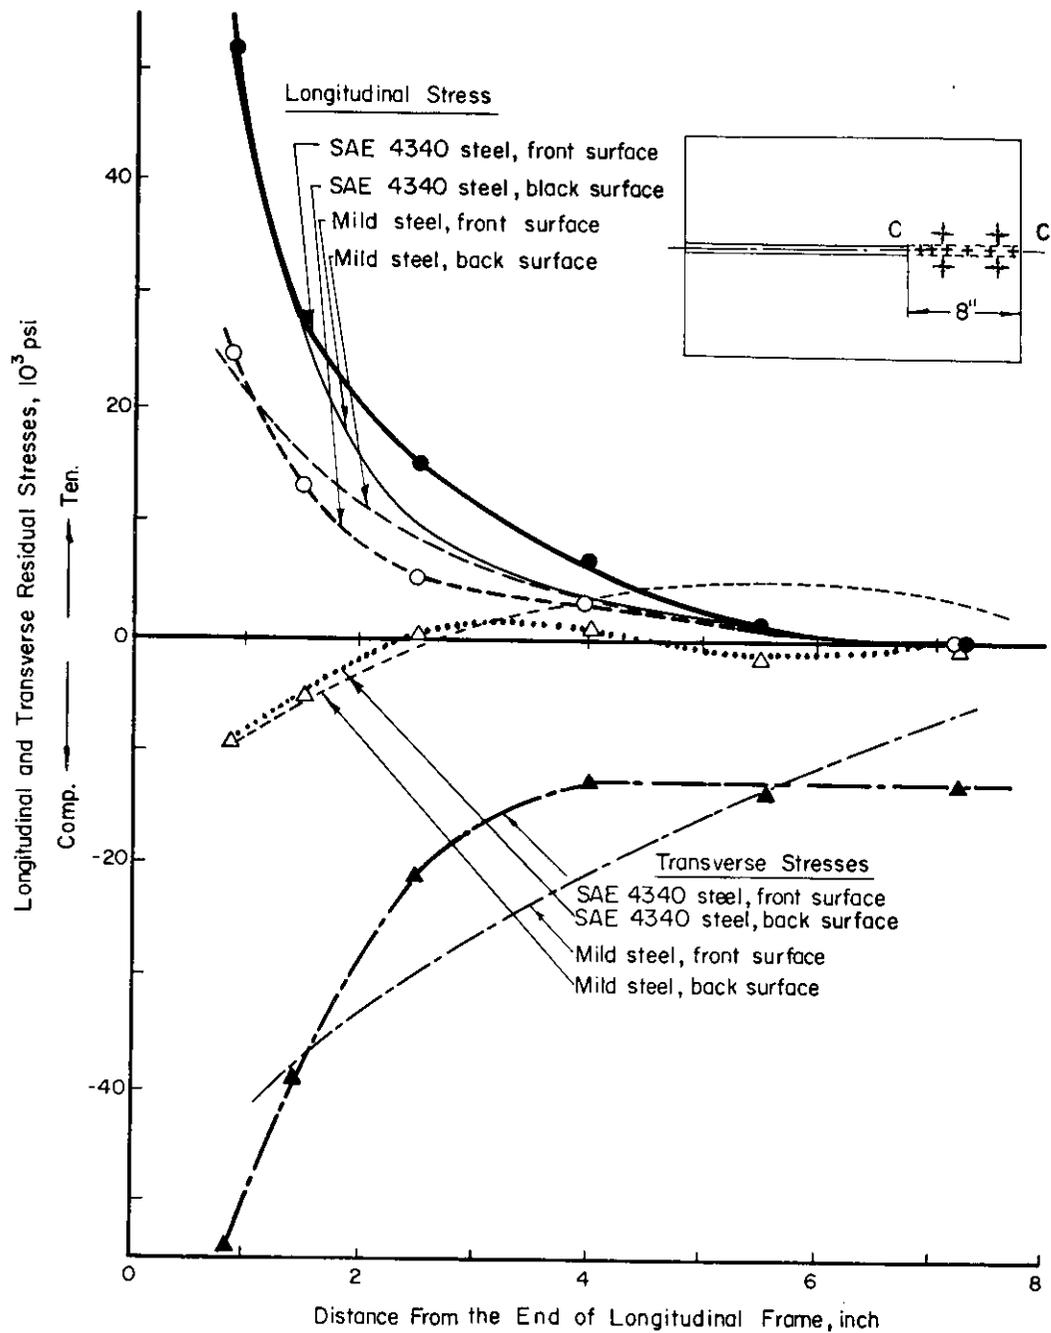
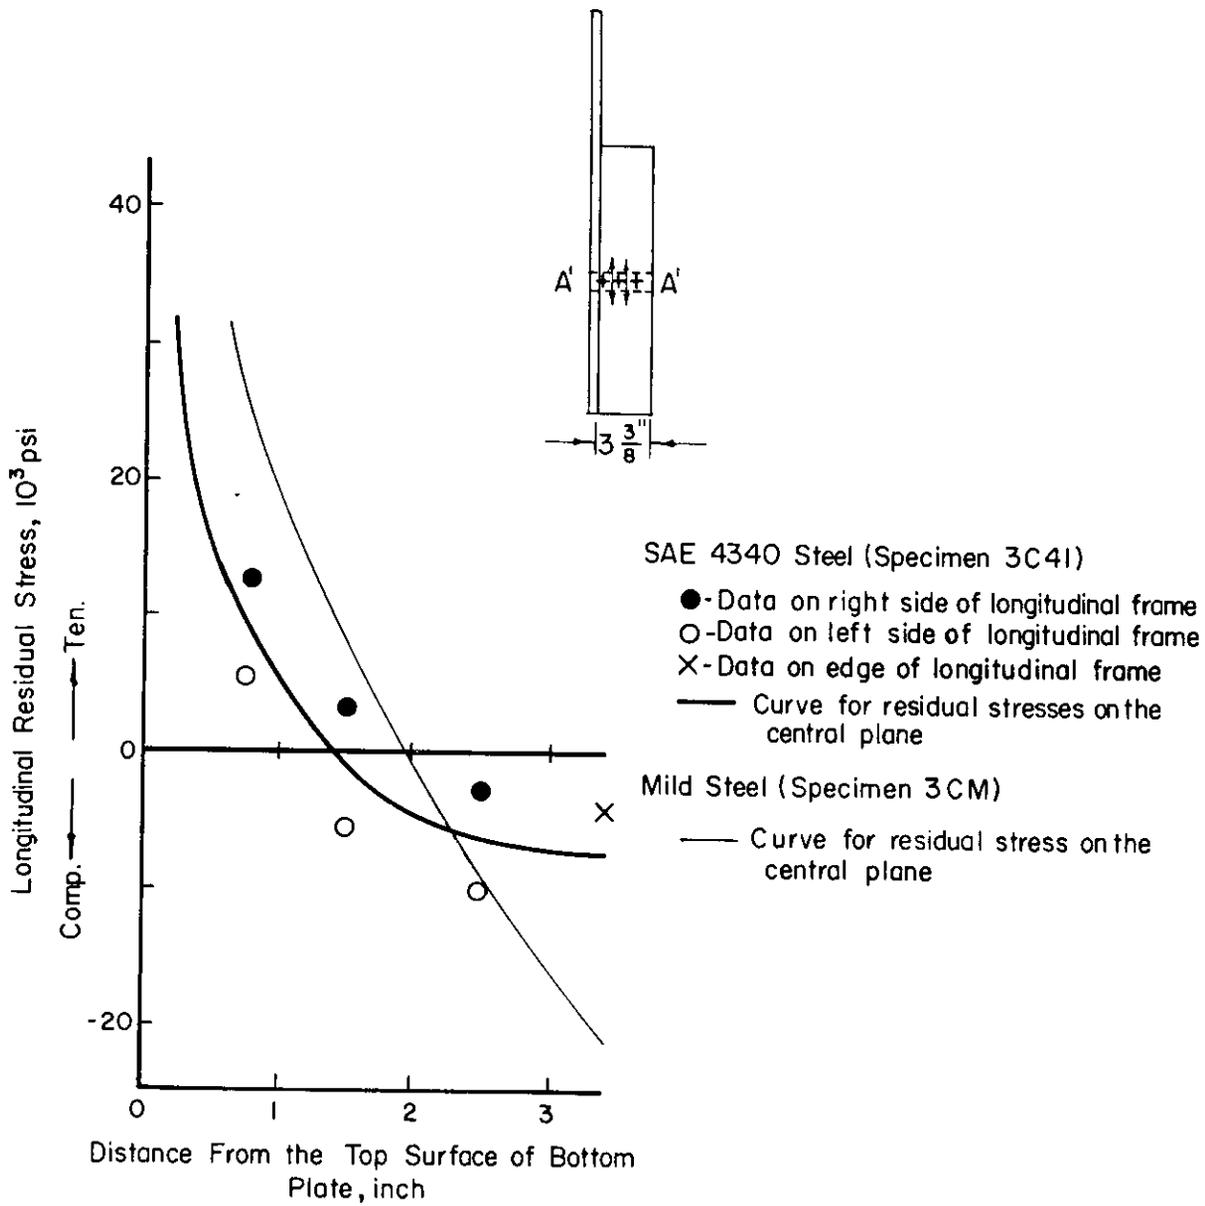
a. Distribution of longitudinal residual stresses in the bottom plate along line AA.

b. Distributions of transverse residual stresses in the bottom plate along line AA.

c. Distributions of longitudinal residual stresses in the bottom plate along line BB.

d. Distributions of transverse residual stresses in the bottom plate along line BB.

e. Distance of longitudinal and transverse residual stresses in the bottom plate alloy line CC.

f. Distribution of longitudinal residual stresses in the longitudinal frame along line A'A'.

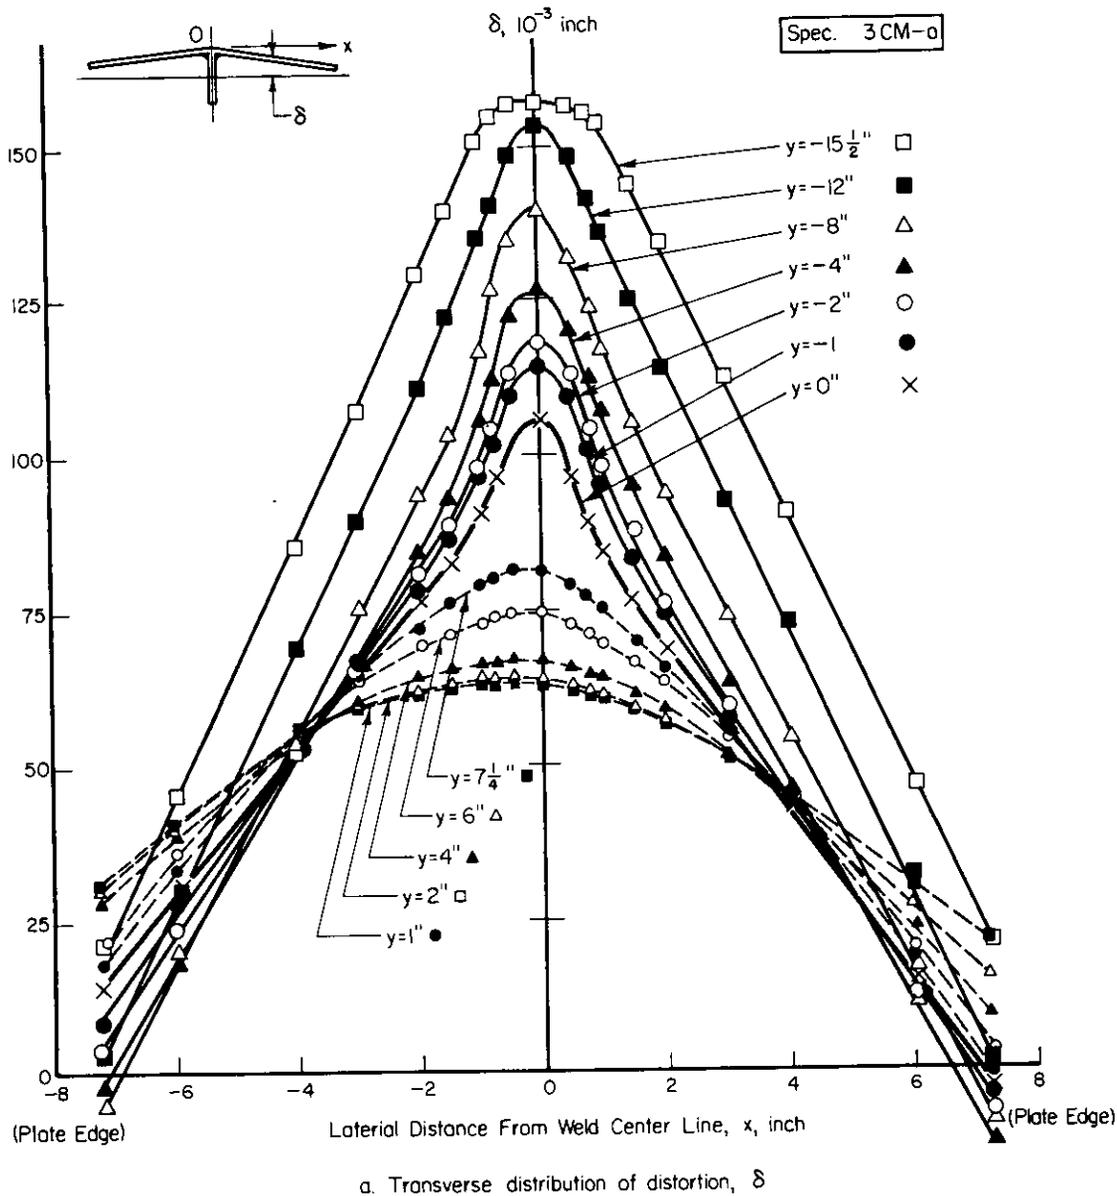
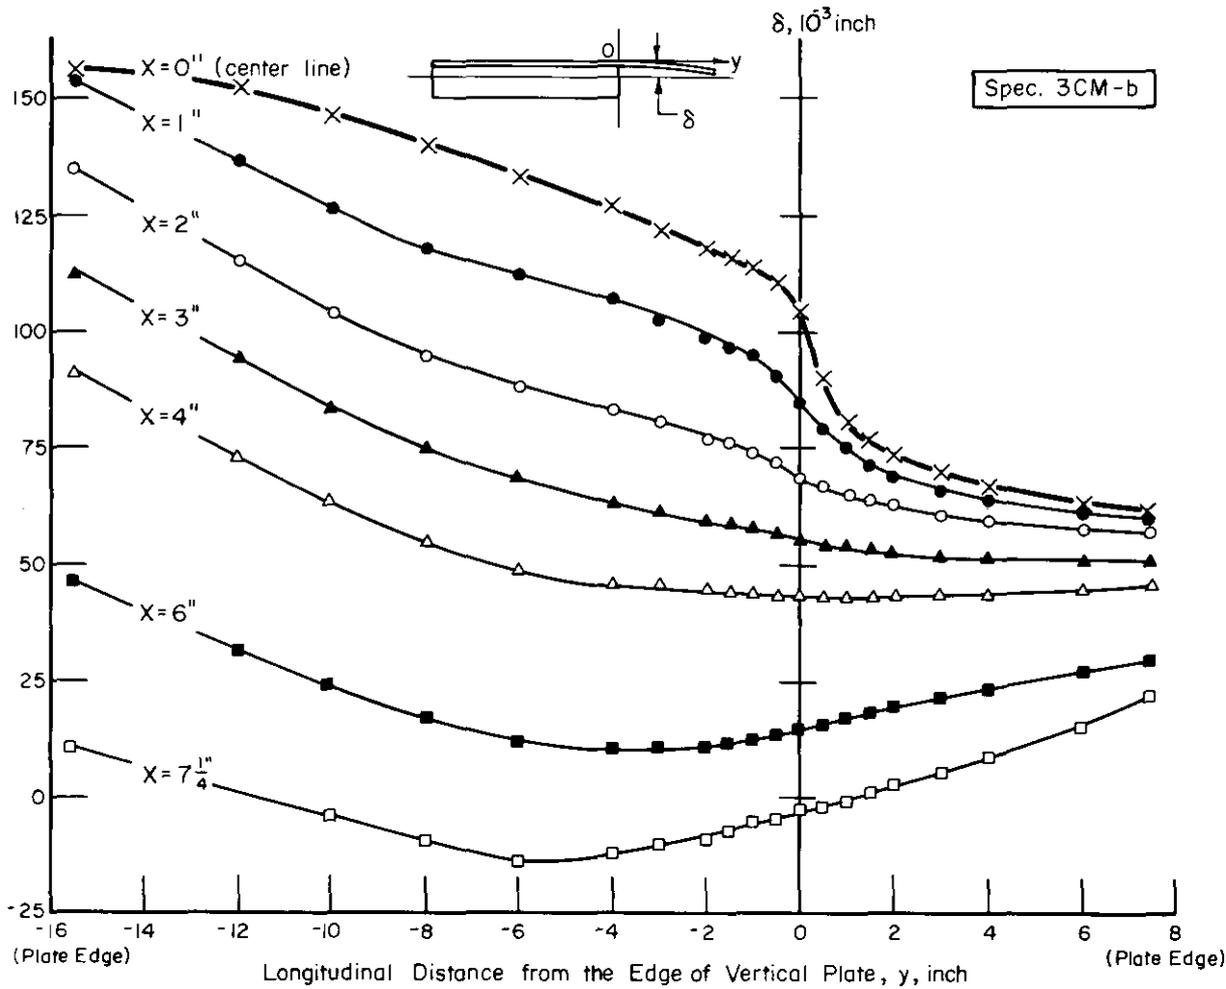
Fig. 34. Distortion due to welding of Specimen 3CM (Complex structure, mild steel).

b. Longitudinal distribution (+ X side) of distortion,  $\delta$

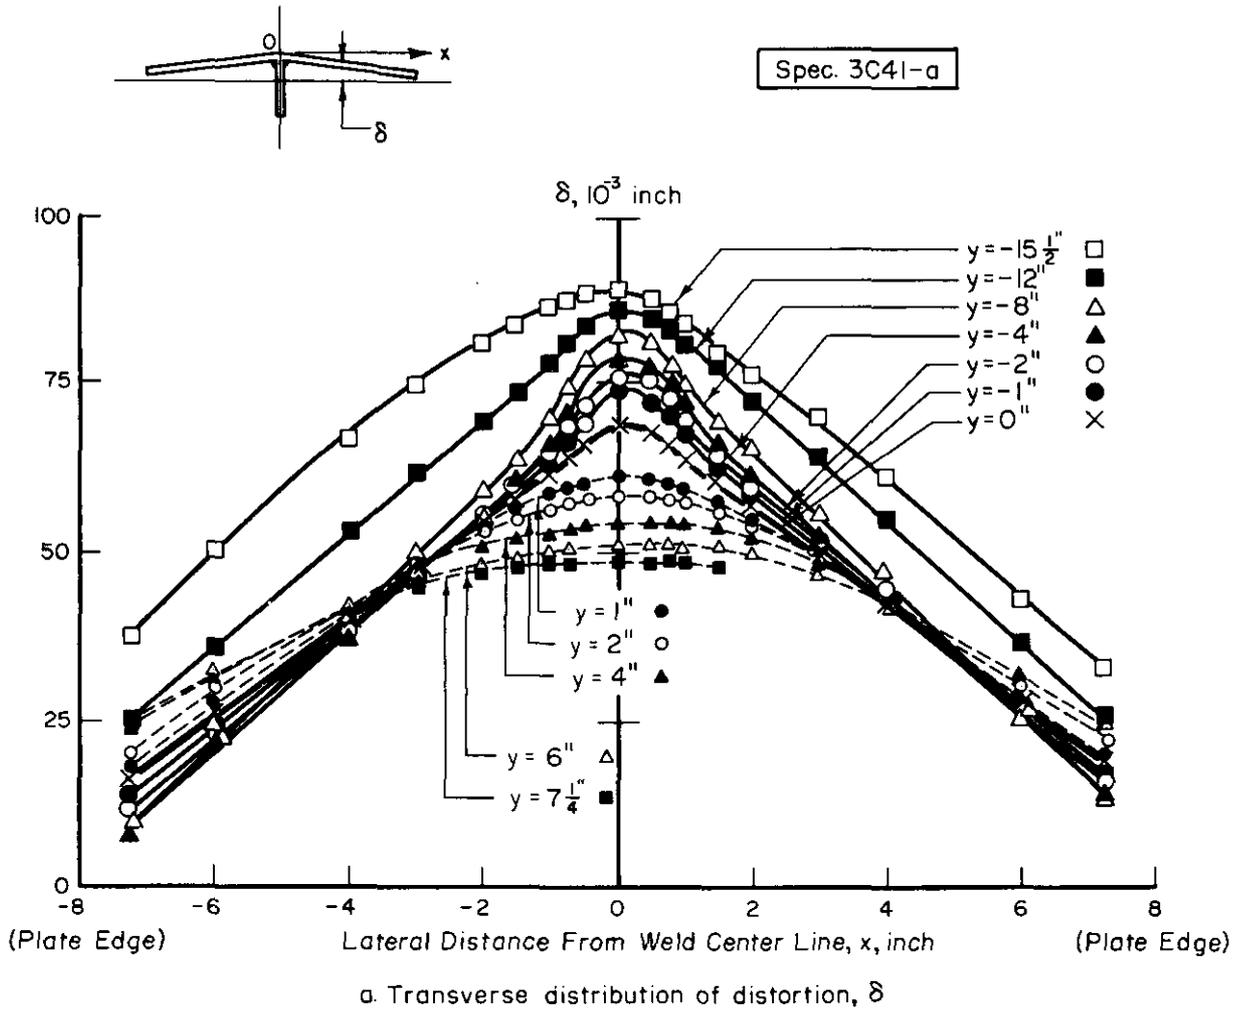
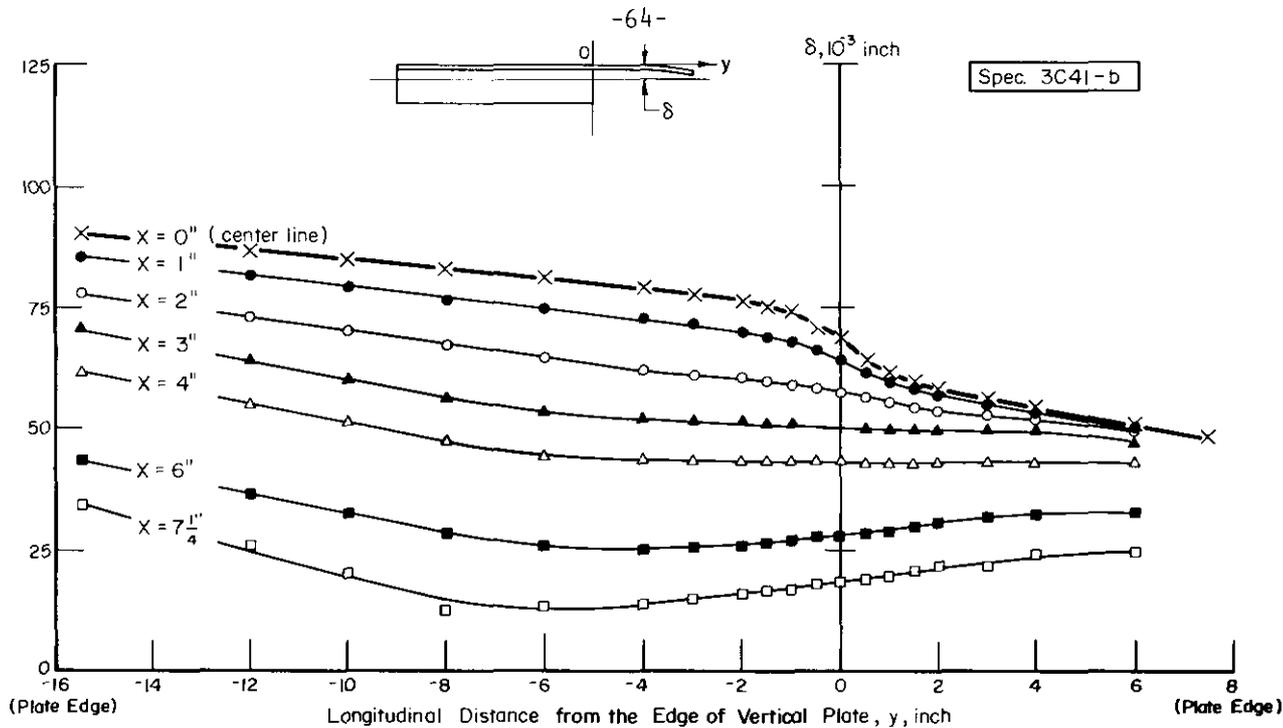
Fig. 35. Distortion due to welding of Specimen 3C41 (Complex structure, SAE 4340 steel).

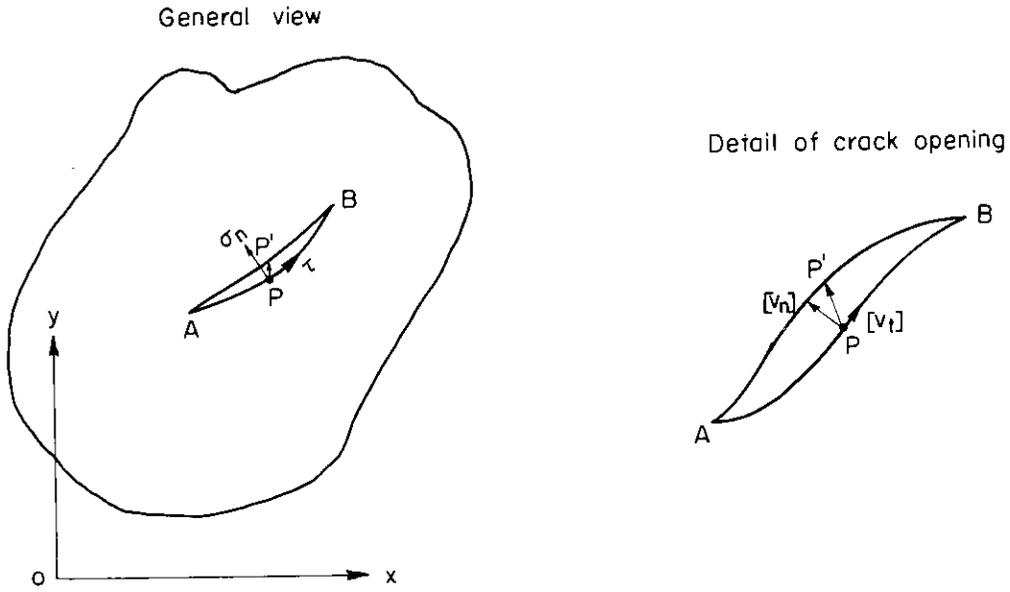
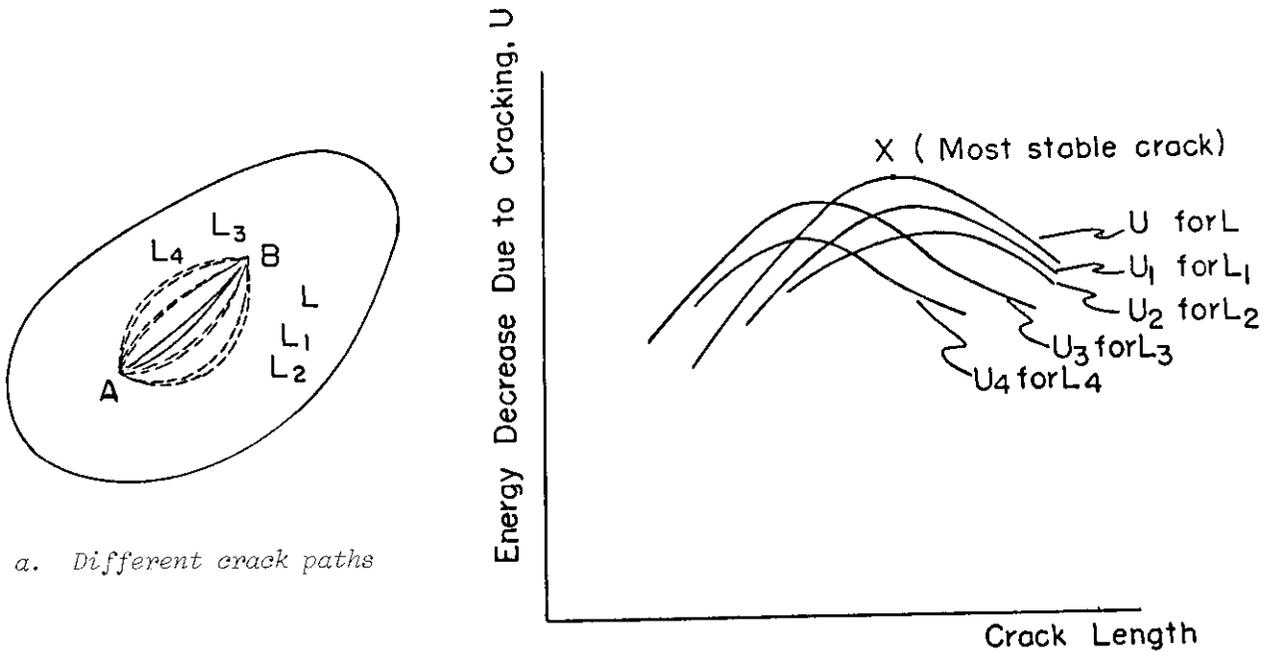
Fig. 36. Occurrence of a crack in a body containing residual stress.

b. Changes of energy decrease due to cracking,  $U$ , for cracks which have different paths and different lengths

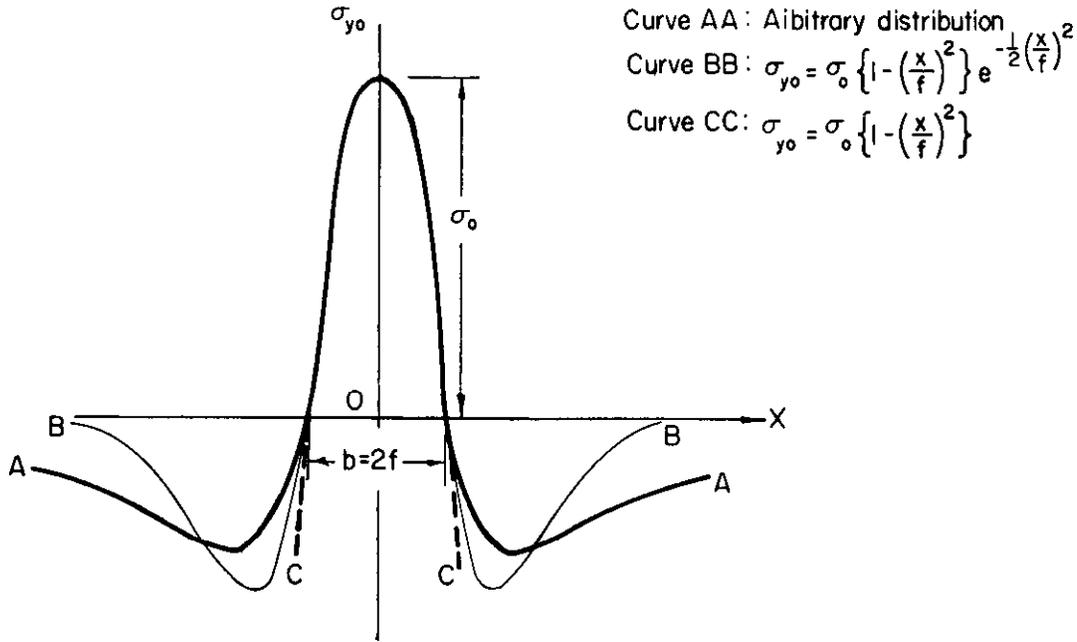
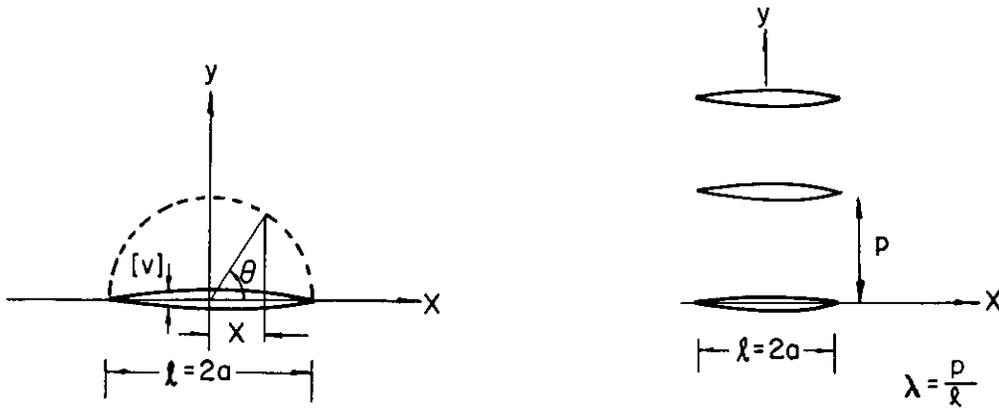
a. Distributions of longitudinal residual stress  $\delta y_0$ .

b. Straight single crack

c. Parallel cracks

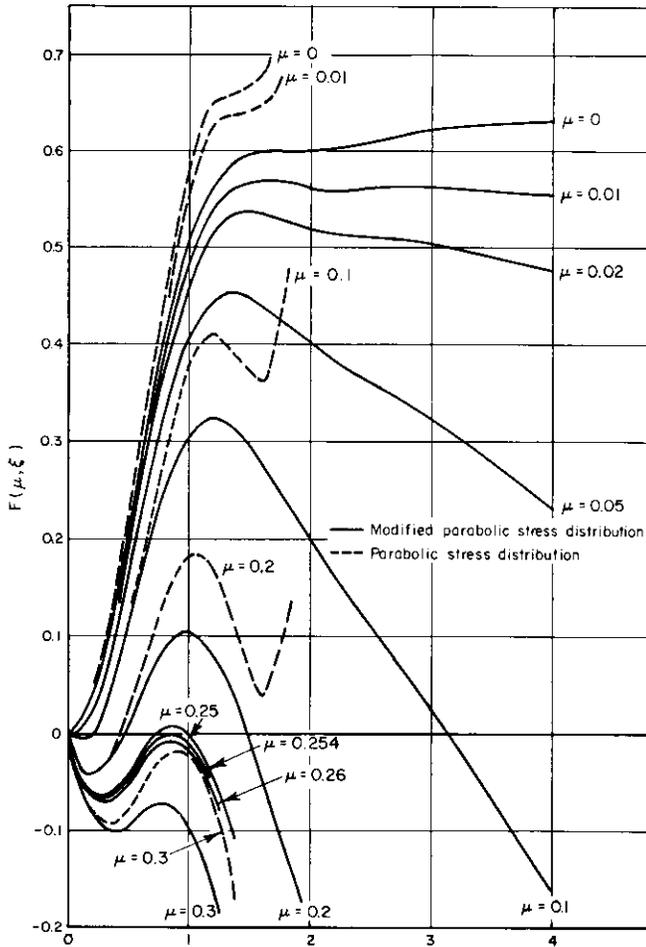
Fig. 39. Curves of  $F(\mu, \xi)$  for modified parabolic and parabolic residual-stress distributions.

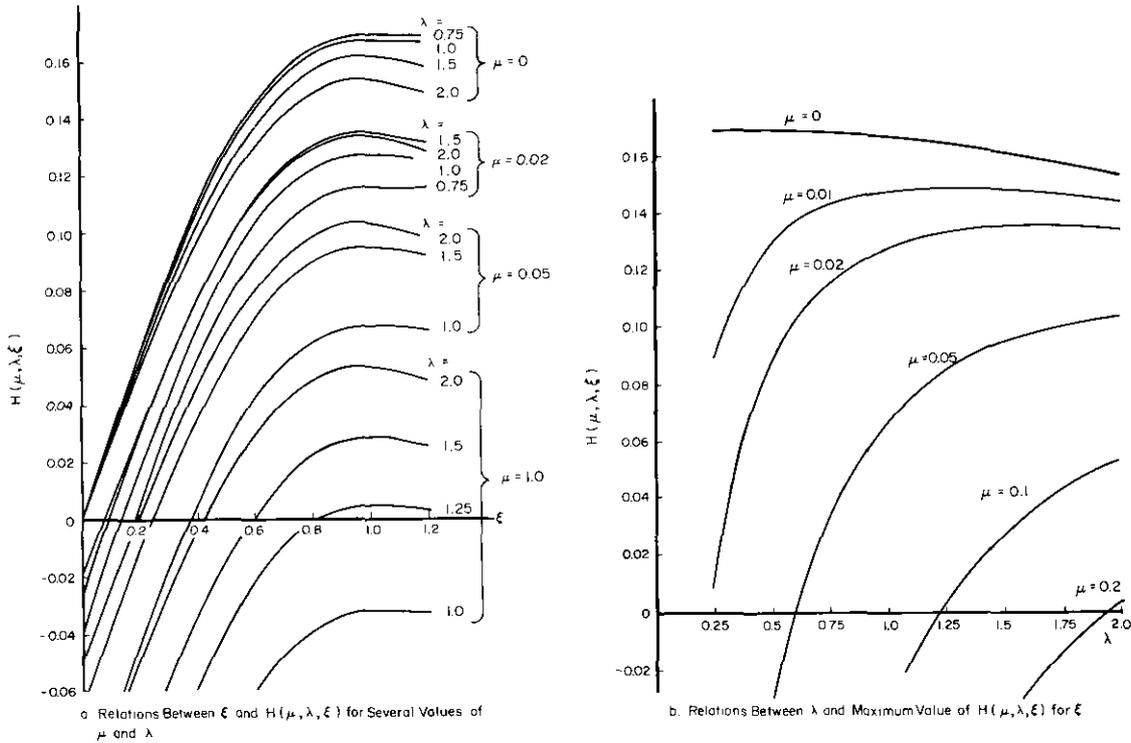
Fig. 40. Curves of  $H(\mu, \lambda, \xi)$  for parallel cracks.

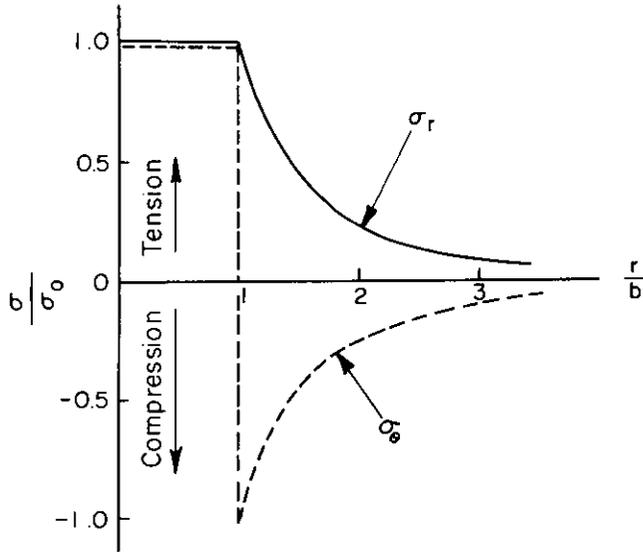
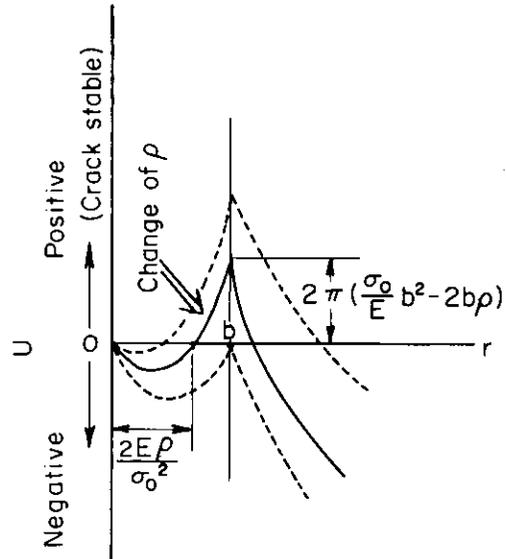
a. Residual-stress distribution

b. Strain-energy release (Schematic)

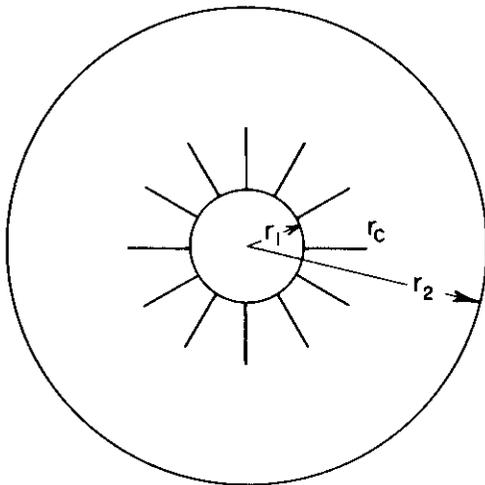
Fig. 42. A system of radial cracks.

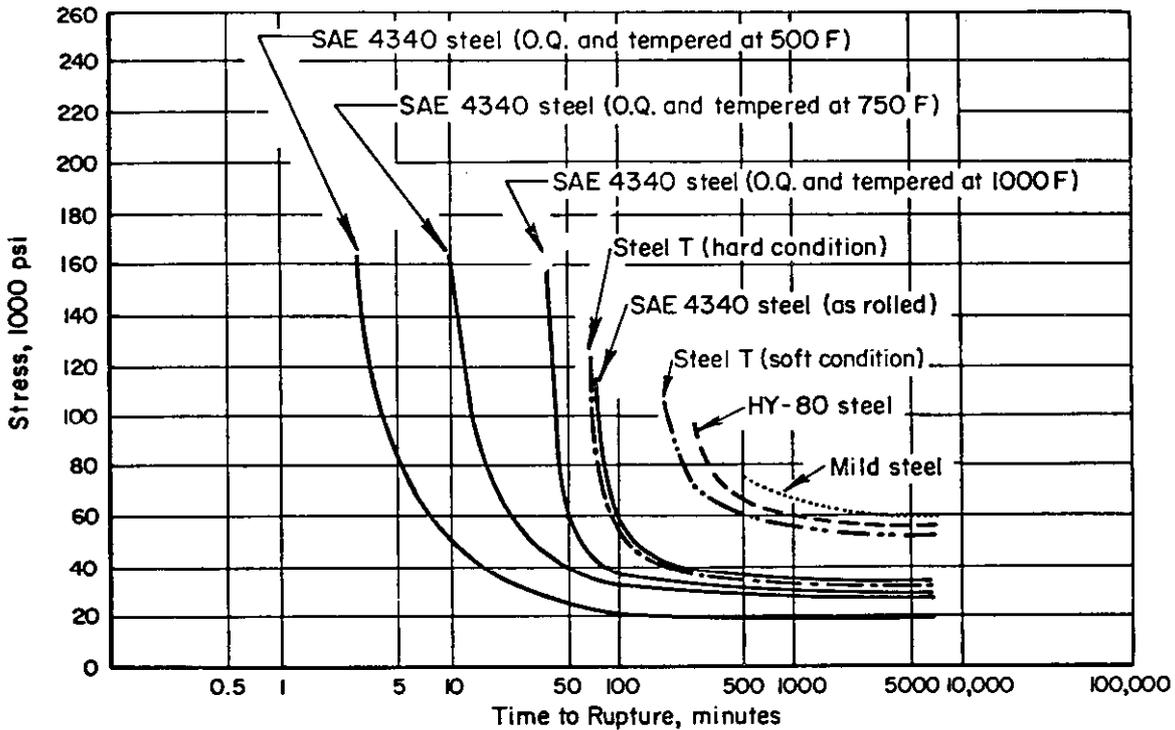
Fig. 43. Hydrogen-induced delayed-fracture characteristics of various steels used in this research. Curves were estimated from results obtained by Simcoe, et al. (9) The commercial high-strength structural steel is identified as Steel T in the above figure.
