## **Ship Structure Committee Case Study**

### *RMS TITANIC: ALTERNATIVE THEORY: Complete Hull Failure Following Collision with Iceberg*

**Summary:** The wreck of RMS Titanic is arguably the most famous marine casualty of modern times. On 14 April 1912 during her maiden voyage, RMS Titanic struck an iceberg southeast of Newfoundland, Canada. She floated for approximately two hours, eventually assuming an extreme trim by the bow and breaking in half.

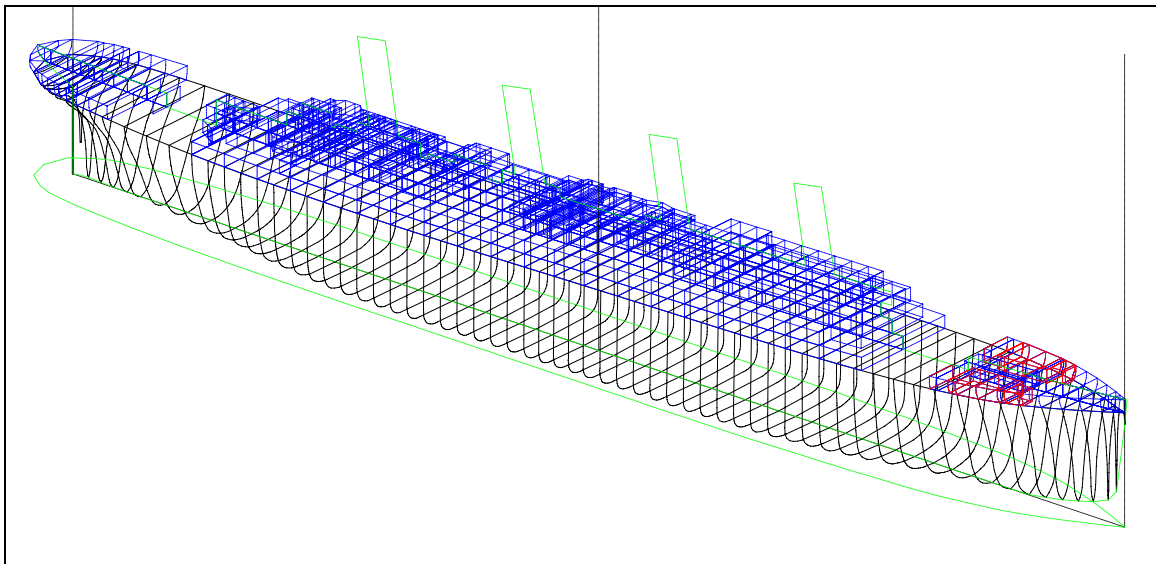
**Figure 2. HECSALV Hull Model**

JMS developed a HECSALV digital hull model of the TITANIC's hull suitable for calculation of hydrostatics, stability, hull bending moments, and shear force. This included main and secondary watertight compartments in the forward half of the vessel for determination of damaged compartment volumes, flooded weight and free surface. Hull and structural modeling were based on vessel plans. Figures 2 through 4 show the hull model and watertight subdivision.

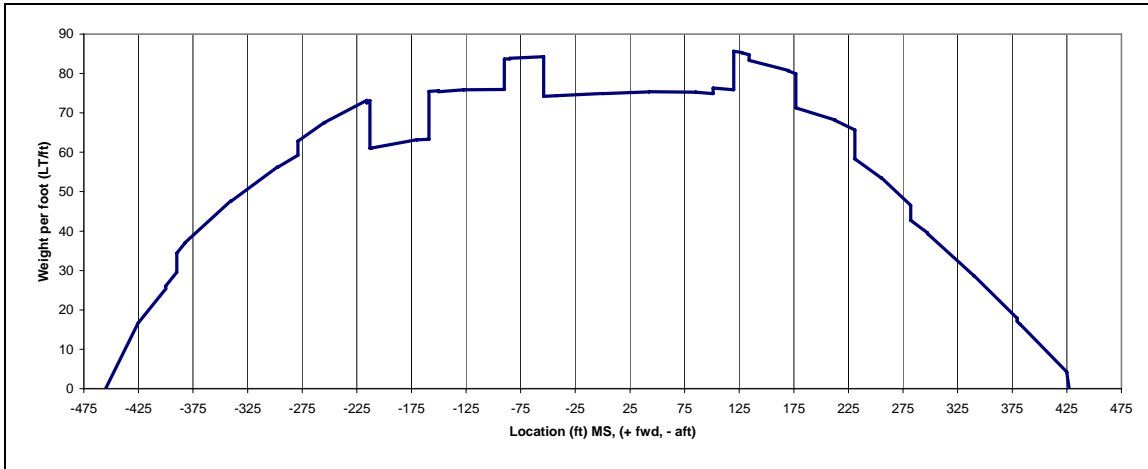
**Figure 5.** Weight Distribution Curve

It was assumed that the intact loading condition (just prior to collision with the iceberg) resulted in a displacement of 50,220 LT. The resulting drafts are 30 feet at the forward perpendicular and 35 feet 7 inches at the aft perpendicular. The weight curve shown in Figure 5 was developed based upon general naval architecture assumptions as summarized in Table 1.
