Yesterday's Technology—Today's Ships— Some Tanker Experience

D. J. Szostak, Member, Marine Transport Lines, Inc., New York, N.Y.

ABSTRACT

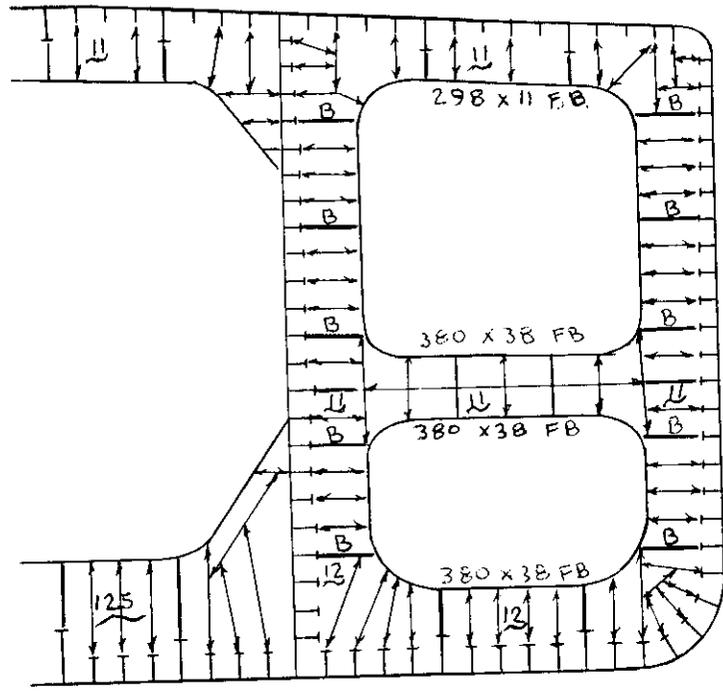
Figure 15 - Case II - Midship Section As Built

The scantlings of the transverse ring, as built, are shown in Figure 15.

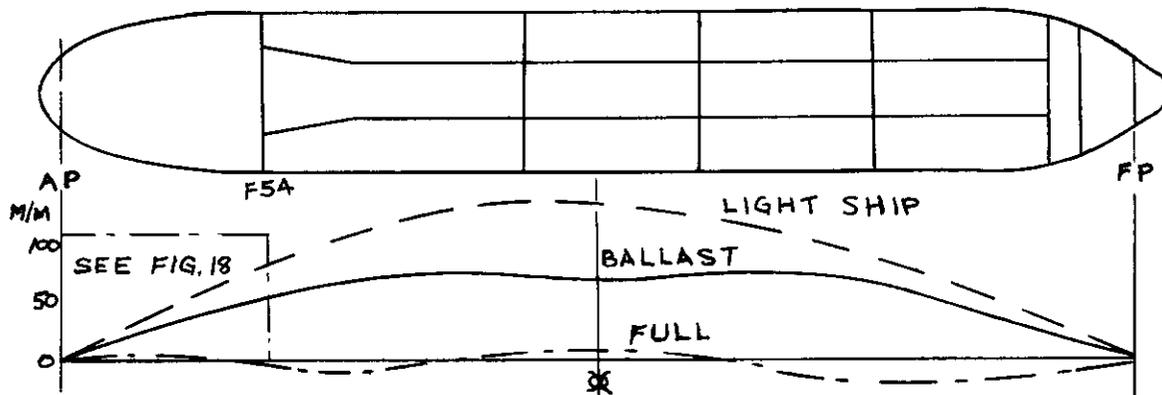
Figure 17 - Deflection of Hull Girder

During the design stages of this class of vessels the anticipated hull deflection was calculated using the conventional longhand longitudinal strength computation methods for different conditions of loading. The results are illustrated in Figure 17 and show a fairly typical tanker deflection curve. It can be seen that the characteristic hogging conditions exist in light ship and ballast conditions. The full load condition shows almost no deflection aft, but some sagging forward. The effect of empty midship ballast tanks is evident in this figure.

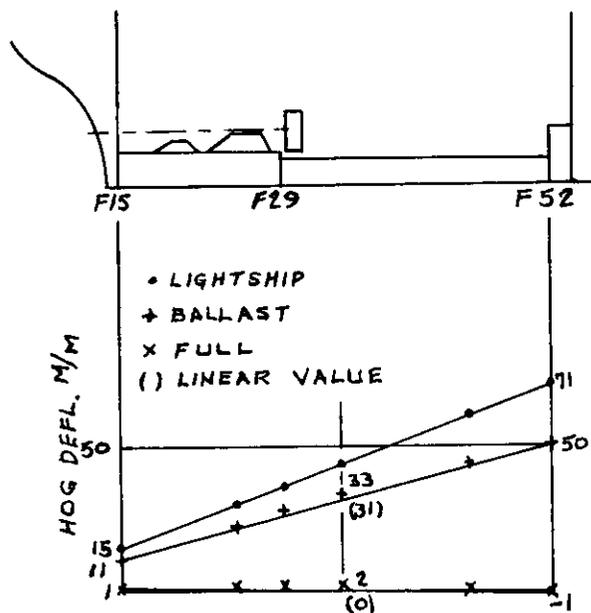
Figure 18 - Deflection of Hull Girder in Way of Engine Room

An enlargement of the engine room portion of the hull girder deflection curve is presented in Figure 18. From the figure it can be seen that the engine room deforms essentially linearly. There is indicated up to 2mm upward deviation from a linear projection from the stern frame to the engine room forward bulkhead in the fully loaded and ballast conditions. However, the relative deflection of the engine room double bottom from the linear between those two operating conditions doesn't change. For example, forward of Frame 29, the location of the main reduction gears, the deviation from the linear is 2mm in both loaded and ballast conditions. The conclusion was to neglect the change in deformation of the hull as a girder for practical operating conditions. Proper shaft alignment for the ballast condition was considered to be valid for all the operating

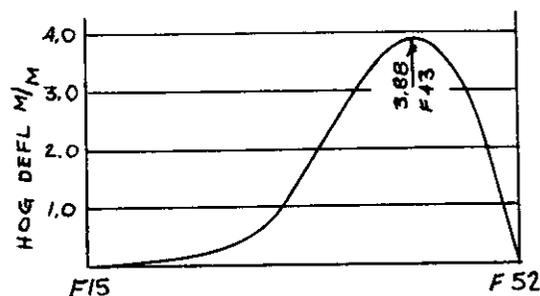
Figure 19 - Deflection at \mathcal{C} Due to 6.1 Meter Draft Change

The importance of determining the local deflection of the double bottom under the bearing foundations was recognized. A finite element analysis technique was applied utilizing a newly developed computer programmed Matrix Method of Structural Analysis of Framed Structures. The result of this analysis of the steel work as a complex box structure indicated an expected deflection pattern at the ship's centerline to be as indicated in Figure 19 for a uniform load equivalent to 6.1 meters (20 feet) draft variation. The calculated deflection increased from 0 at the afterpeak bulkhead to 0.47mm at the after end of the gear case, 0.85mm at the bull gear forward bearing to a maximum of 3.88mm at Frame 43, well forward of the gearing and line shafting. Expressed in terms of deflection at the bull gear forward bearing per foot of vessel draft aft the expected deformation amounted to 0.42mm/10 feet.
